Buzzards Bay Salt Marshes: Vulnerability and Adaptation Potential

Callista Macpherson, Buzzards Bay Coalition
SNEP Symposium, June 12, 2024

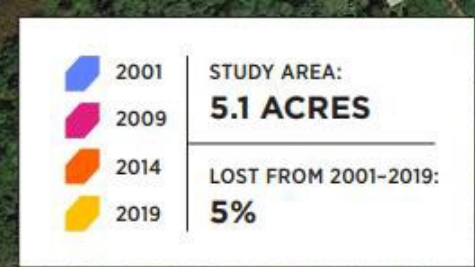
Site map with marsh area in different years shown by shaded regions. Blue, pink, and orange shading indicate areas that were previously vegetated but were bare in 2019. Created with Google Earth.

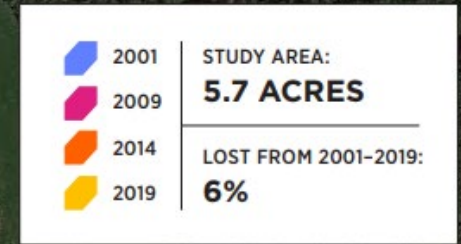
Site map with marsh area in different years shown by shaded regions. Blue, pink, and orange shading indicate areas that were previously vegetated marsh but were bare in 2019. Created with Google Earth.

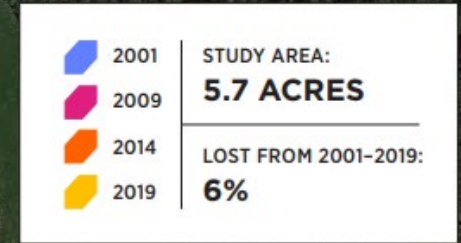
Site map with marsh area in different years shown by shaded regions. Blue, pink, and orange shading indicate areas that were previously vegetated marsh but were bare in 2019. Created with Google Earth.

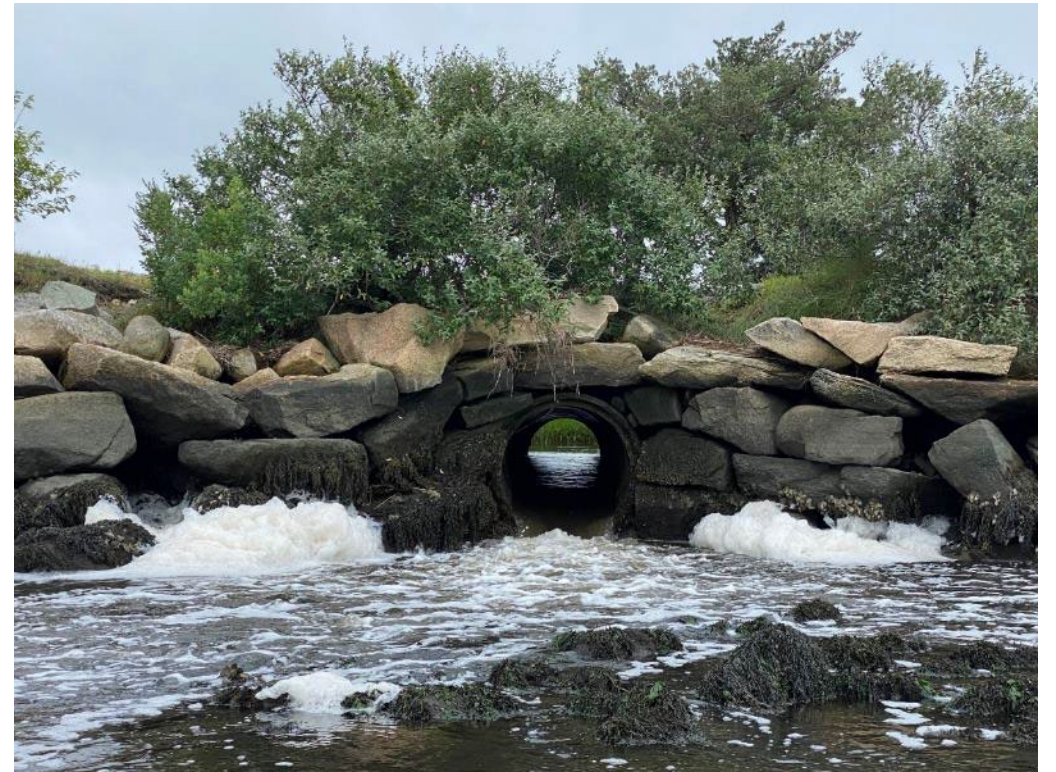
Results

- Between 2001-2019, 2 acres of marsh loss
 - Suggests 200 acres baywide

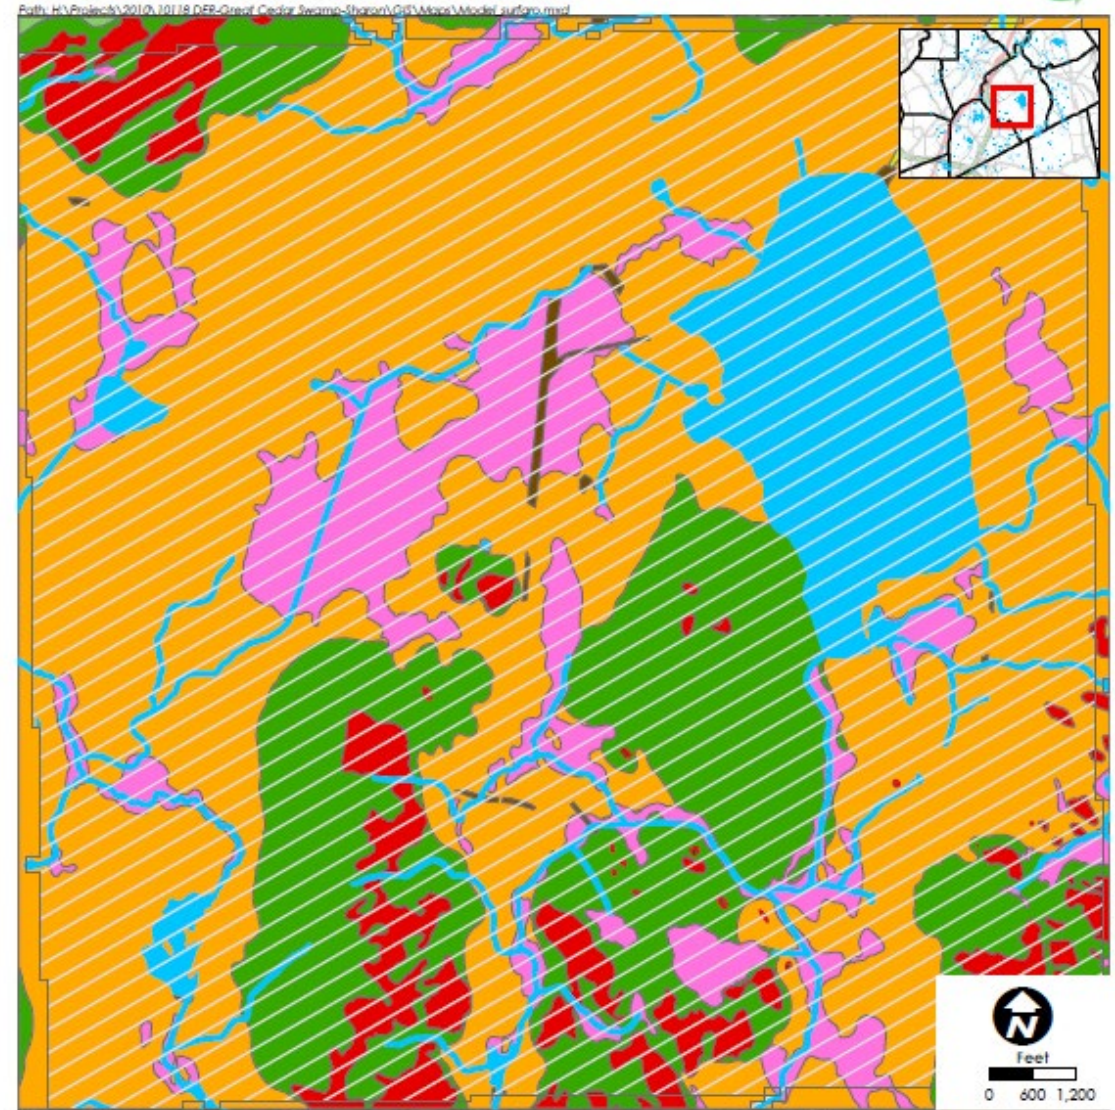
Groundwater Modeling

Model Setup

- Field Data
 - 2010 and 2023 surveys
- USGS surficial geology
- Subsurface boring logs
- Hydrography data
- LiDAR elevation data
- Previous water table maps

Surface Flowlines	bedrock outcrops
Surface Waterbodies	flood-plain alluvium
Model Domain	glacial stratified deposits, coarse
Surficial Geology	swamp deposits
areas of abundant outcrop or shallow bedrock	thick till
artificial fill	thin till

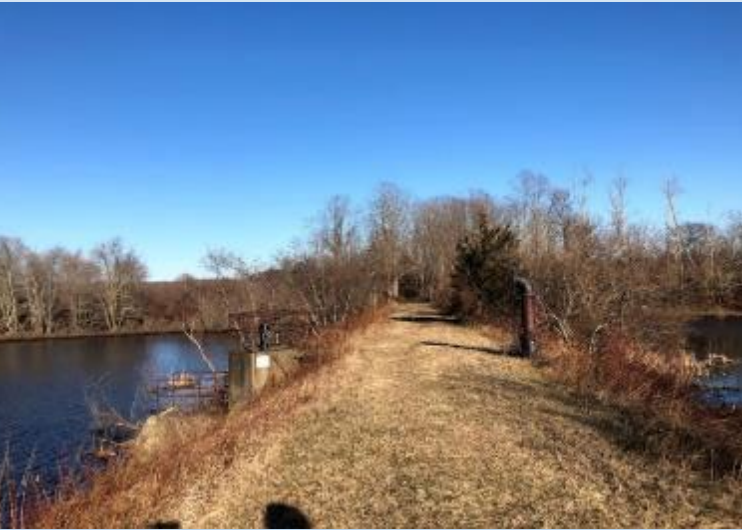
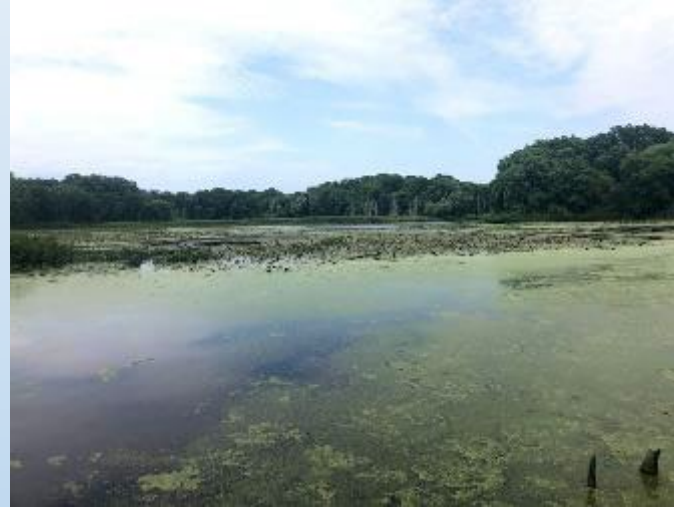
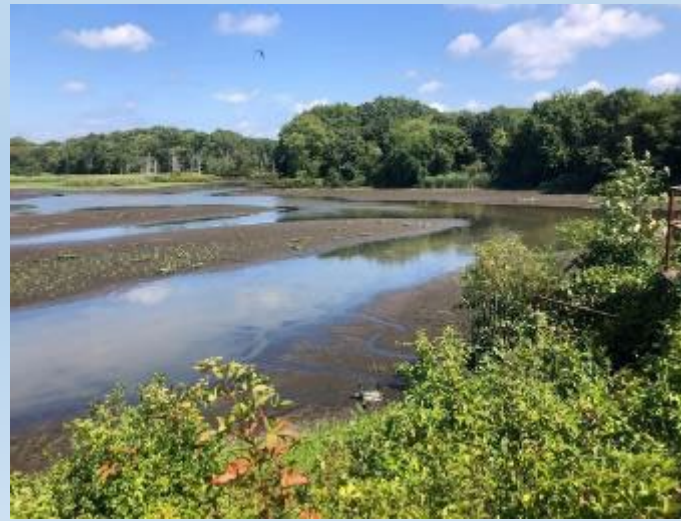
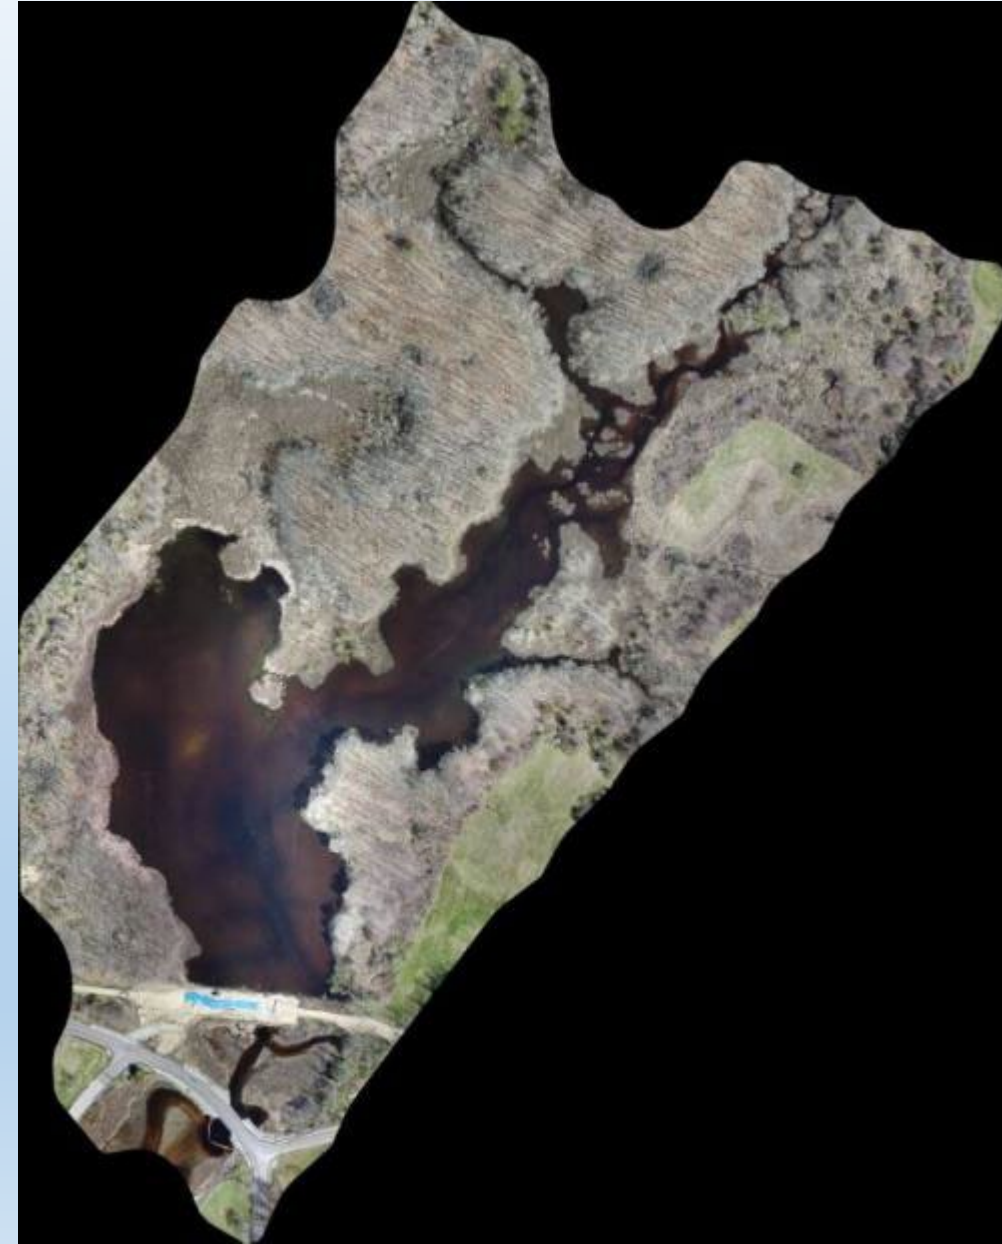
Upper Kickemuit Reservoir Dam

- Berm built in 1961 to protect water supply during coastal storms
- Dam requires repairs and not built to current State standards

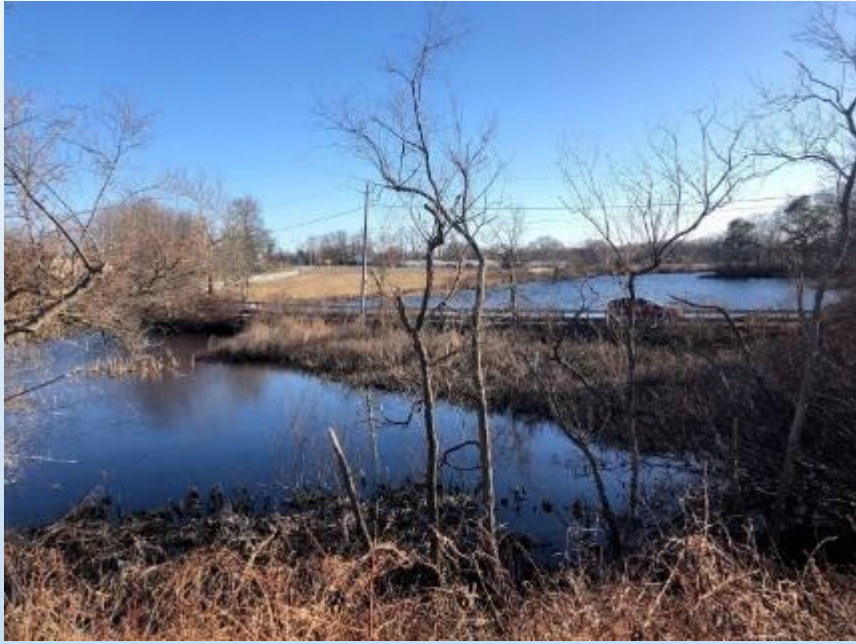
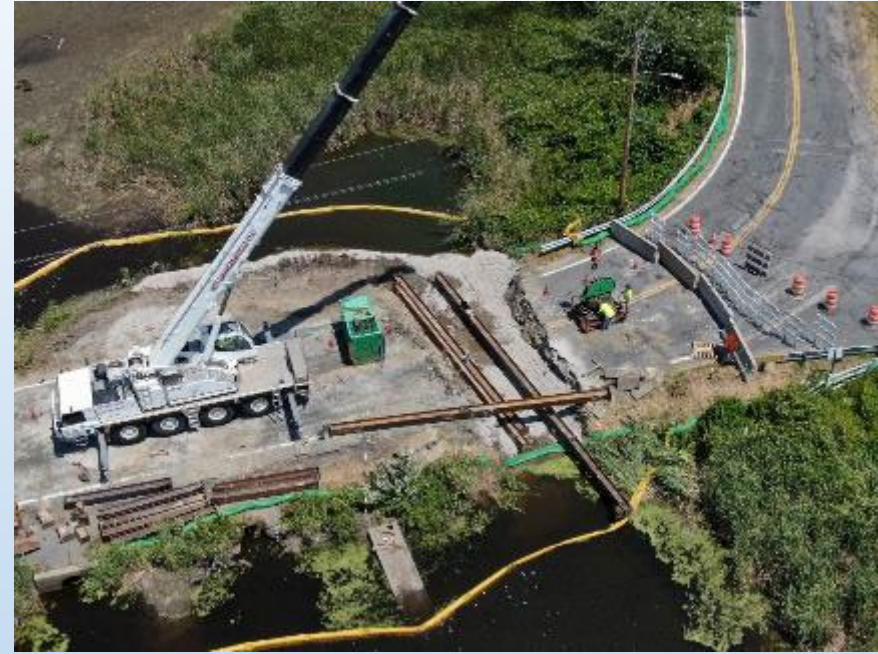
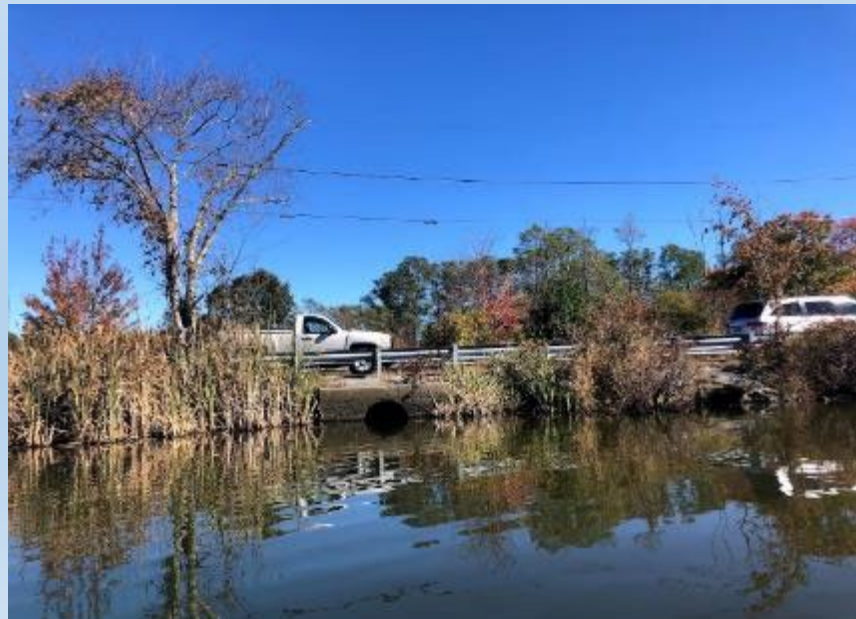
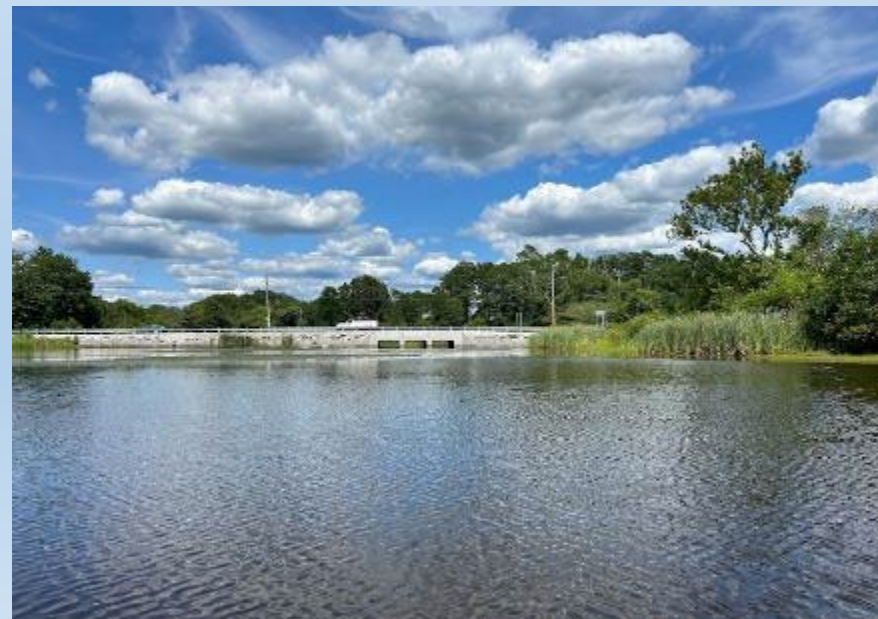
Phase 1: State elevated state-owned road and resized culverts (2022)

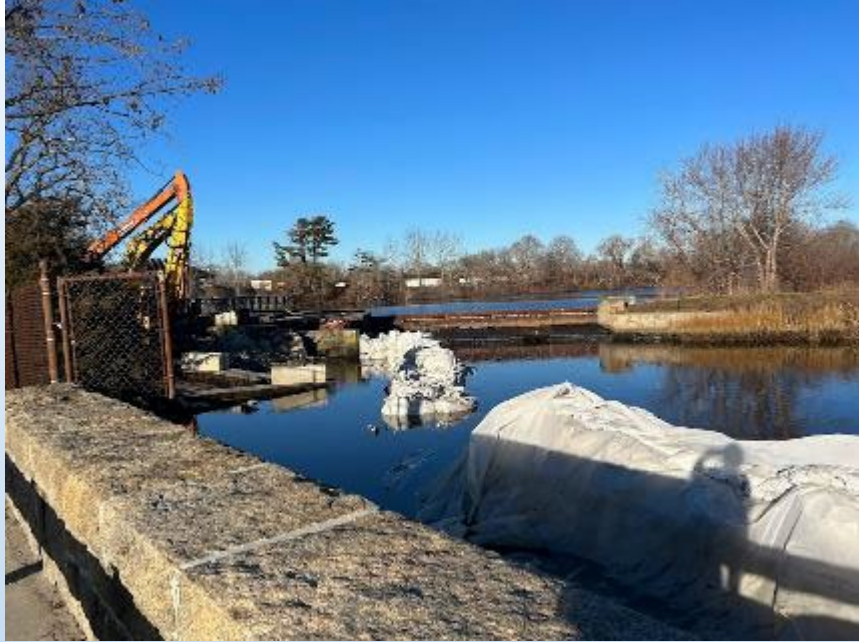
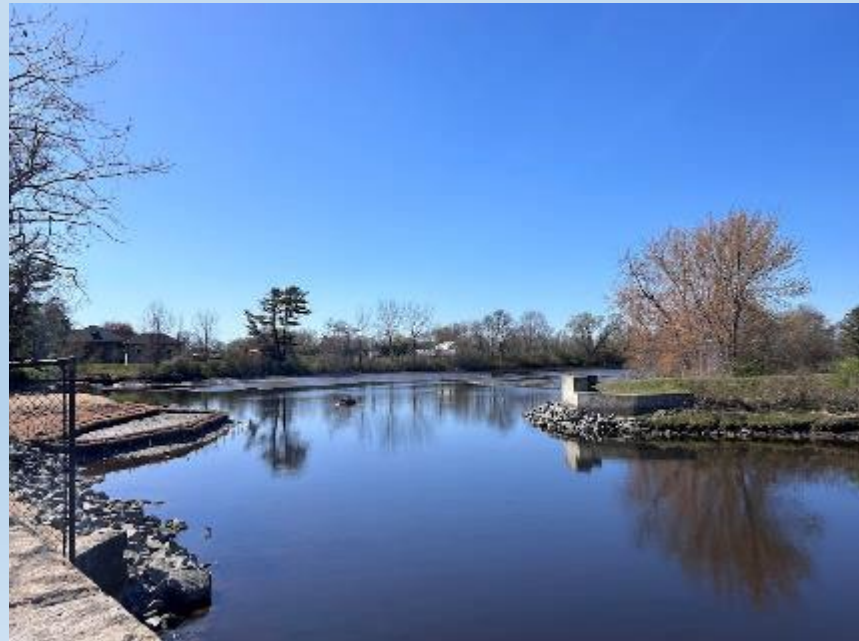
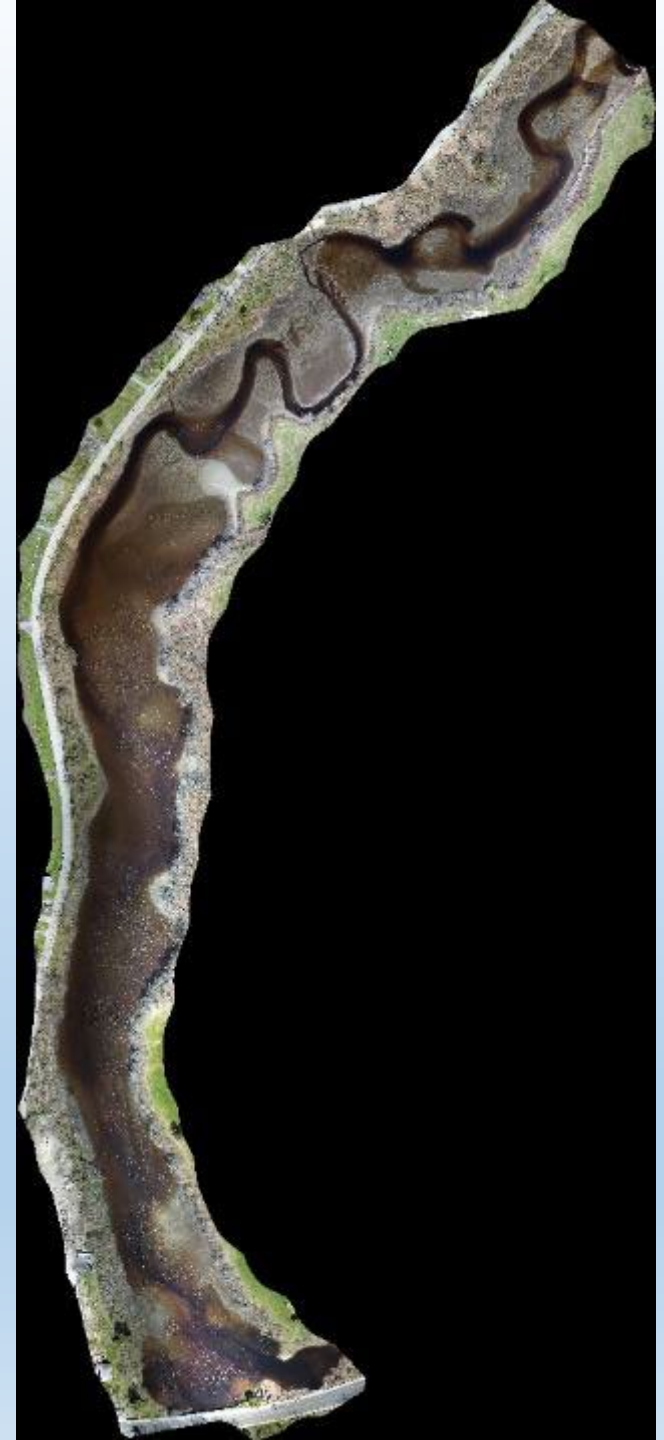
Phase 2: Lower Dam Removal

Fall 2023 – Winter 2024

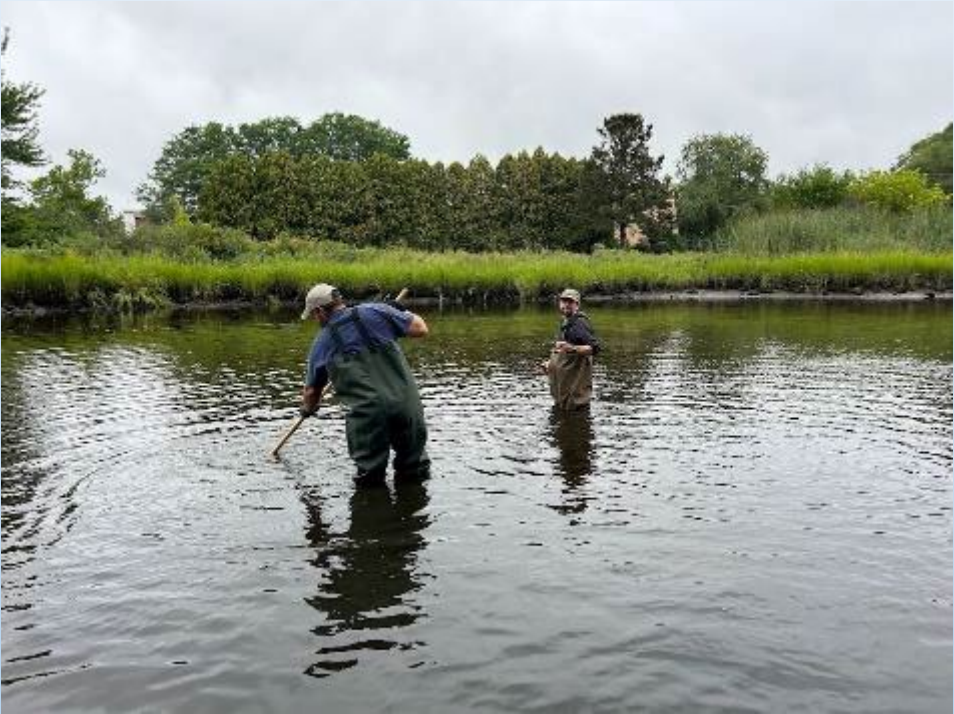
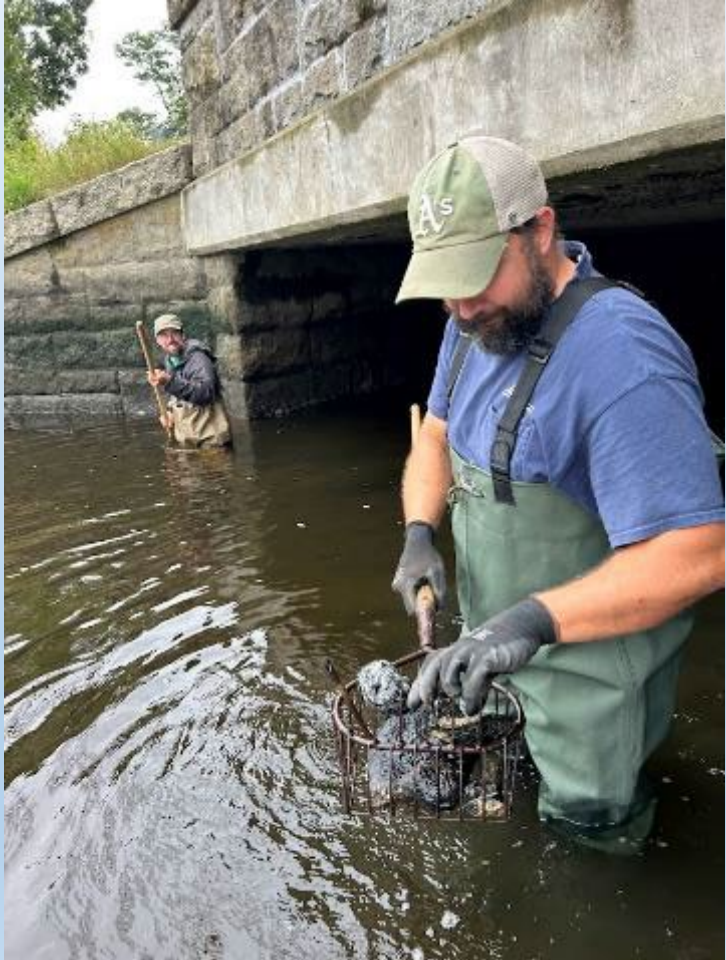
Relocation of oysters located just below Lower Dam prior to dam removal activity

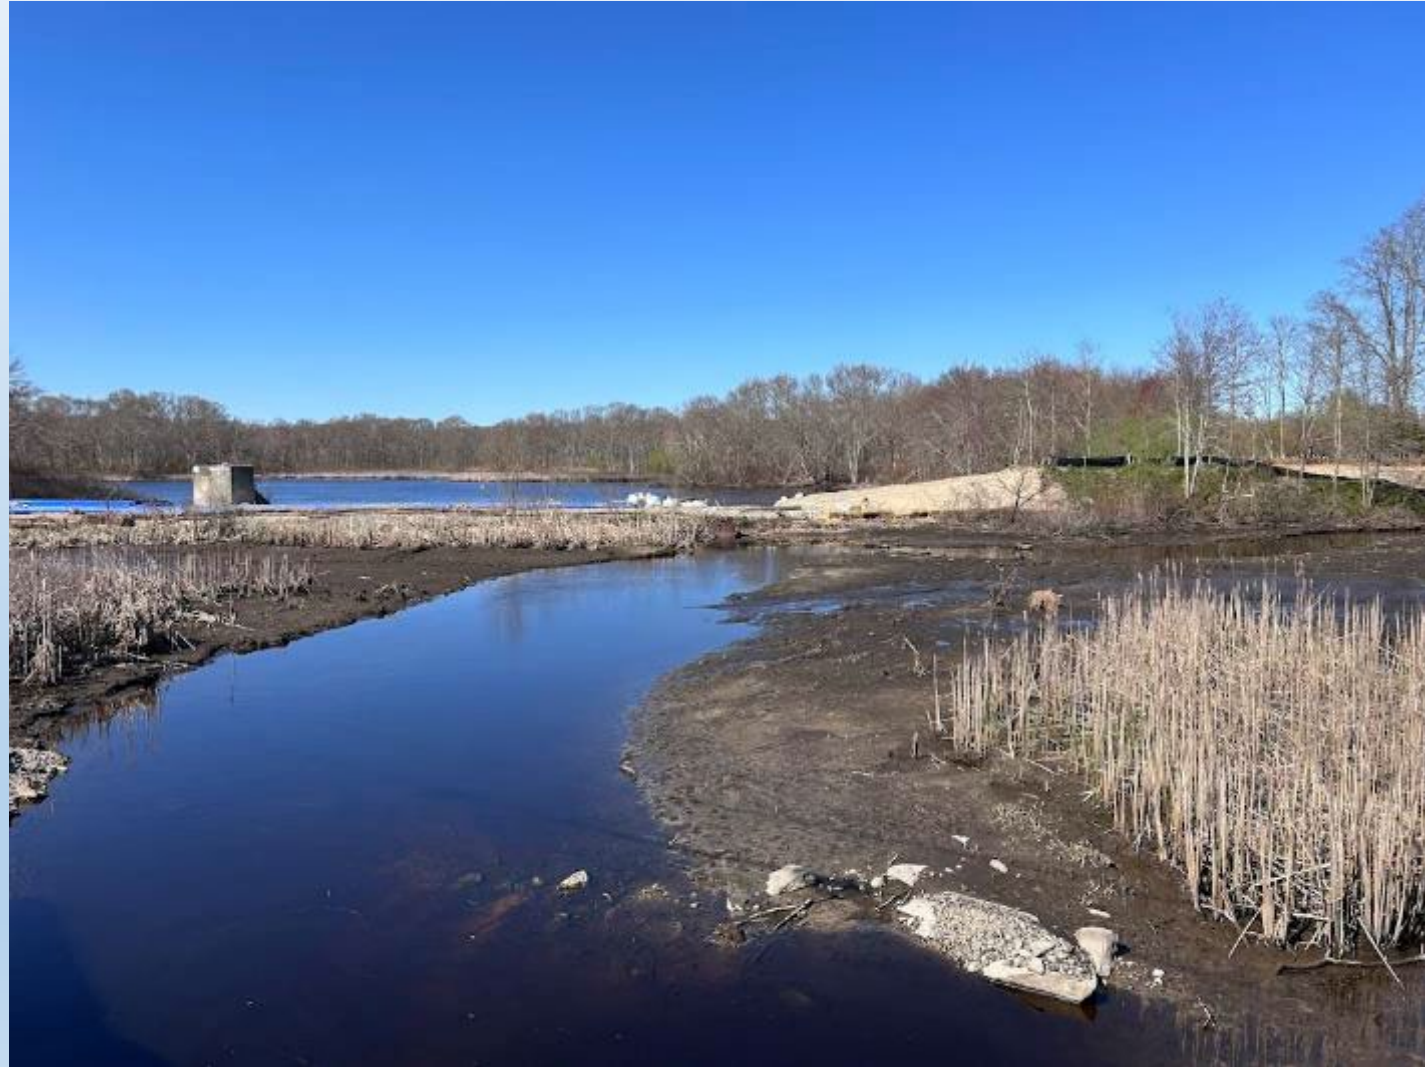
Phase 3: Upper Dam Removal

- Full removal in Summer 2024

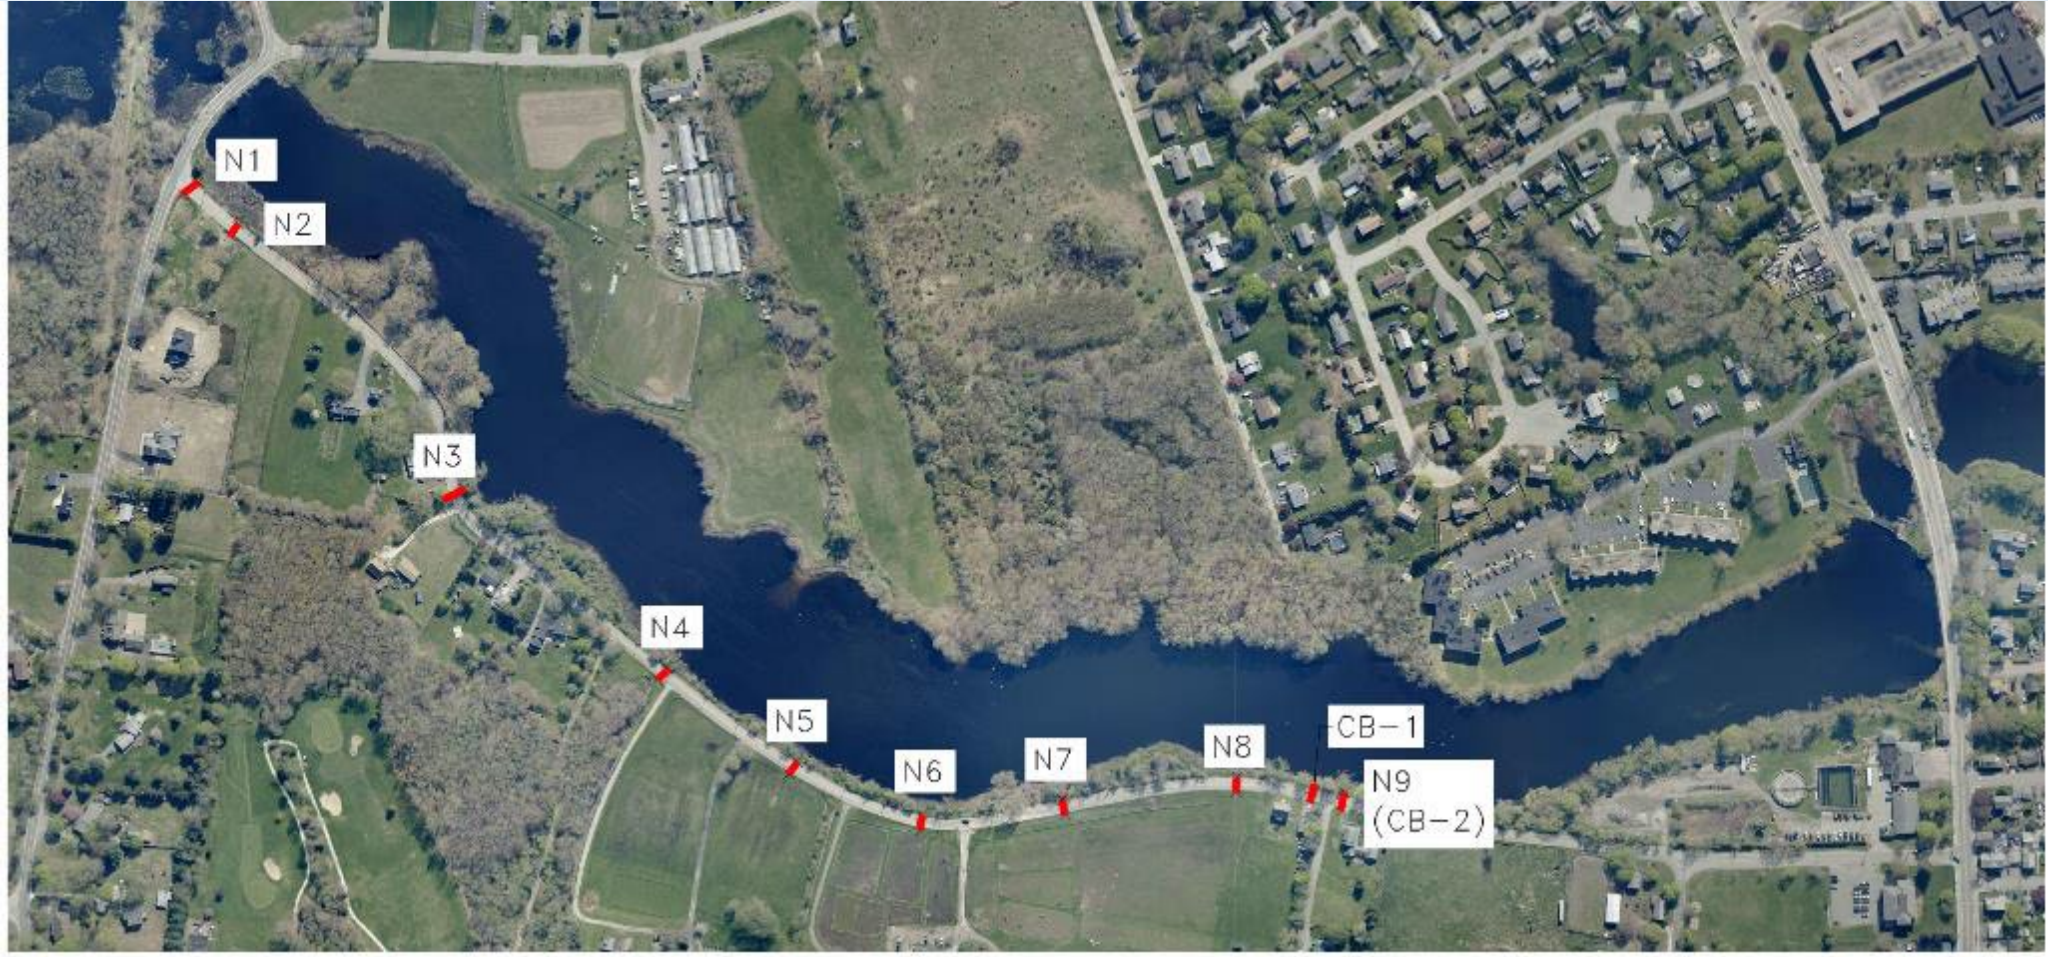
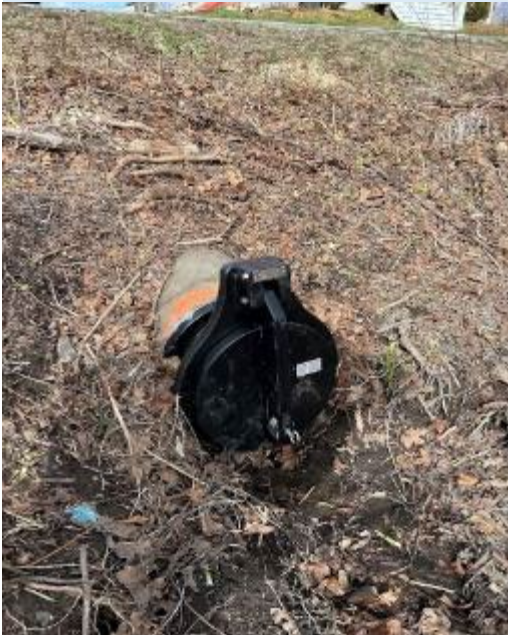
- Flap gates installed at culverts along Serpentine Road

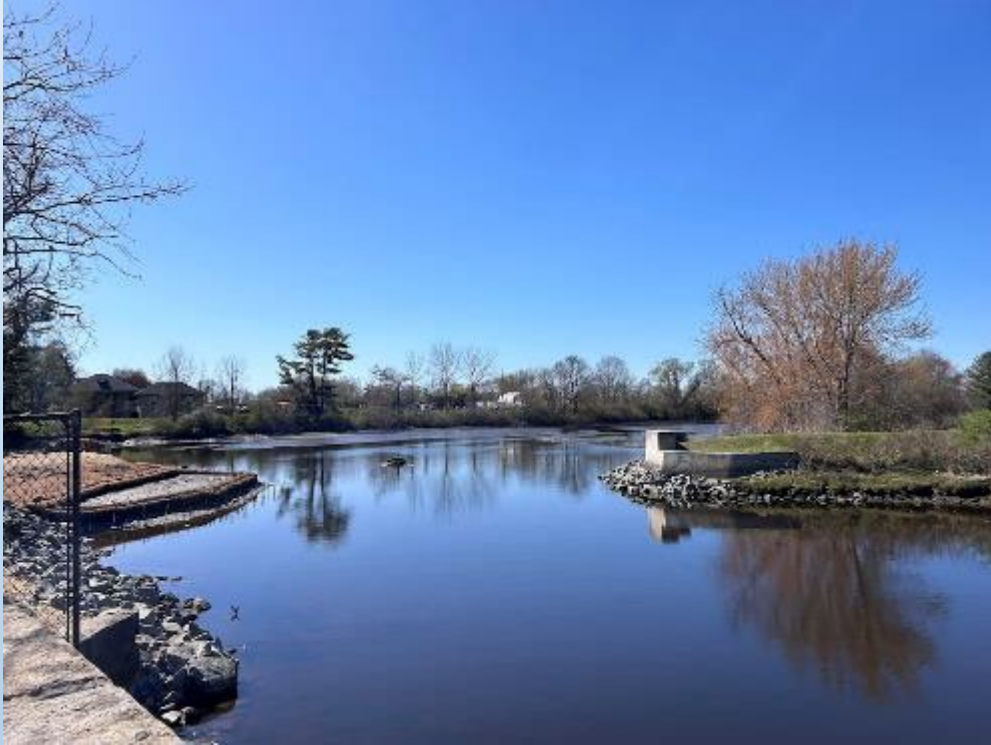
- Lower Dam project essentially complete
- Dam fully removed

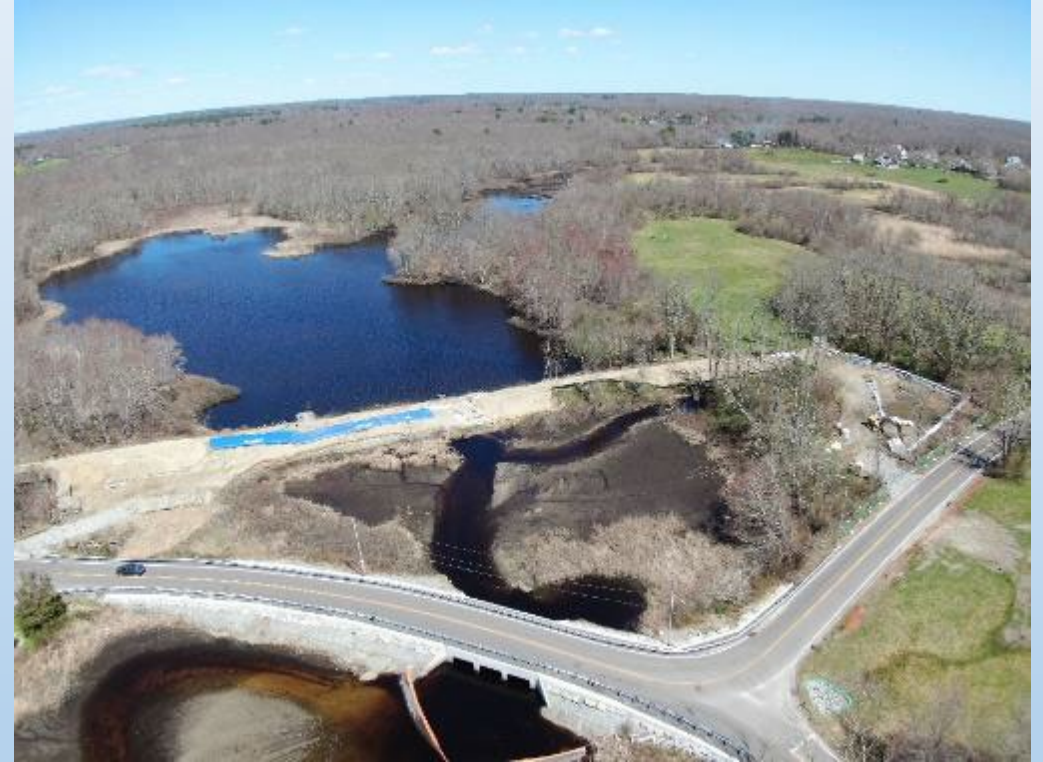
- Upper Dam to be completed in Summer 2024
