NONPOINT SOURCE SUCCESS STORY

Adding Agricultural Best Management Practices Reduced Sediment Loads and Decreases Suspended Solids in Soldier Creek

EPA 841-F-24-001L April 2024 For additional information contact:

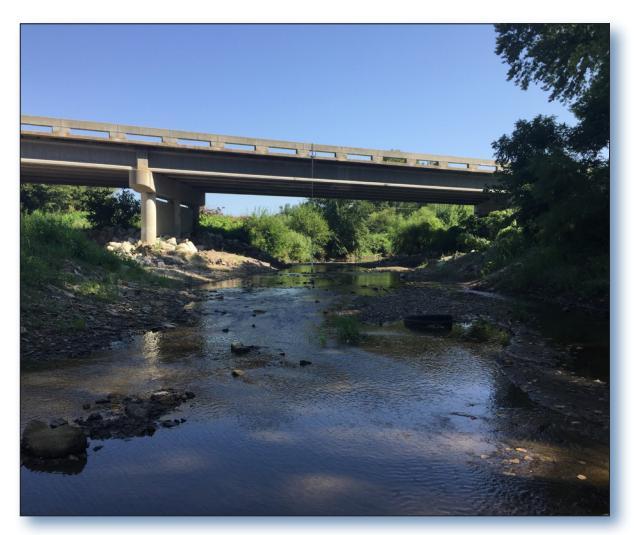
Figure 1. Water quality monitoring station on Soldier Creek in the Kansas River watershed.

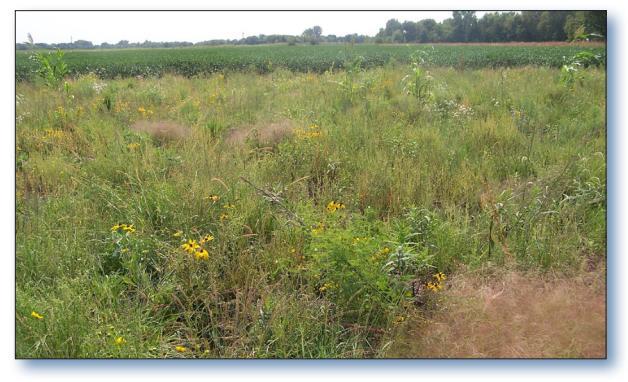
Figure 2. Herbaceous cover planting water quality buffer strips were added in the Soldier Creek watershed.

Ninety-nine sediment-reducing best management practice (BMP) projects were implemented in the Soldier Creek watershed between 2012 and 2022. This included 64 cover crop projects on 4,656 acres of cropland. Cover crops between rows of cash crops improve soil health and aggregation by covering the soil with foliage and anchoring the soil with living roots. Cover crop foliage provides shade to buffer soil temperatures and reduces the impact of raindrops. Living roots physically hold soils in place, and their exudates encourage the growth and proliferation of beneficial soil organisms. Other sediment-reducing BMPs included one riparian herbaceous cover planting, one critical area planting, one sediment basin, one diversion, nine grassed waterways, and 21 terraces (Figure 2). Together, these practices are estimated to have prevented nearly 7,590 tons of sediment from entering Soldier Creek.

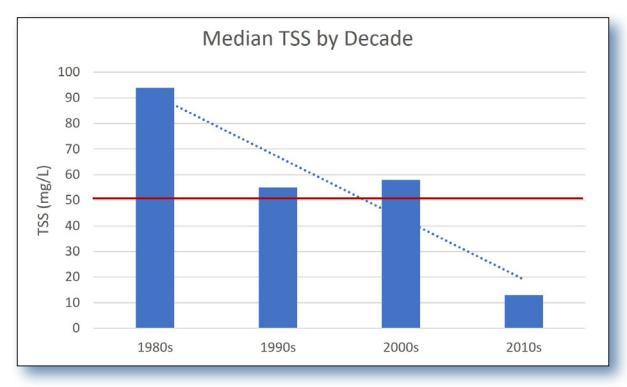
Figure 3. Soldier Creek TSS concentrations by decade. The 2010s data bar includes 2010–2021.

Sediment loading rates in Soldier Creek are evaluated using a water quality test that measures TSS. This test measures the amount of solid materials, such as soil and clay particles, that are carried in the water column of a lake or stream. Data collected between 1980 and 2021 show a marked decrease in TSS levels in Soldier

Creek near Delia, Kansas. Average TSS levels at stream flows less than 1,000 cubic feet/second (cfs) decreased 75% from the 1980s to the post-2010s—from 204 milligrams/liter (mg/L) to 50 mg/L. The desired endpoint stated in the 2005 TMDL was average TSS levels below 100 mg/L at flows less than 1,000 cfs. The available data would suggest that this endpoint has been achieved. However, KDHE TMDLs currently consider median TSS values less than 50 mg/L as a desired endpoint. Median TSS decreased 86% from the 1980s to the post 2010s—from 94 mg/L to 13 mg/L (Figure 3). This long-term improvement in TSS will ultimately benefit aquatic life in Soldier Creek and could eventually return it to supporting status.
