Hudson River PCBs Site EPA Phase 1 Evaluation Report

Prepared for:
US Environmental Protection Agency, Region 2

Prepared by:
The Louis Berger Group, Inc.

March 2010

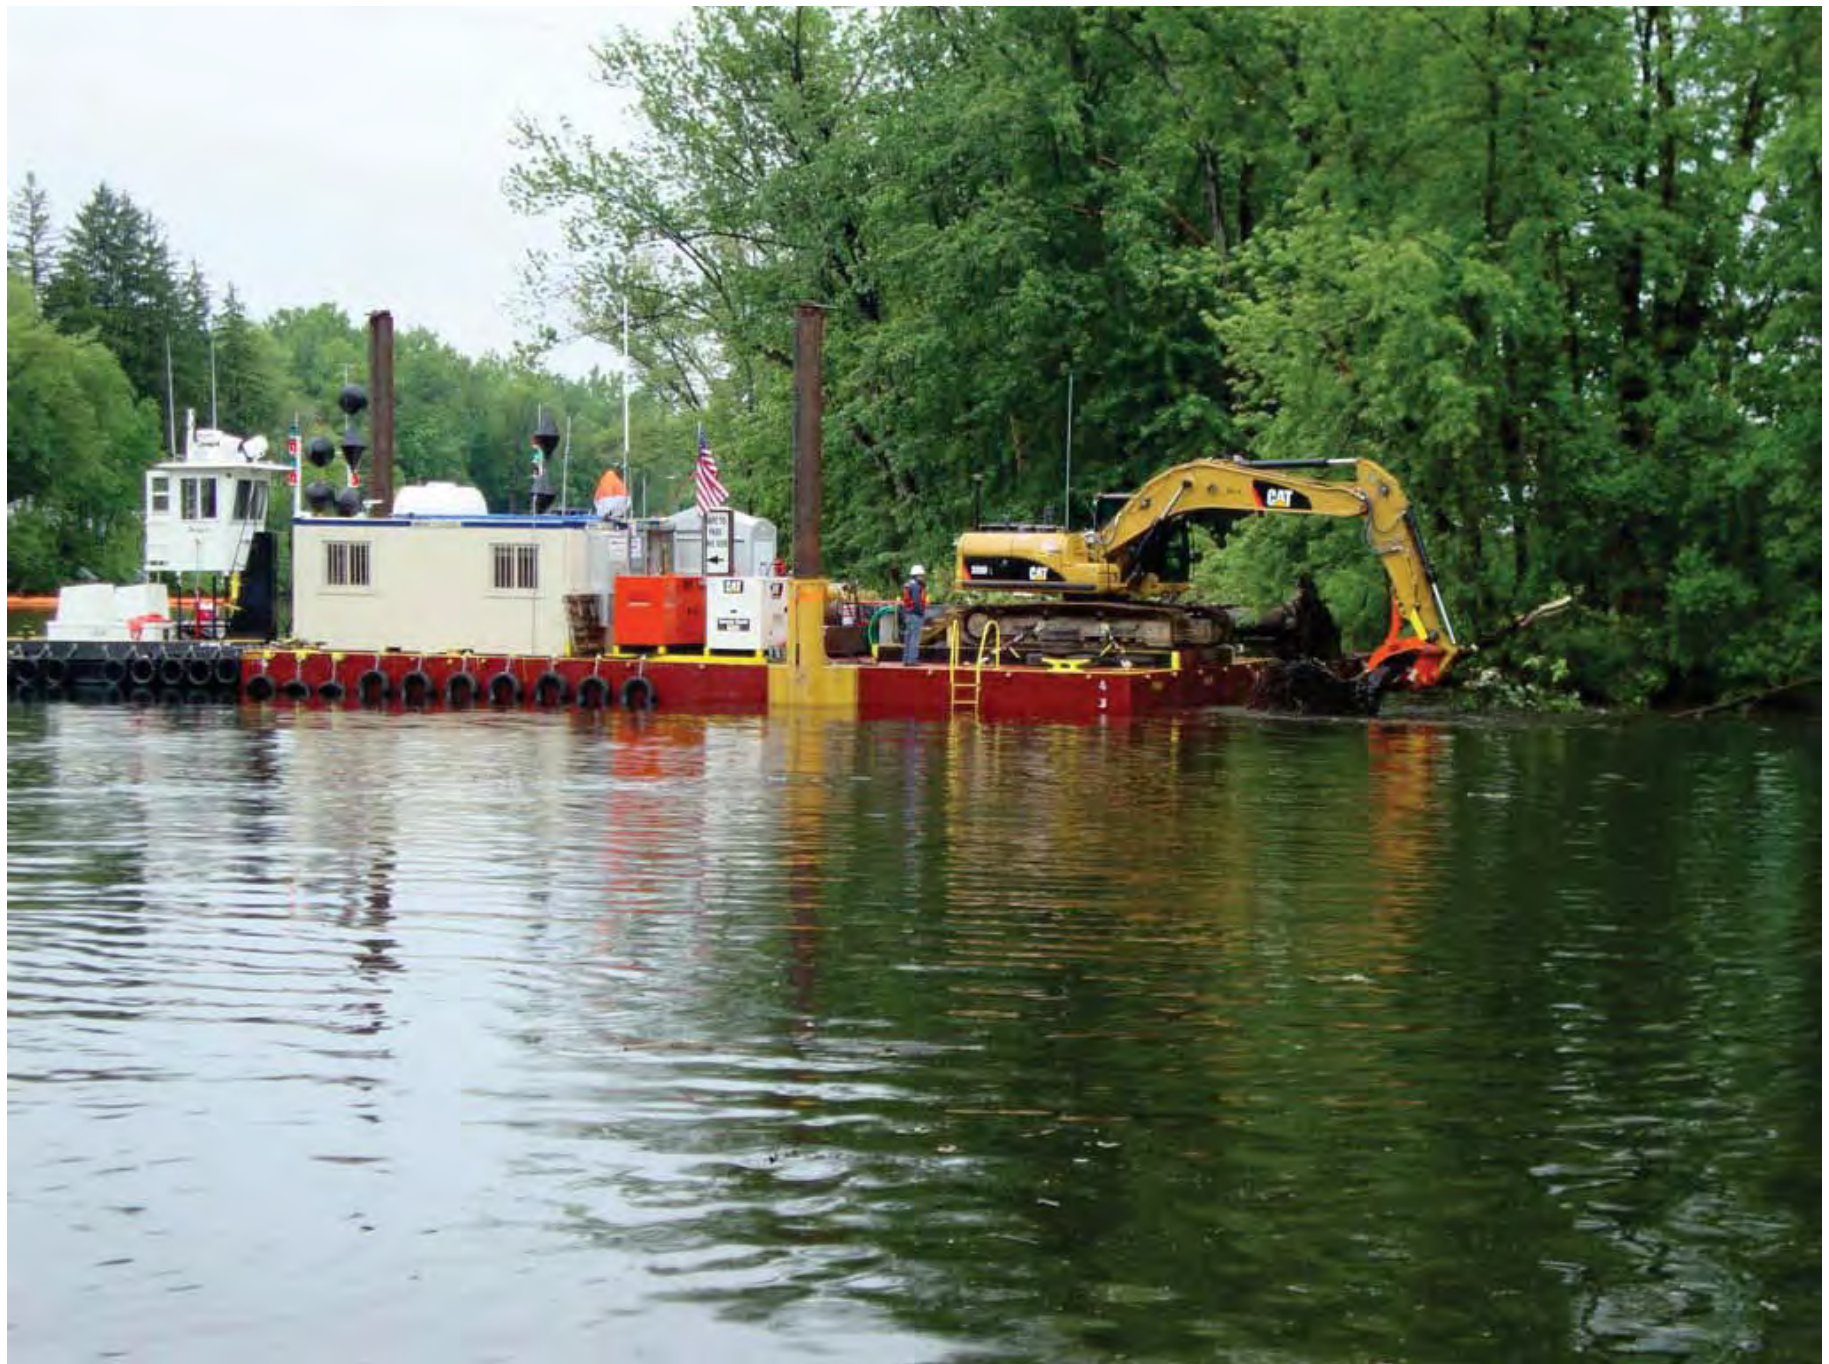
Tree Trimming Equipment

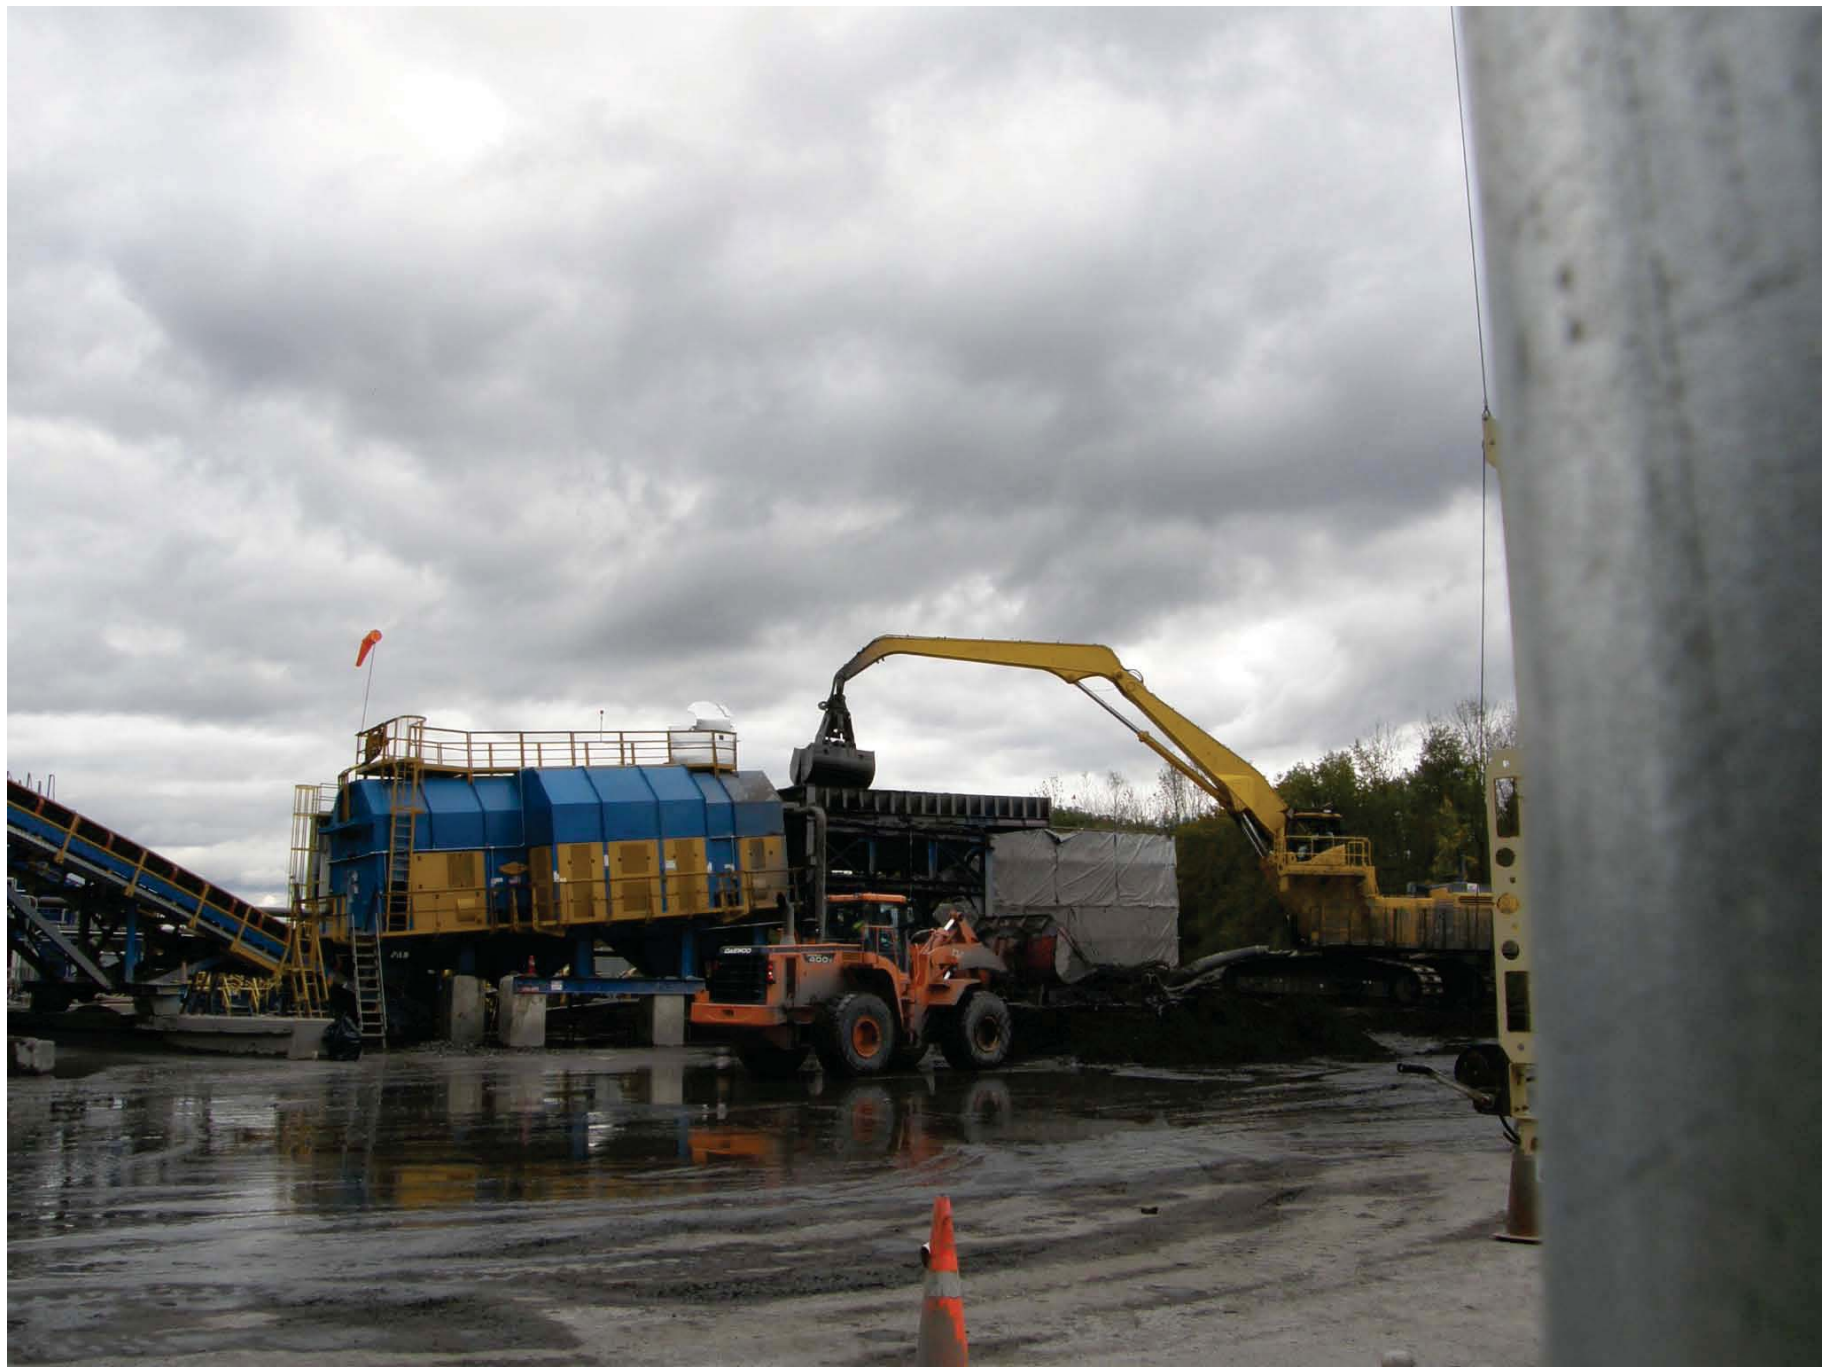
Komatsu Excavator Unloading Sediment Into Trommel Screen

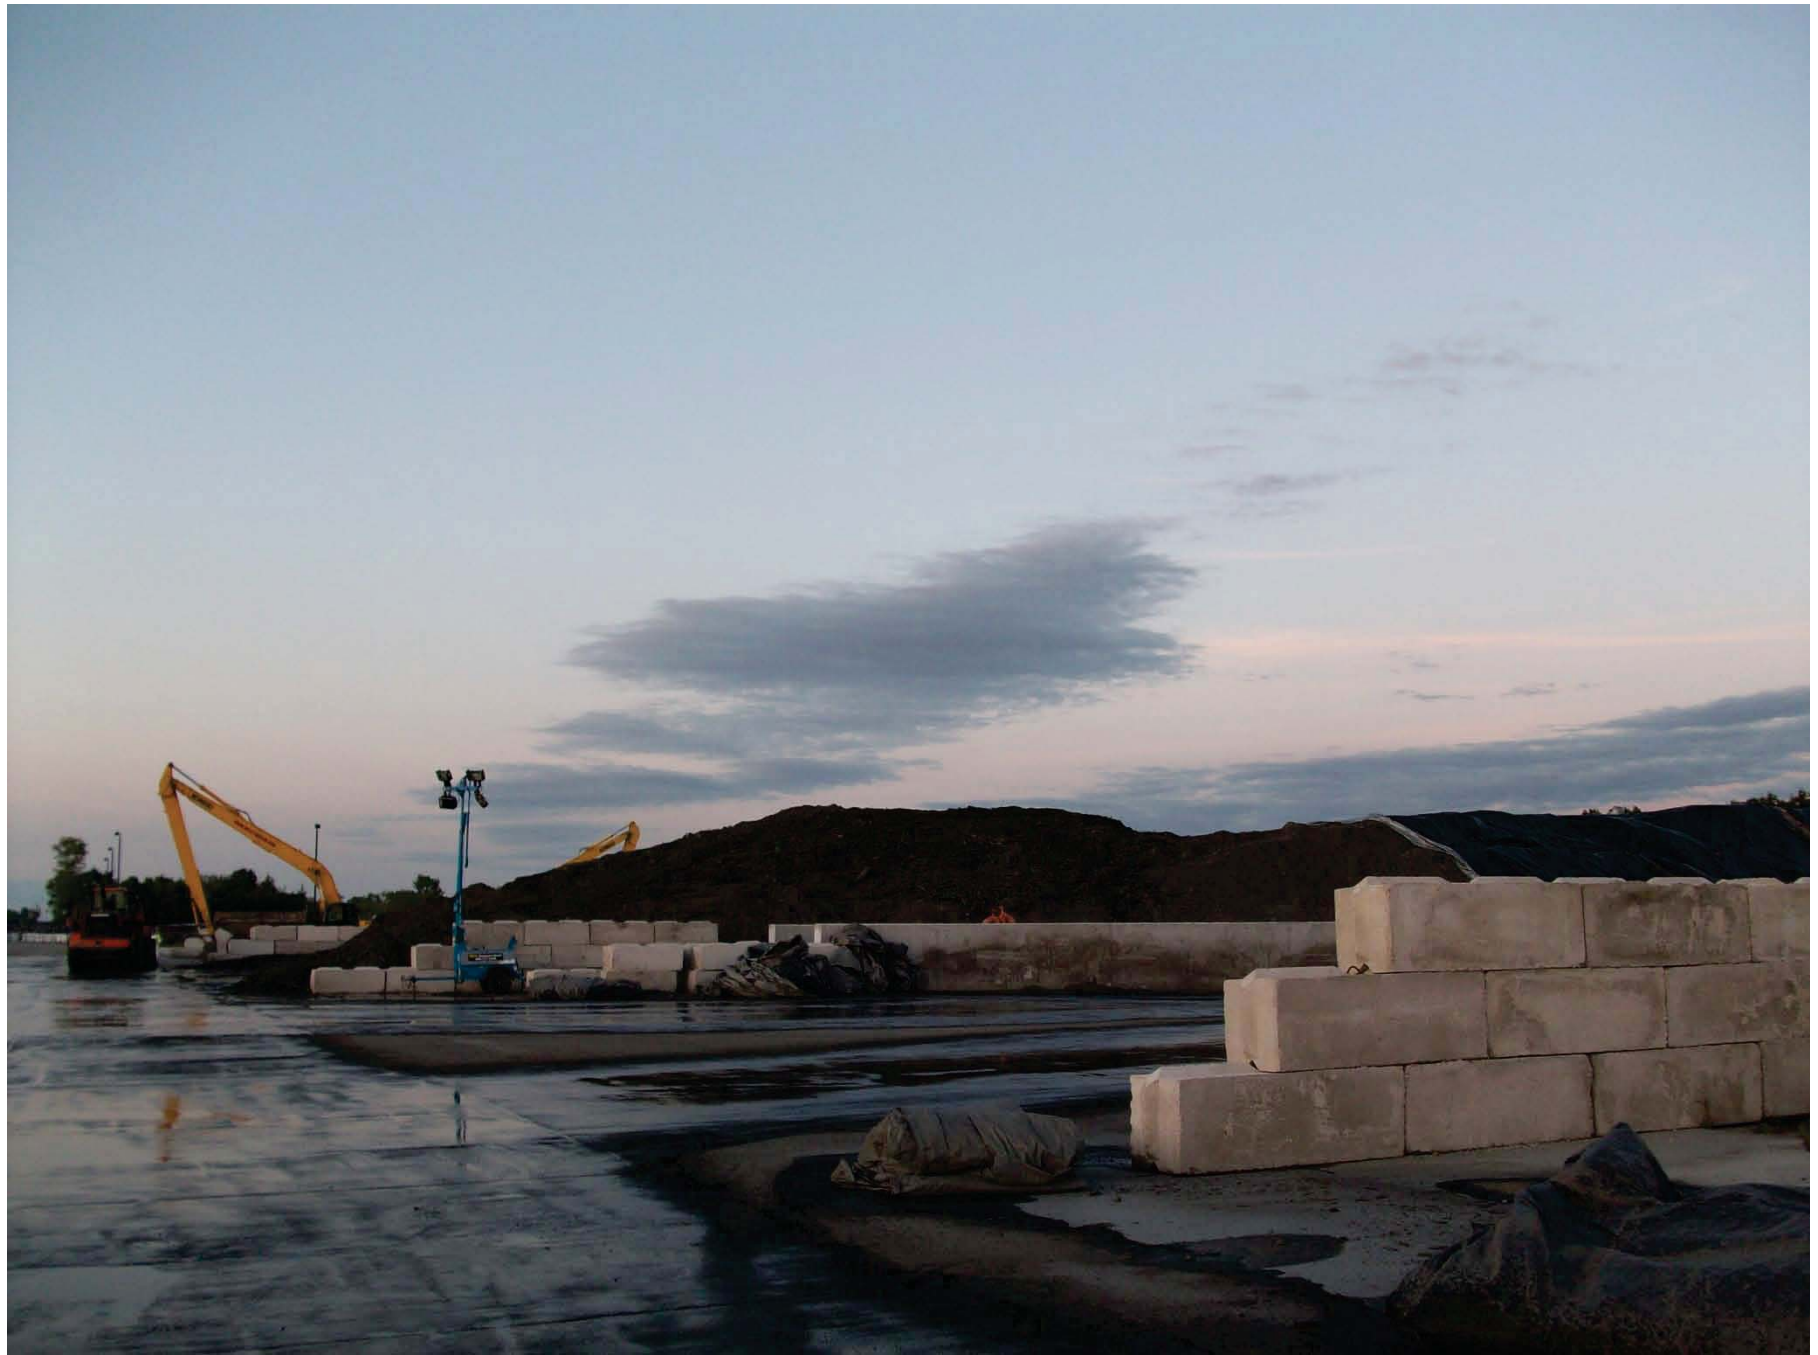
Coarse Material Storage Pile
