SRI/USEPA-GHG-VR-12
September 2001

Environmental Technology Verification Report

KMC Controls, Inc.
SLE-1001 Sight Glass Monitor

**Greenhouse Gas Technology Center
Southern Research Institute**

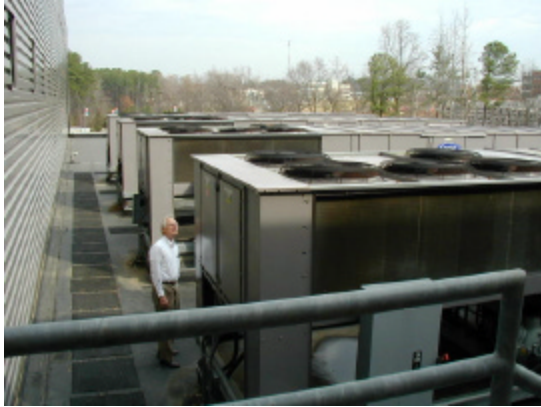
Figure 1-3. Photographs of Test Systems

Commercial Roof-Top Air-Conditioning System

Carrier manufactured the rooftop HVAC system selected for testing. This air-to-air exchange unit is a moderately large (75 tons) commercial unit, providing comfort cooling for the tenants of the Research 4 building of the NCSU Centennial Campus. It is one of four identical systems that meet the cooling loads of the approximately 38,000 ft² office building. Records are available listing repairs conducted and refrigerant additions. Each of the two compressors and its associated condenser, evaporator, and valving operates independently from the other. The SGM was installed on the “B” compressor, which is rated for a nominal charge of 64.5 lb R-22 refrigerant.

Figure 1-3 presents photographs of the two systems that were used in the verification and Table 1-1 summarizes their key features. A brief description of each system follows.

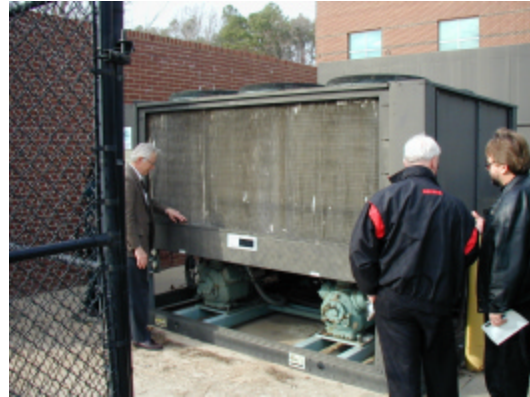
Reciprocating Chiller

All test systems were previously equipped with factory installed sight glasses. The rooftop air-conditioning unit was factory equipped with a vertically oriented sight glass. No change in glass orientation was required for that unit, but the glass was quite dirty. A certified HVAC technician replaced the sight glass and the inline refrigerant filter/dryer. The technician relocated the reciprocating chiller sight glass from horizontal to vertical position and replaced the inline refrigerant filter/dryer core.

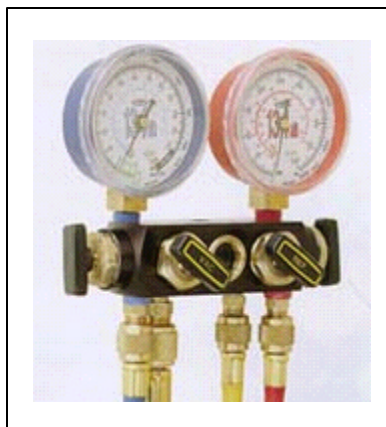
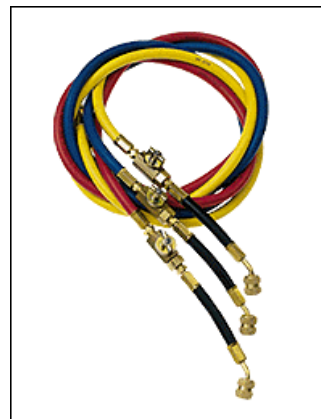
Figure 1-5. Refrigeration Gauge Manifold and Hoses

The second step was to recharge each system with refrigerant and determine the full charge capacities. This was done with an industry standard design gauge manifold system. The manifold system is universally recognized as the instrument for testing air-conditioning equipment. It is used for checking operating pressures, adding or removing refrigerant, adding oil, and performing other necessary operations such as leak testing. Figure 1-5 illustrates a gauge manifold system: the HVAC technician used a newly purchased TIF manifold system during the verification tests. Figure 1-6 provides a simplified diagram of the manifold system installed on a refrigeration unit.

Gauge Manifold

Refrigeration Hoses
