**Missouri Department of Natural Resources  
Water Protection Program**

**Total Maximum Daily Load (TMDL)**

**Tributary to Pond Creek**  
(now correctly identified as Pond Creek)

**Washington County, Missouri**

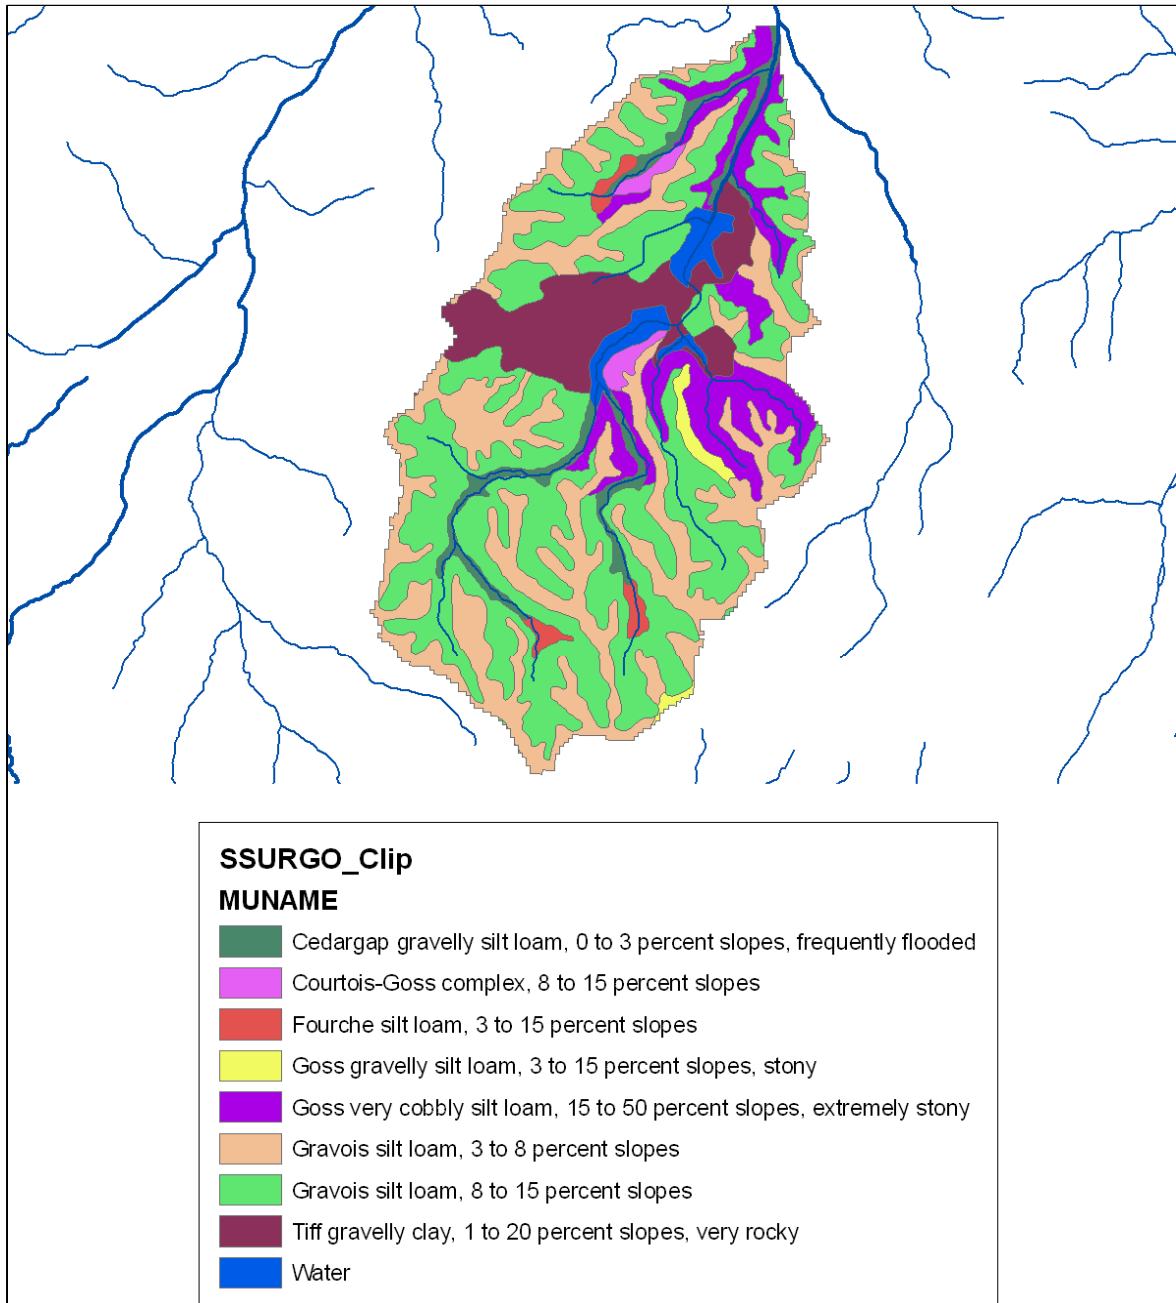
Figure 3a. Map of Soils in the Upper Pond Creek (WBID 2128) Watershed (NRCS 2007)

A map illustrating the soil types in the Pond Creek watershed can be found in Figure 3a. The headwaters of Pond Creek incise the Tiff soil series, which consists of very deep (over 60 inches), well-drained, moderately permeable soils that formed clayey residuum<sup>7</sup> on uplands. These soils are on nearly level to moderately steep areas that have been truncated by mining operations with slopes ranging from 1 to 20 percent. The soil's taxonomic class is clayey-skeletal, kaolinitic, mesic Rhodic Paleudalfs. Typical pedon<sup>8</sup> is tiff gravelly clay - on a convex escarpment of 13 percent slope in a mined area at an elevation of 710 feet (USDA NRCS 2005).

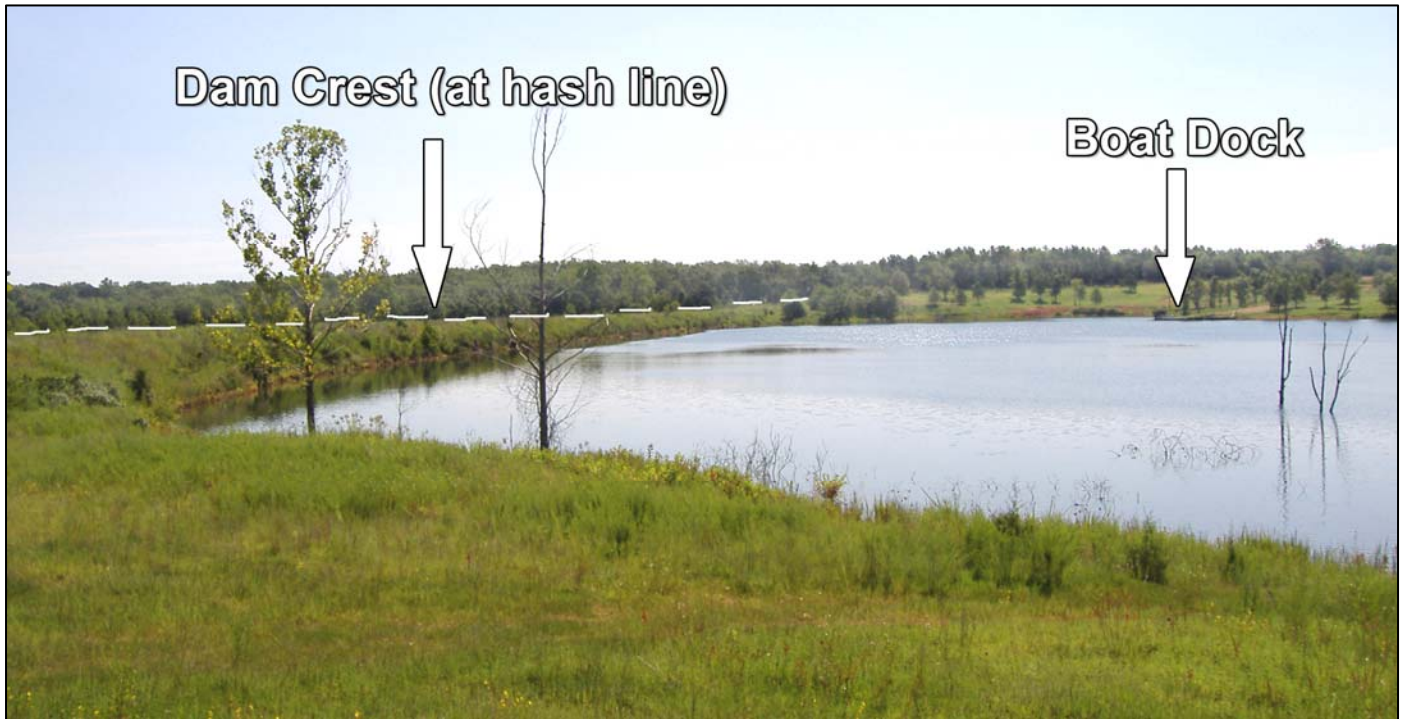
**Figure 4. King Arthur's Dam, looking east (See hash marks drawn along dam crest). The current landowner's private residence is off the photo to the right of the boat dock (Photo taken Aug. 2008).**

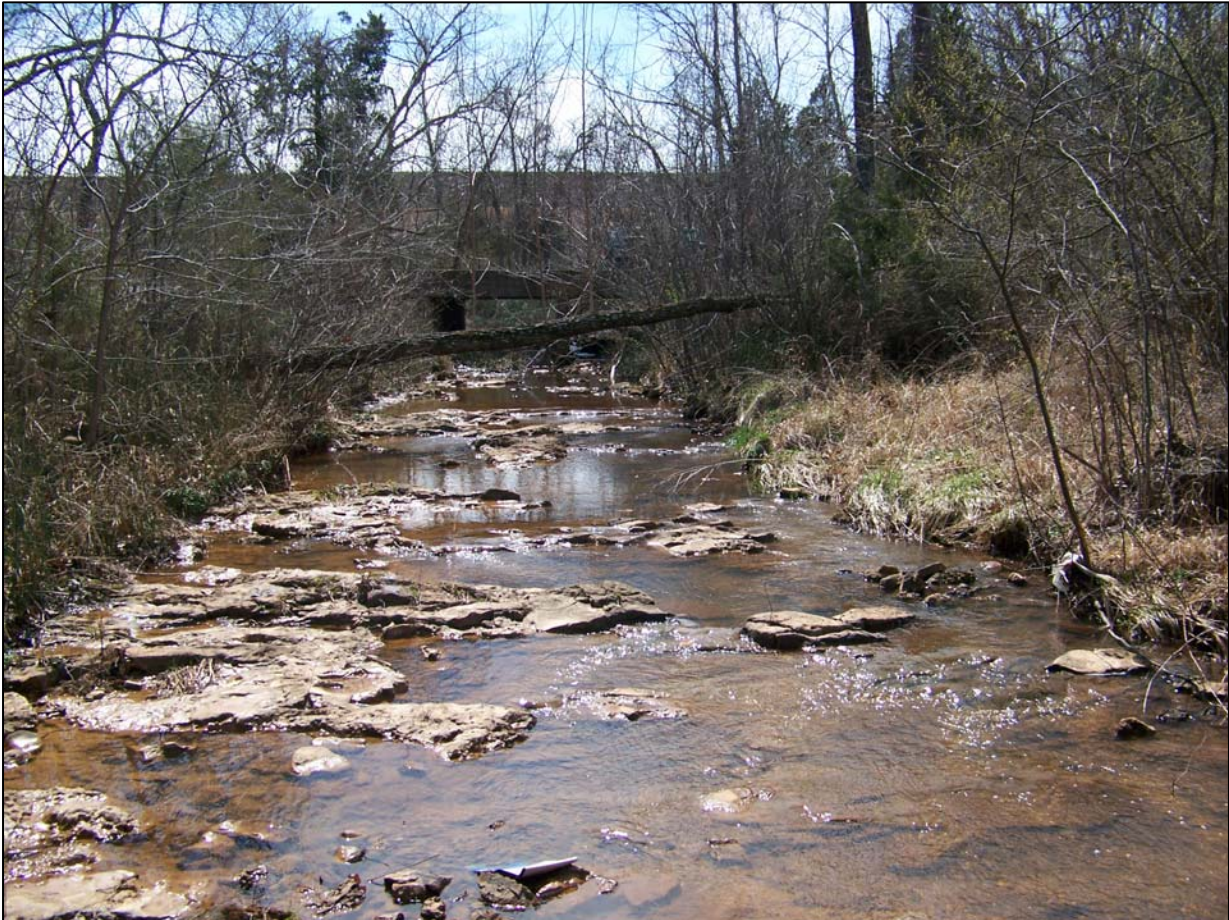
**Figure 5. Pond Creek (WBID 2128) near sampling Site #2, looking upstream (south) at Pond Creek Road bridge and on to King Arthur's Dam (along horizon). Note bedrock on creek bottom (Photo taken March 2009).**

It is important to note that Pond Creek Site #2 (on the impaired segment) was observed to be a small, predominantly bedrock-dominant stream segment with a shallow coating of fine sediment (See Figure 5). It was proposed in the department study that bedrock does not provide ideal habitat for macroinvertebrates and may have contributed to the appearance of an impairment.

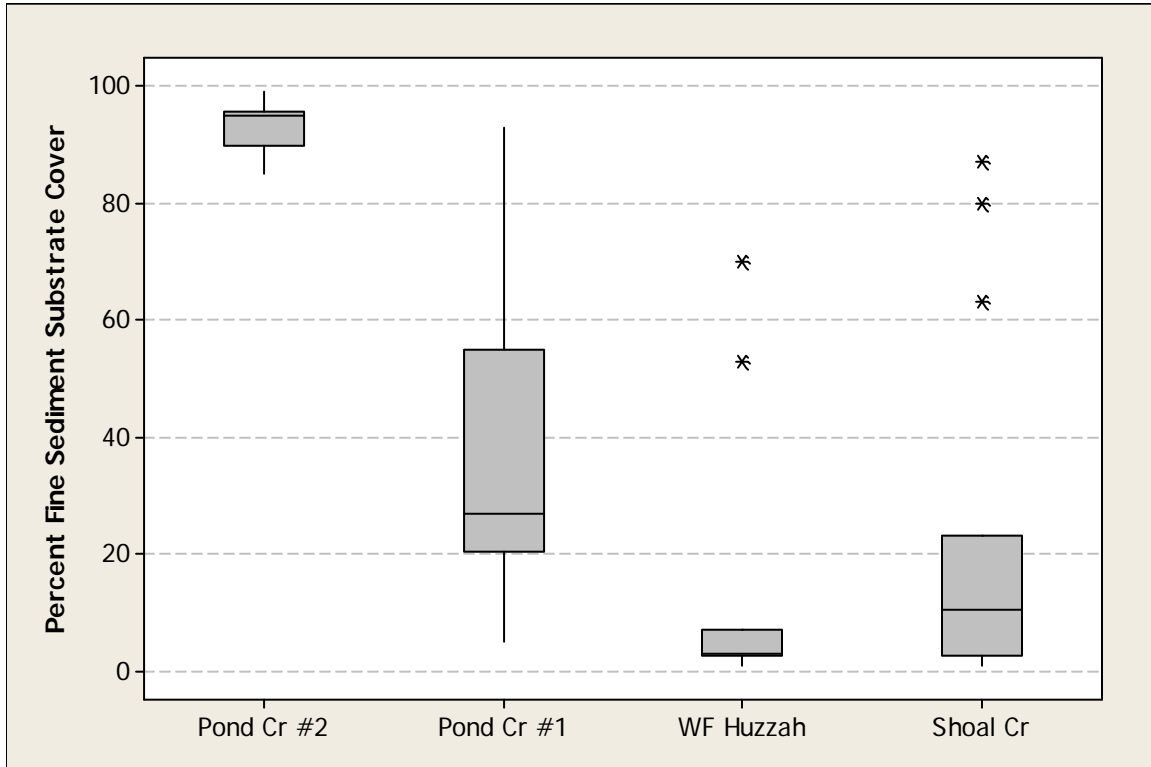
**Figure 6. Boxplots of fine sediment observations in Pond Creek and control streams. (Boxes indicate 25<sup>th</sup>, 50<sup>th</sup> and 75<sup>th</sup> percentiles, lines extend to 0<sup>th</sup> and 100<sup>th</sup> percentiles, and “\*” indicate outliers.)**

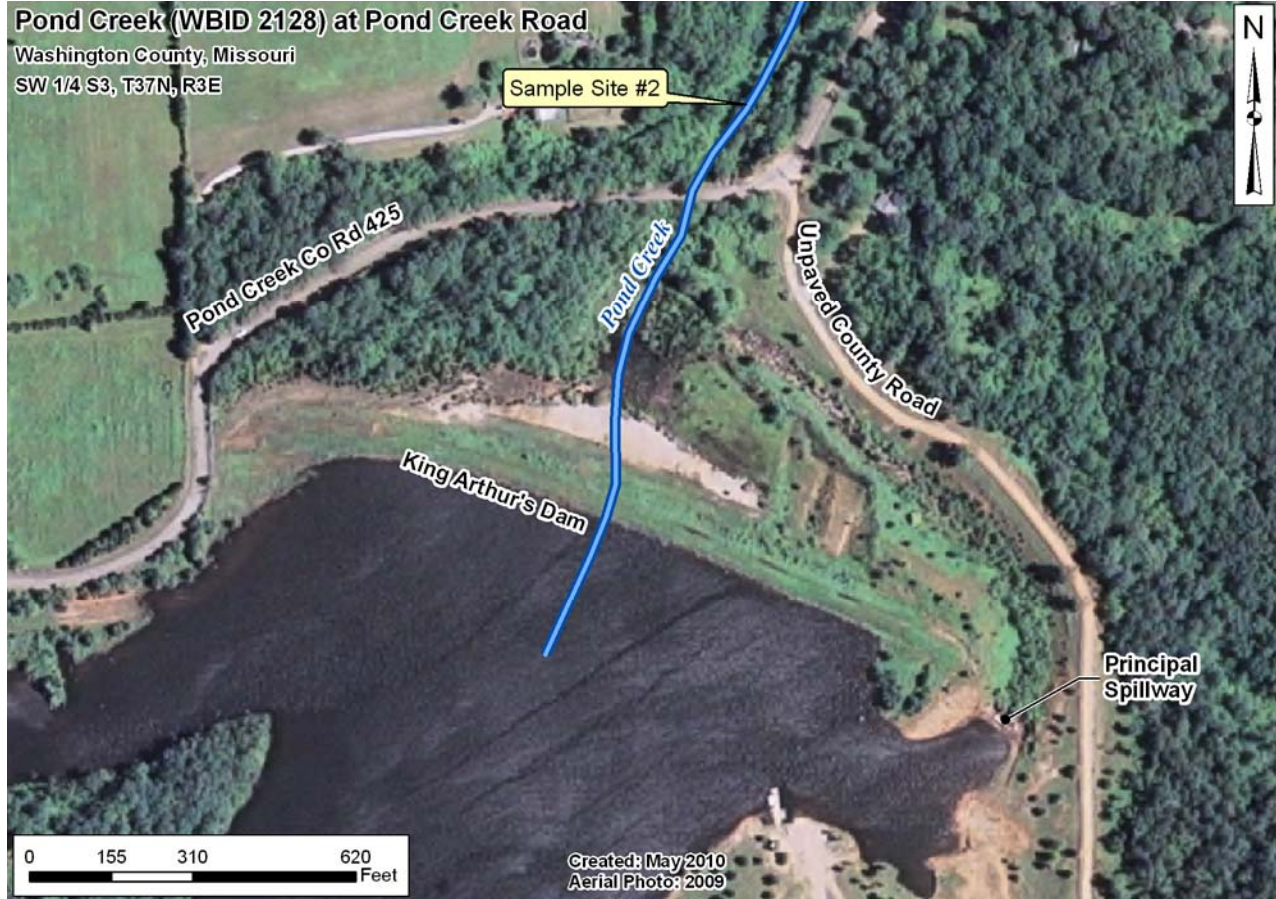
**Figure 7. 2009 aerial photo illustrating Pond Creek (WBID 2128), and King Arthur's Dam and it's principal spillway, in relation to county roads.**

The downstream face of King Arthur's Dam consists of an upper, heavily-vegetated slope below the crest (See Figures 7 and 8), followed by a flat "bench" approximately 10 to 15 feet wide (See Figures 8 and 9), followed by a second lower slope (See Figures 7 and 9) leading down to the dam's base (i.e., toe; See Figure 10). The crest (See Figure 4), and slope immediately below it, may have been built up with soil during the 2003 spillway modification, or at some point previously, as suggested by the dense vegetation in this area.

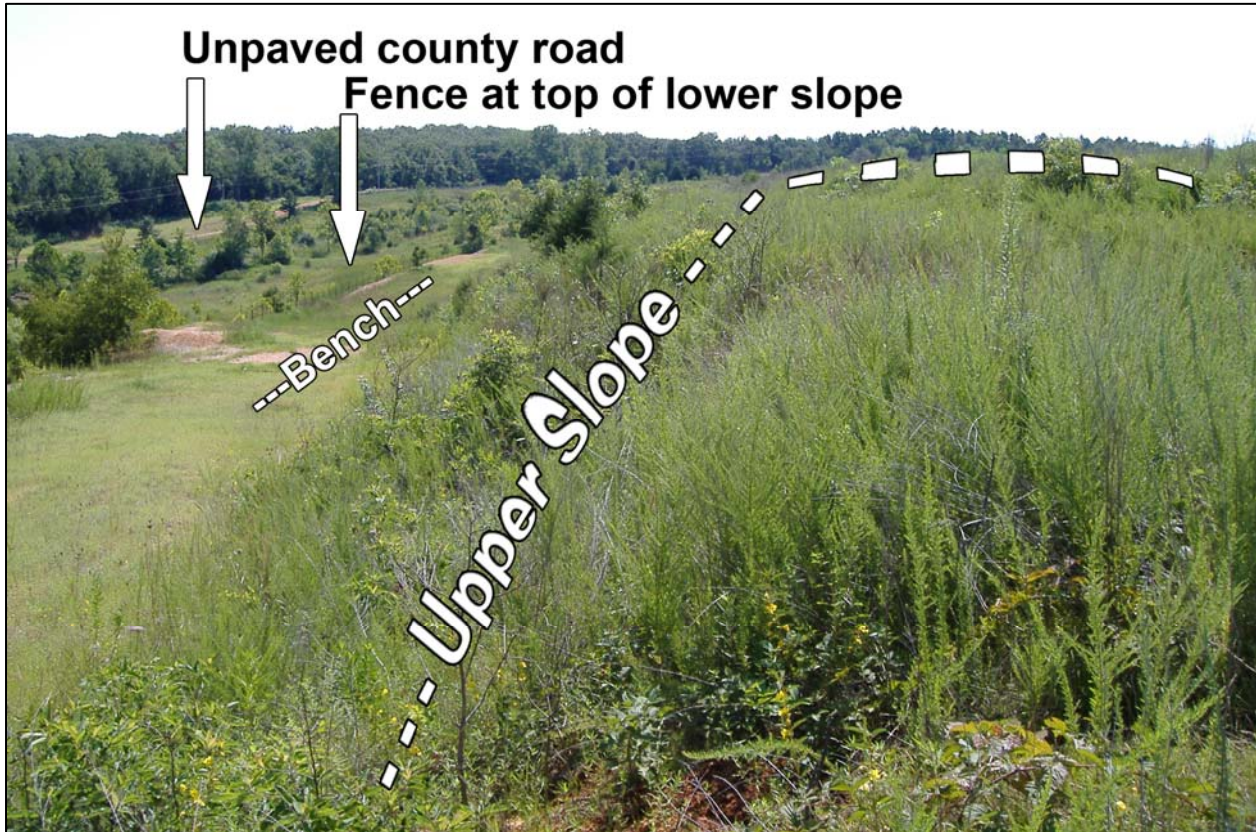
**Figure 8. The heavily vegetated upper slope of the downstream face of King Arthur’s Dam, looking southeast. Note relatively flat “bench” downhill from the upper slope and the fence in center of bench marking the top of the lower slope (Photo taken Aug. 2008).**

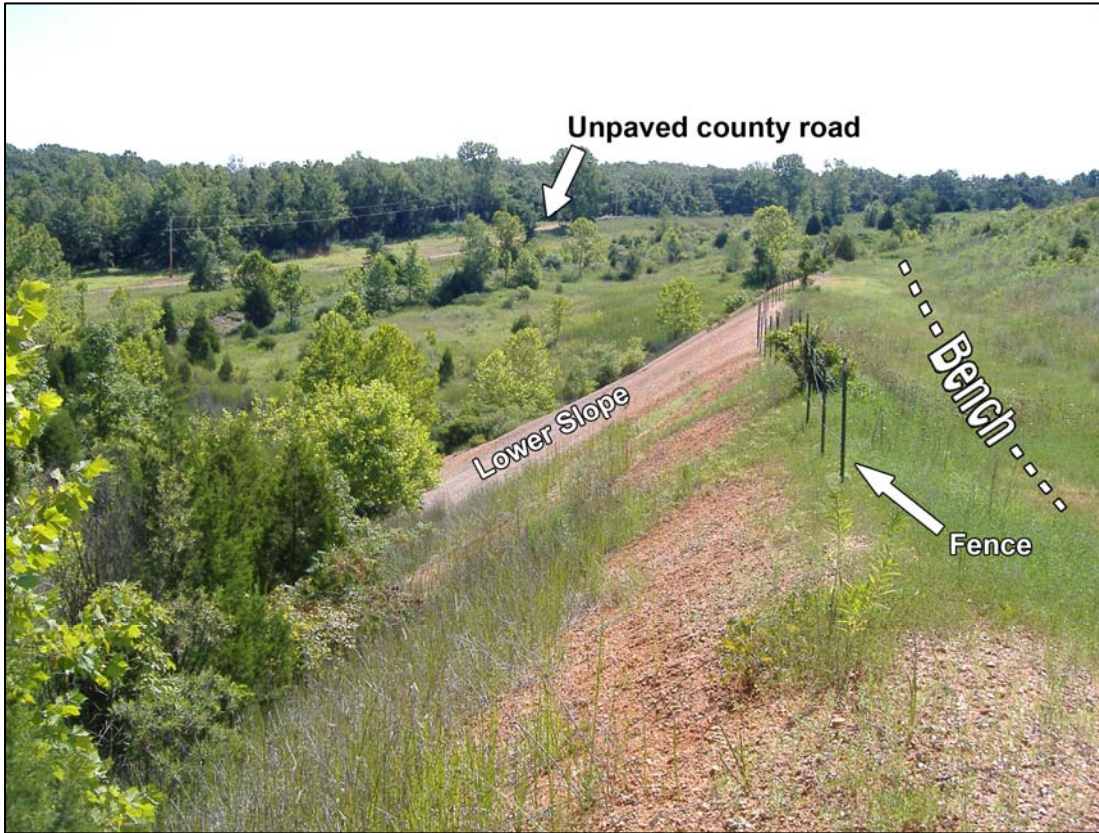
**Figure 9. King Arthur's Dam looking southeast at the "level bench" (on right) separating the upper dam face slope from the lower dam face slope (center). Note the fence at the top of the slope, and the unpaved county road running along the tree line east of the dam**  
(Photo taken Aug. 2008).

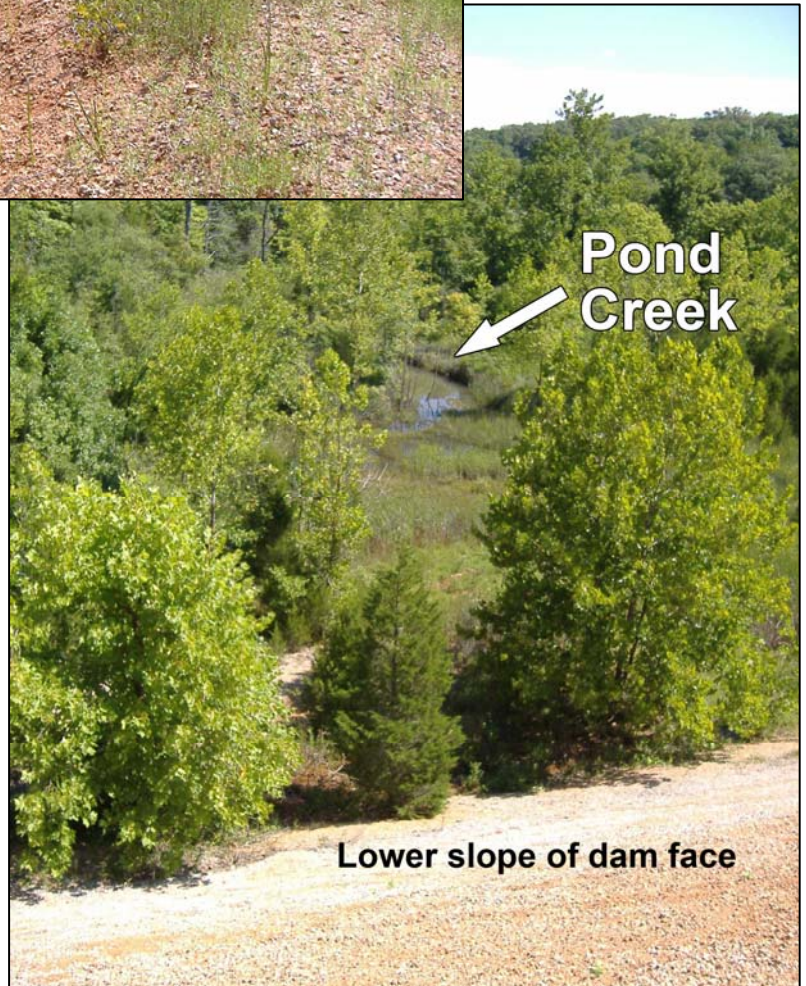
**Figure 10 (to right). Looking downstream, past the toe of the dam, at Pond Creek** (Photo taken by the fence at top of the lower slope (See Figure 8); Aug. 2008).

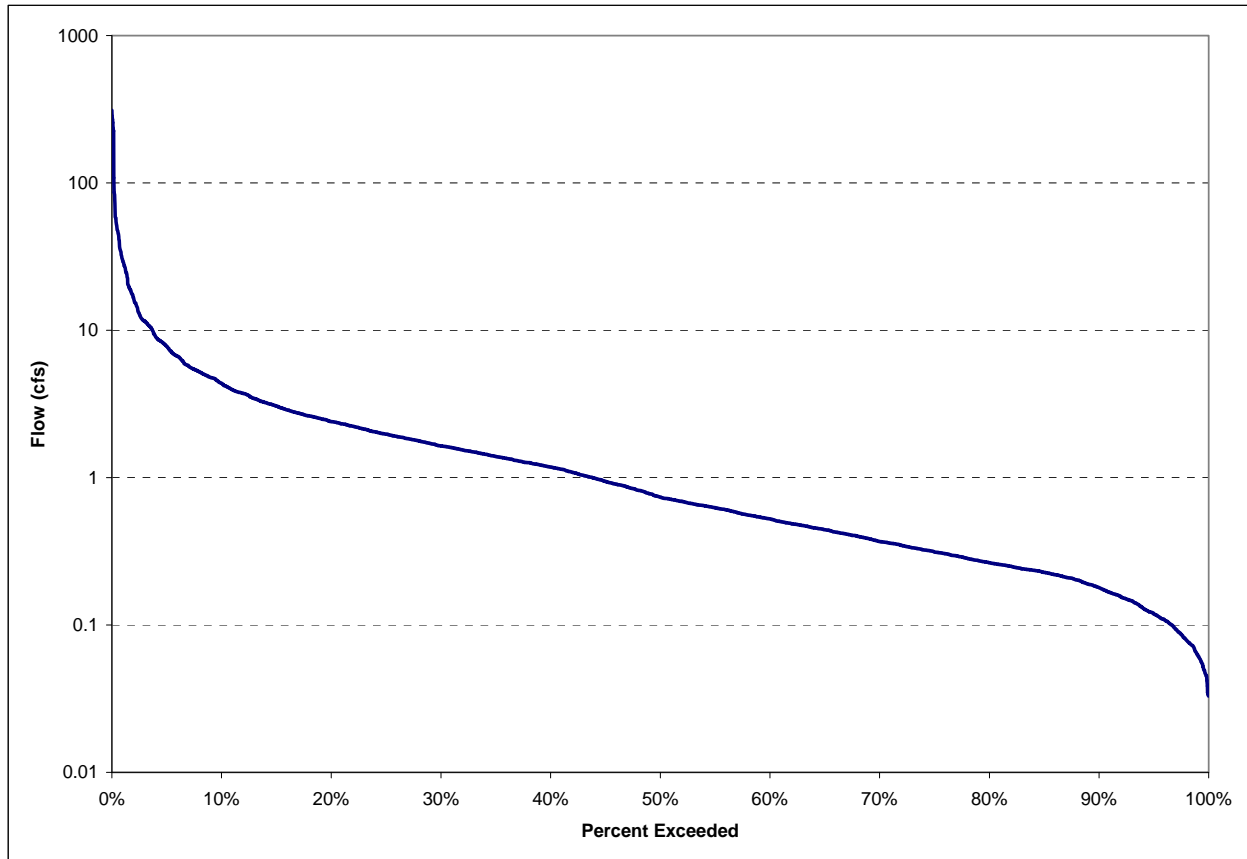
**Figure 11. An estimated flow duration curve for Pond Creek.**

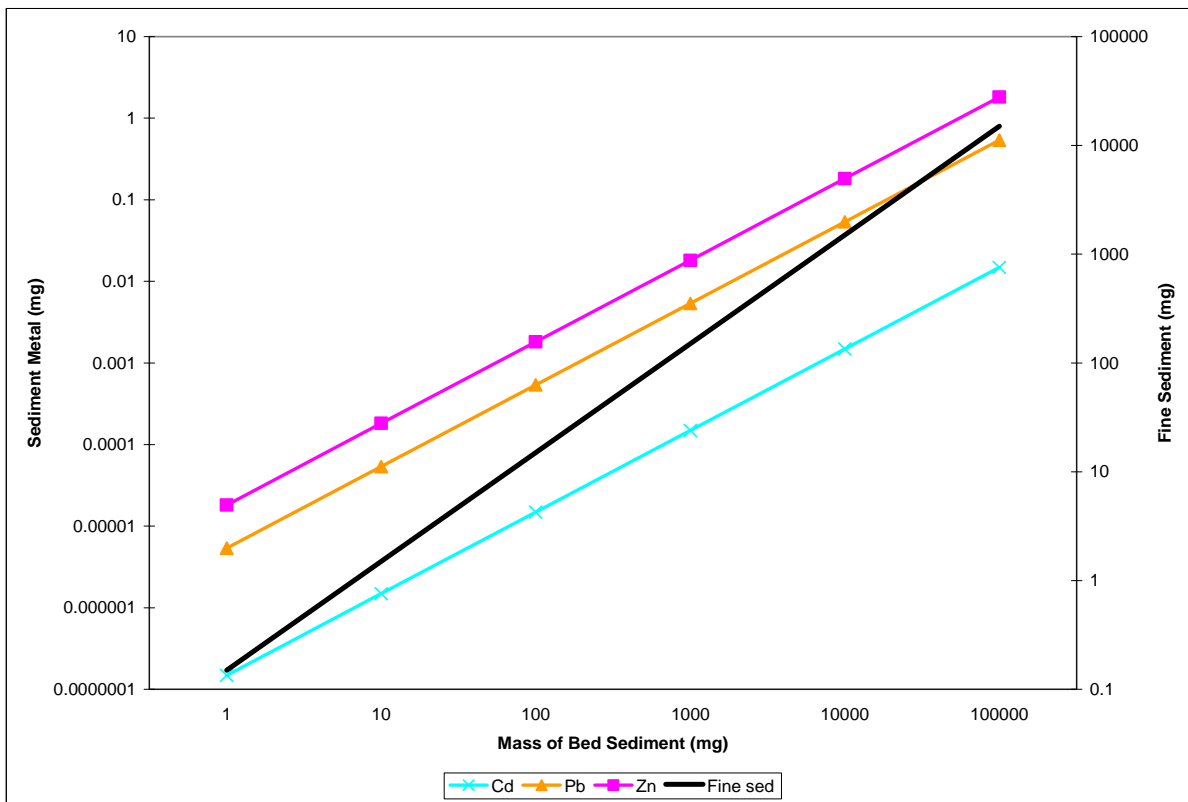
**Figure 12. TMDL for bed sediment: cadmium, lead, zinc and fine sediment.**

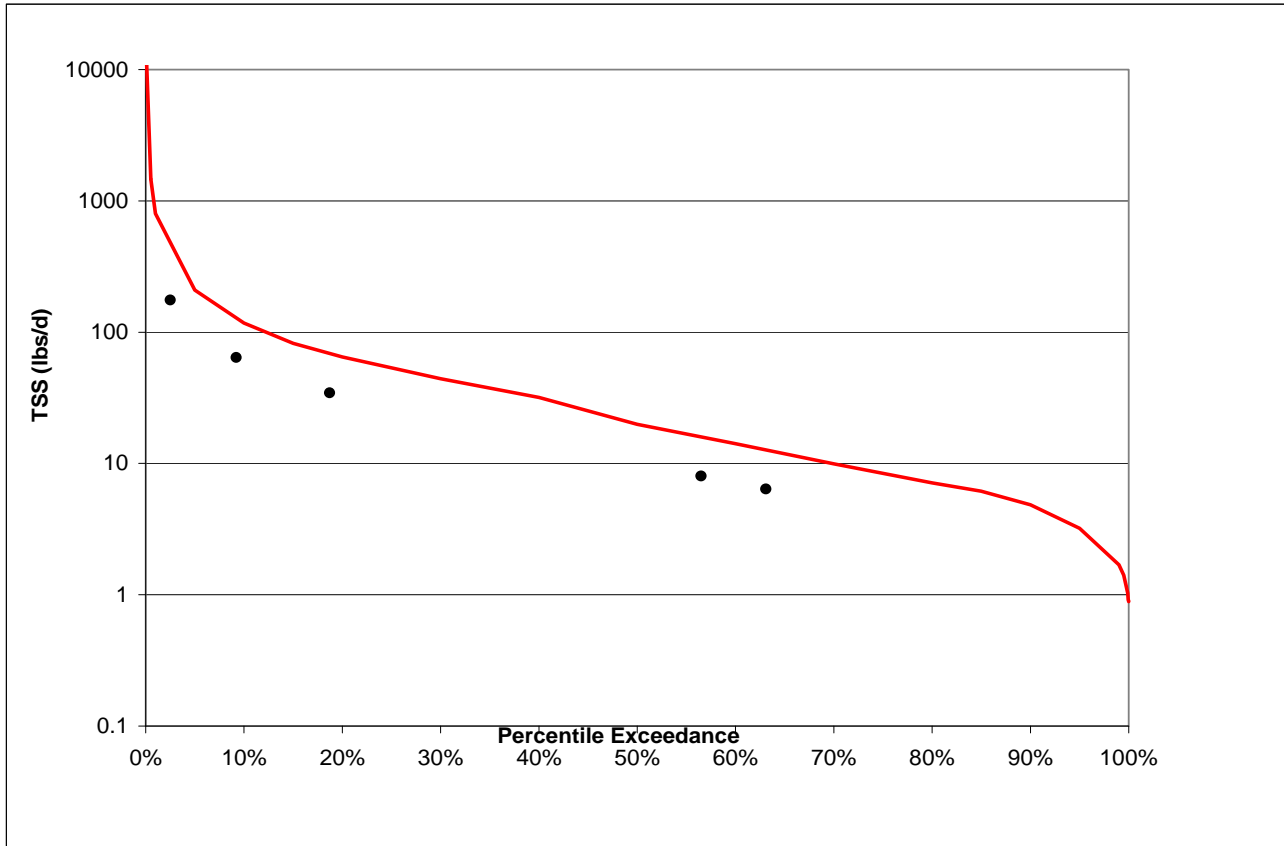
**Figure 13. Load duration curve for inorganic sediment in Pond Creek.**

The wasteload allocations for dissolved cadmium, lead and zinc and inorganic sediment must be achieved at the outlets to each segment. As seen in Figures 13 through 16, wasteload allocation increases with increasing flow. The wasteload allocation for bedded sediment and metals in sediment must be met at any point in each segment.

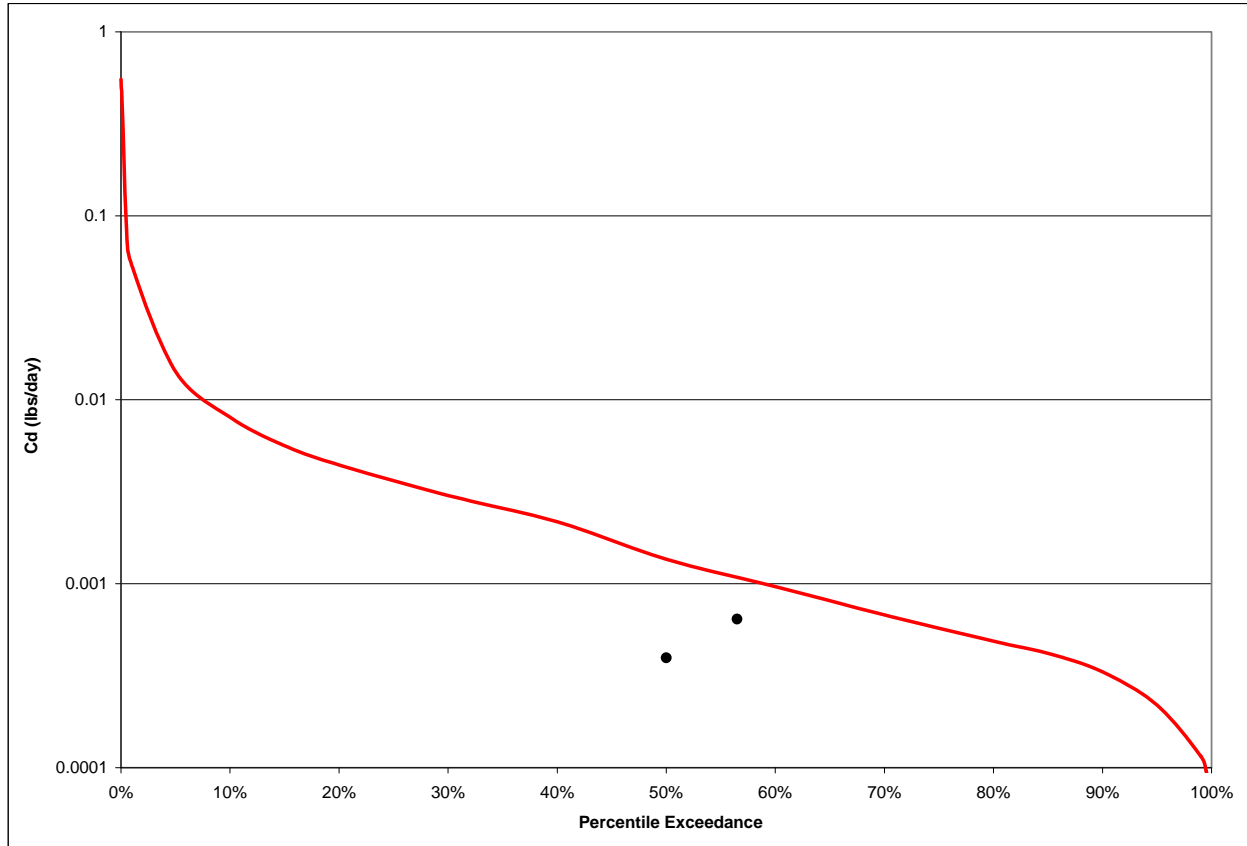
Figure 14. Load duration curve for dissolved cadmium in Pond Creek.

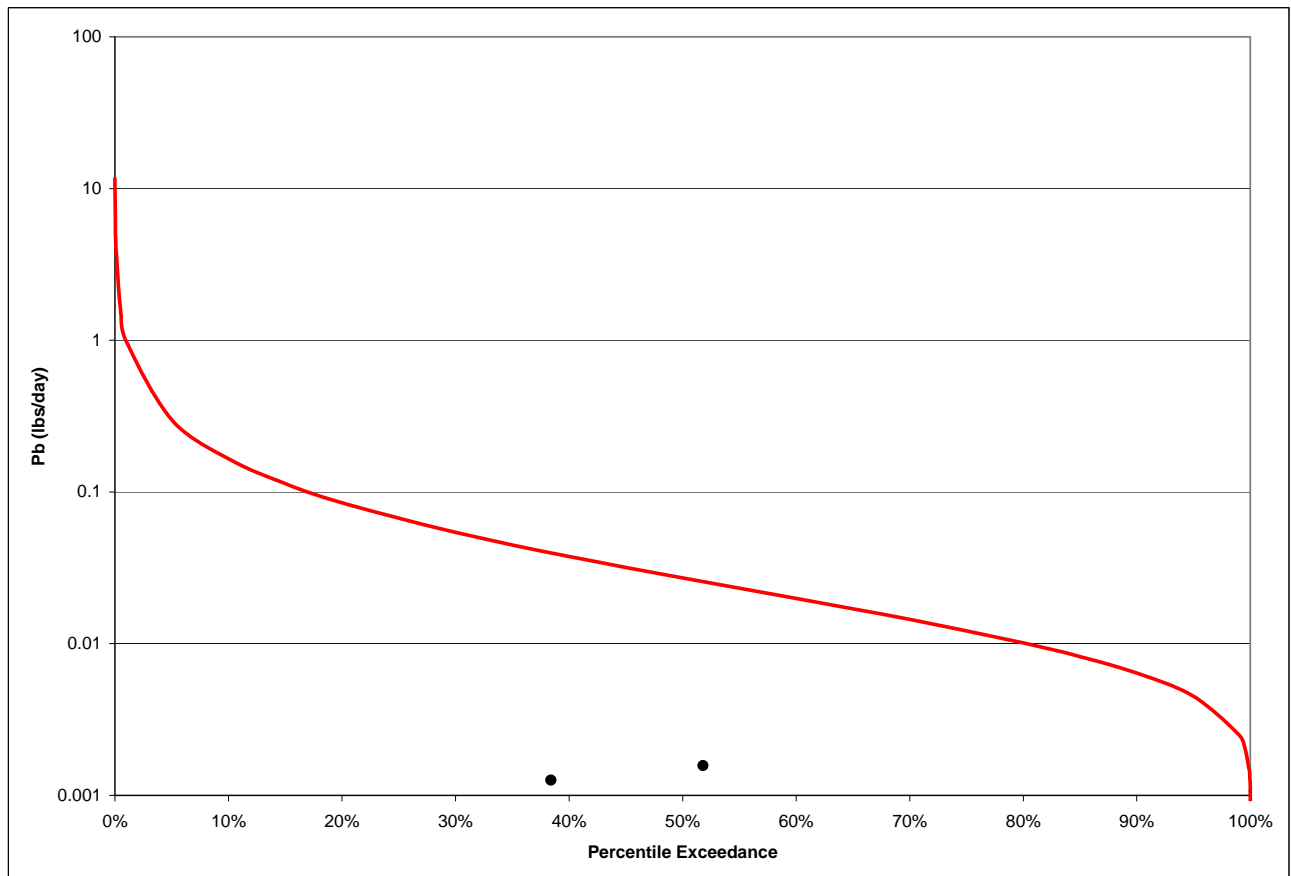
Figure 15. Load duration curve for dissolved lead in Pond Creek.

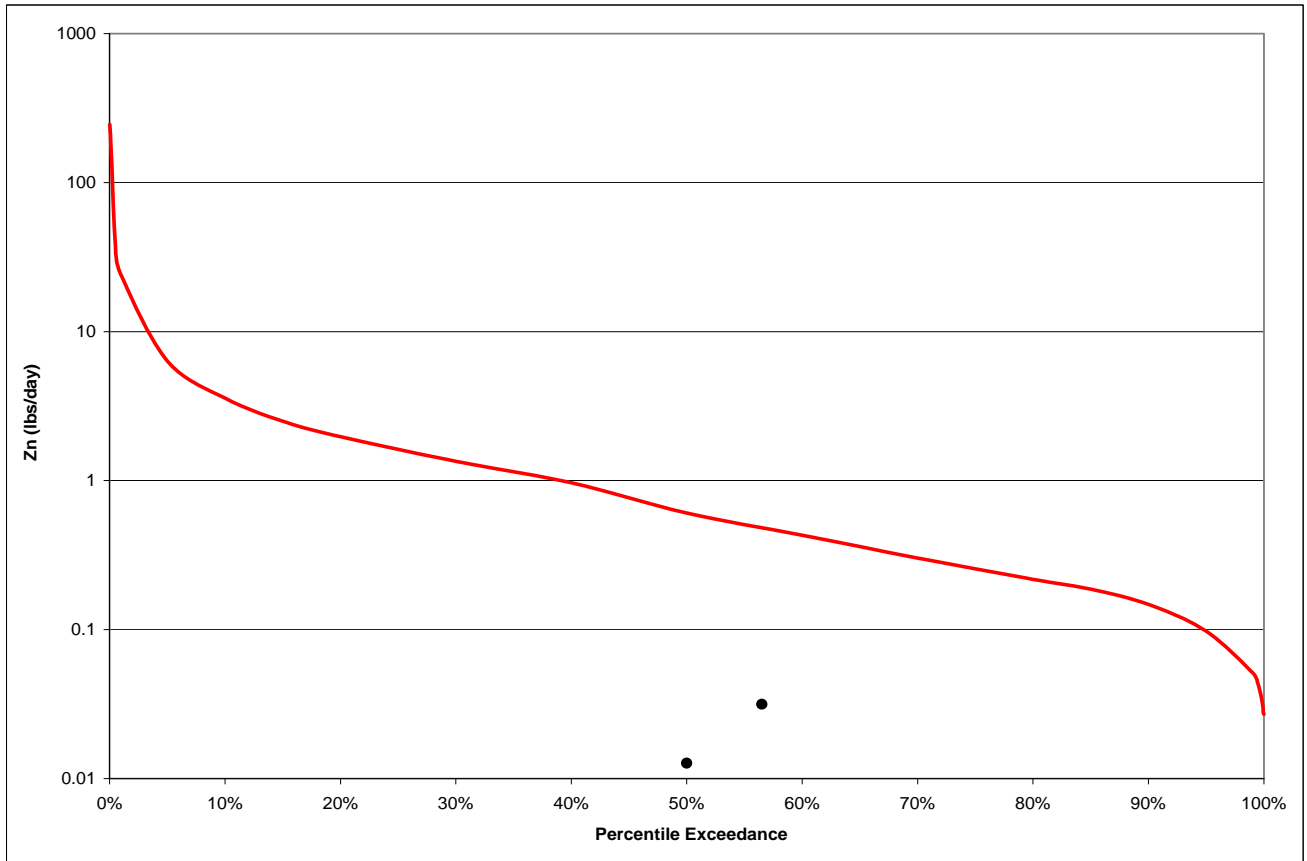
Figure 16. Load duration curve for dissolved zinc in Pond Creek.

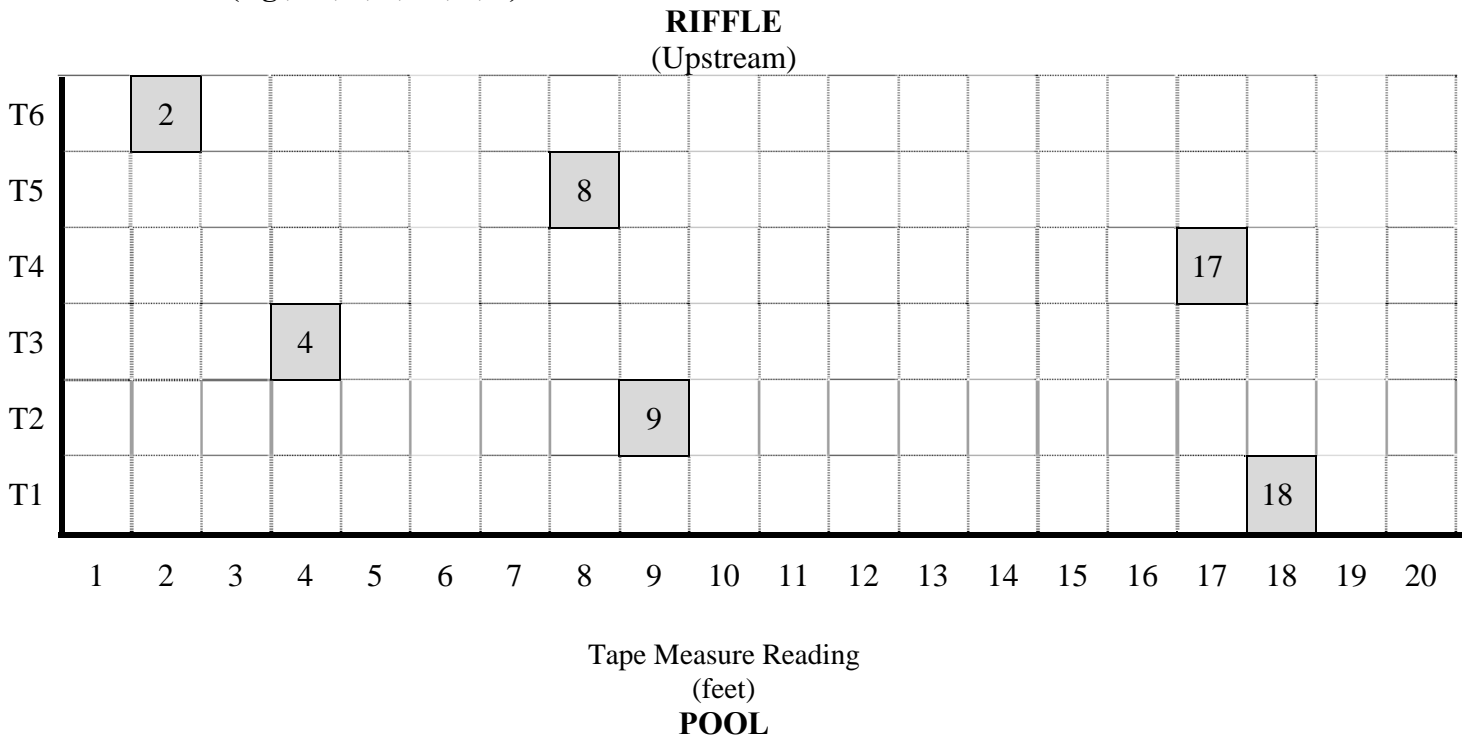
**Figure B-1. Virtual grid of transects (T) and quadrats (in gray, numbered) for estimating percent fine sediment. Example: stream 20’ wide; quadrat placement based on random numbers (e.g., 18, 9, 4, 17, 8, 2).**

Once a suitable area was identified, a virtual grid was constructed (Figure B-1). A 100’ tape measure anchored across the stream became the downstream transverse edge of a virtual grid of

six contiguous transects. Each transect was 12” deep and as wide as the useable grid and was identified by holding a retractable tape measure perpendicular to the 100’ tape. The useable grid width included the width of the stream with relatively laminar flow that excluded eddies, vegetation, and large obstructions. Random numbers, equating to one foot increments, were drawn to determine where the quadrat was placed along each transect. The quadrat was placed within the transect, with the downstream edge contacting the downstream transect edge. Two observers estimated/recorded the percent of fine sediment within the quadrat. The estimates were accepted and recorded if the two observations were within a ten percent margin of error or rejected and repeated until the margin of error was reached. Another random number was drawn and the quadrat was randomly placed in the next transect upstream where the next observation was made. This continued until fine sediment was estimated in each of the six quadrats (one per transect) and the results are summarized in Table B-1.

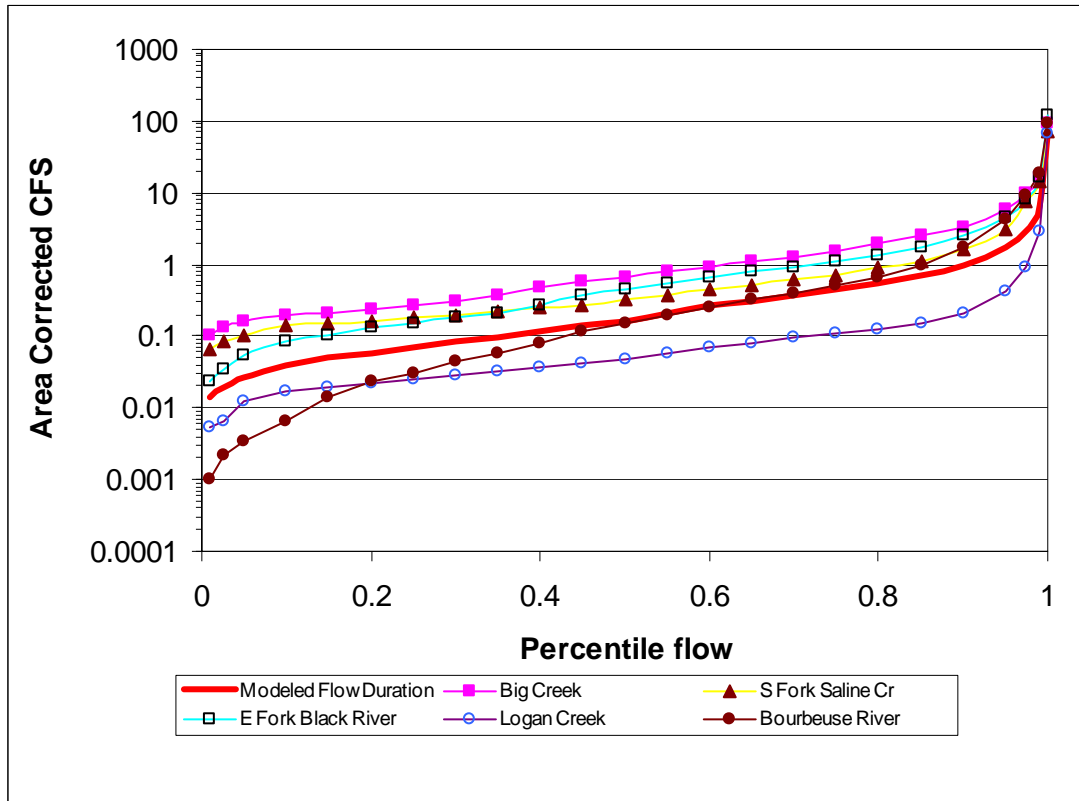
Figure C-1: Modeled and Reference Flow Duration Curves

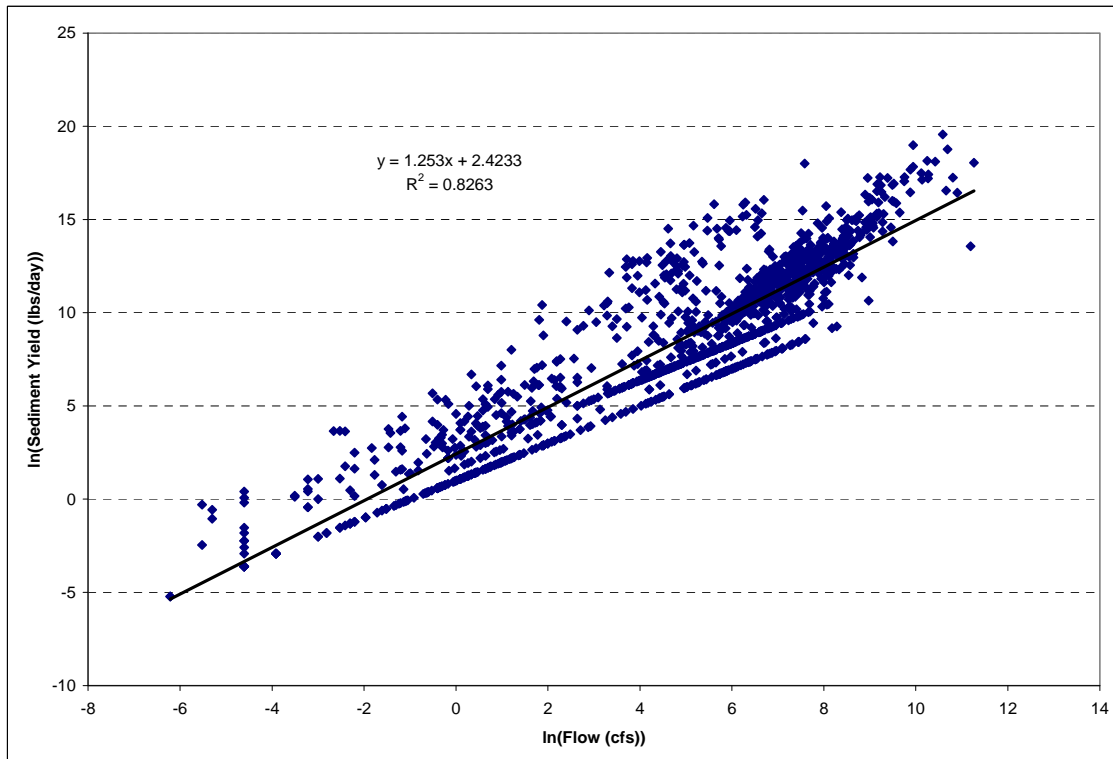
Figure C-2: Sediment yield as a function of instantaneous flow in Ozark/Meramec EDU.

The load duration curve was then calculated by back transforming the regression equation:

$$\text{Sediment yield (lbs/day)} = \exp(1.2538 * \ln(\text{flow}) + 2.4233)$$
