**The Michigan Department of Environmental Quality
Biennial Remedial Action Plan Update
For the
Torch Lake Area of Concern**

Compiled by:
Sharon L. W. Baker

Michigan Department of Environmental Quality
Water Bureau
Aquatic Nuisance Control & Remedial Action Unit

October 29, 2007

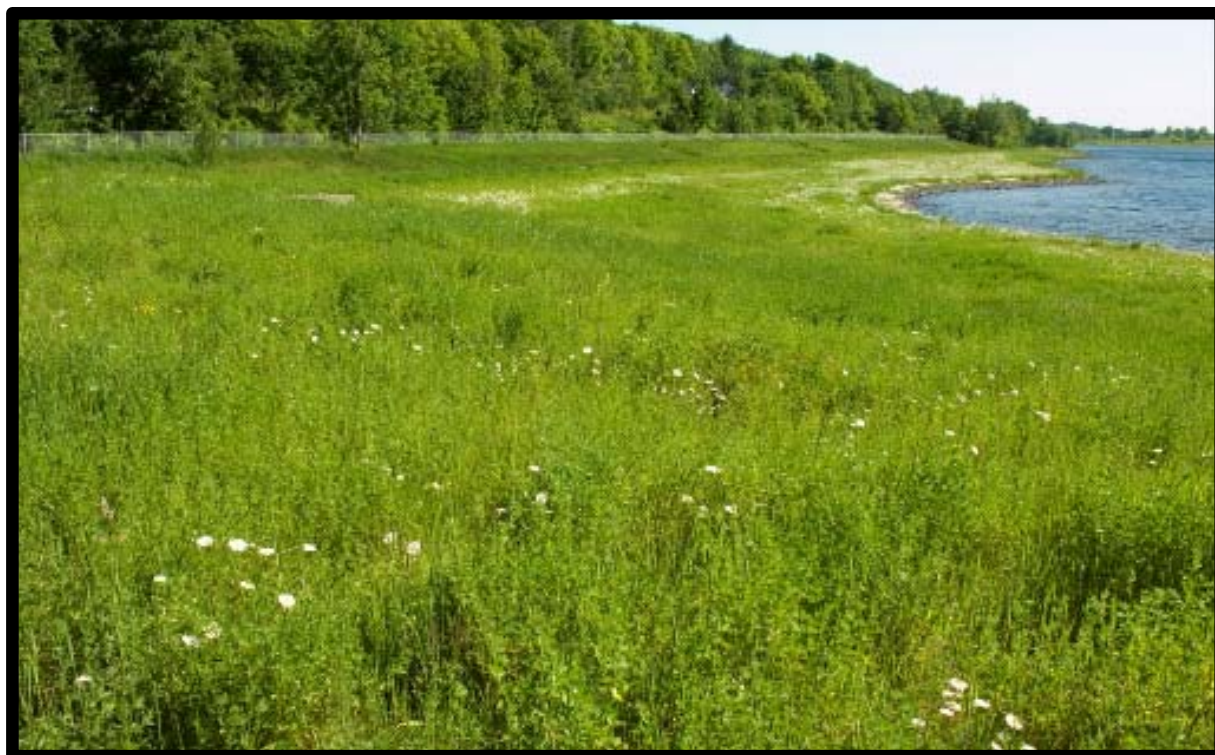
Mason Sands Superfund Site area two years after Superfund remedial activities completed.

Cover: The cover shows the Mason Sands SF Site Area located along the south western shore of Torch Lake, Houghton County, Michigan two years after the completion of the SF recommended remedial action (covering with topsoil and vegetating to prevent erosion by wind or water into nearby waterbodies). These particular “sands” or process wastes are comprised of water quenched slags. These slags are the result of cooling the parent rhyolitic materials with water after separating them from the copper after the smelting process. The picture below is a different view of the Mason sands before the remediation.

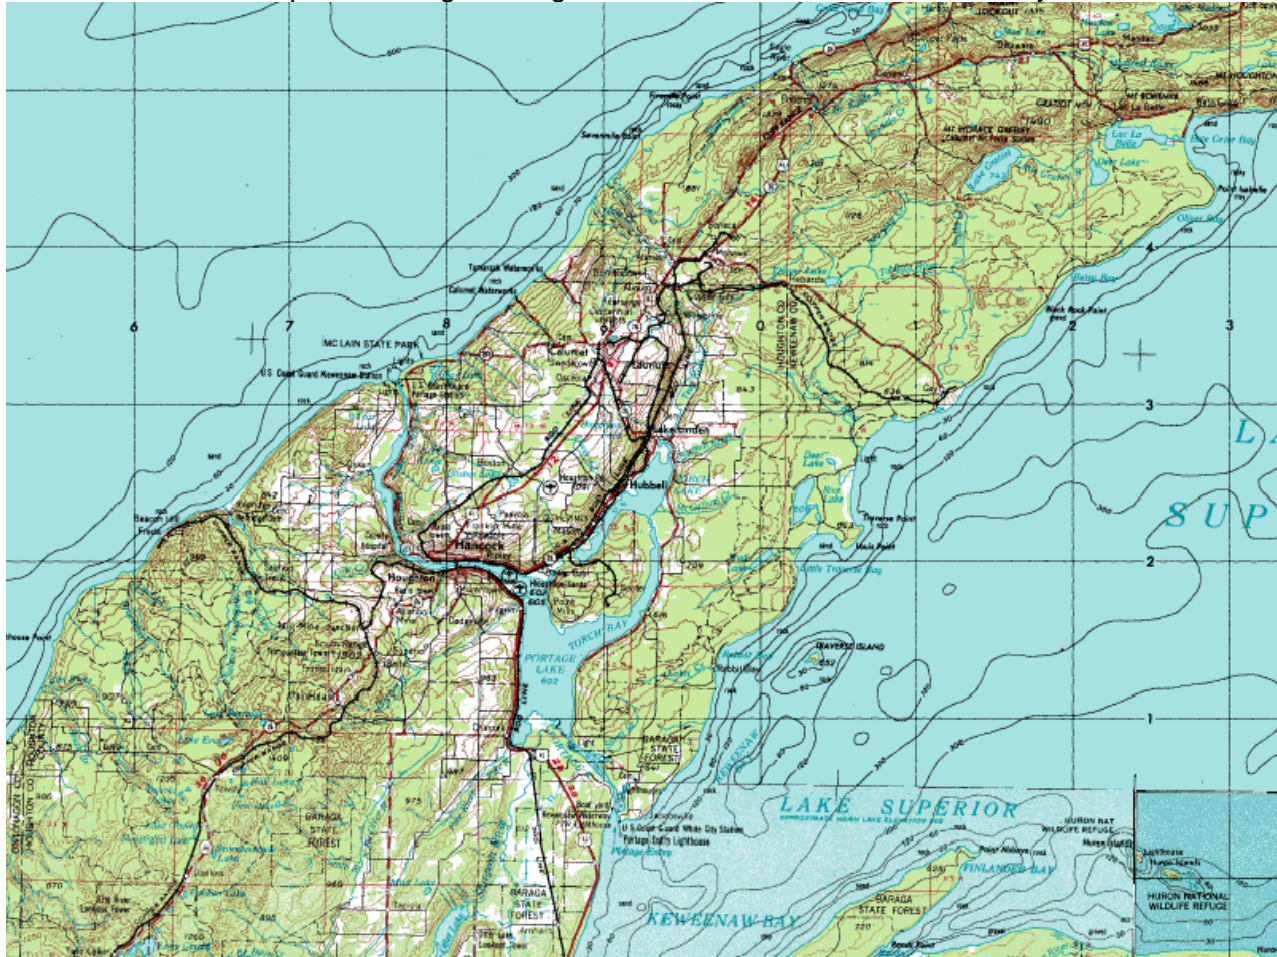
Figure 2: Portion of the Keweenaw Peninsula, Upper Peninsula, Michigan. Torch Lake is connected to Lake Superior through Portage Lake and the Keweenaw Waterway.

The Torch Lake watershed is the head waters of what is referred to as the Keweenaw Waterway. This waterway bisects the Keweenaw Peninsula and is open at both the north and south ends allowing, depending on wind direction, flows into Lake Superior in either direction. Lake Superior seiches can also “push” water essentially flowing into Torch and Portage Lakes causing the lake levels to rise. Torch Lake is used for fishing, boating, limited contact recreation (swimming, jet skis, and water skis), non-contact cooling water supply, treated municipal waste assimilation, and wildlife habitat.
