## Gold King Bond Forfeiture M-1986-013

### Phase I 2008 Permanent Portal Discharge Diversion Structure

## *Gold King Permanent Portal Discharge Diversion Structure*

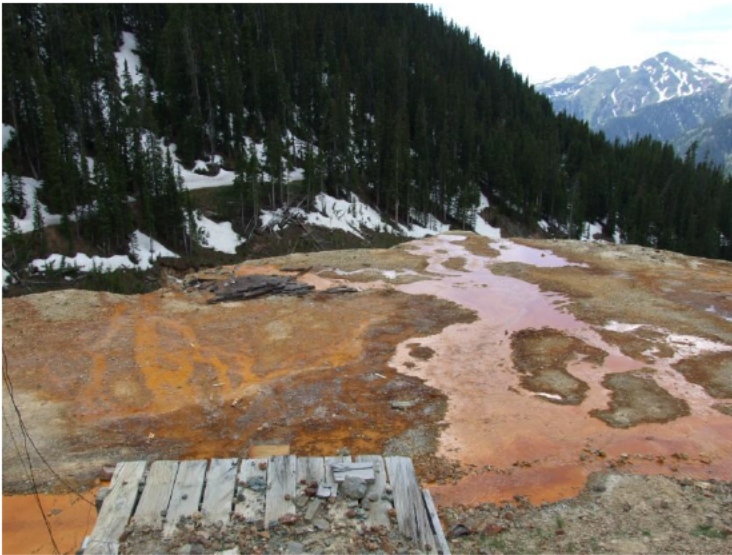
During the summer of 2007 the mine drainage from the Level 7 portal breached the existing ditch and saturated the top of the Level 7 mine waste pile. The saturated conditions of the waste pile lead to a slope failure that partially blocked access to the site and filled the North Fork of Cement Creek and the associated culvert under the access road with mine waste. The landowner of the site, Todd Hennis, re-installed the culvert and removed the mine waste from the access road, but did not completely address the breached ditch.

2007 Saturated Mine Waste and breached ditch

In 2008, DRMS took action and halted the saturation of the Level 7 mine waste pile. DRMS met with (b) (6), landowner, and settled on moving the ditch to an eastward flowing direction and lining the ditch with half round HDPE pipe. The location of the ditch is ideal for both long term closure of the site and any future mining activity.

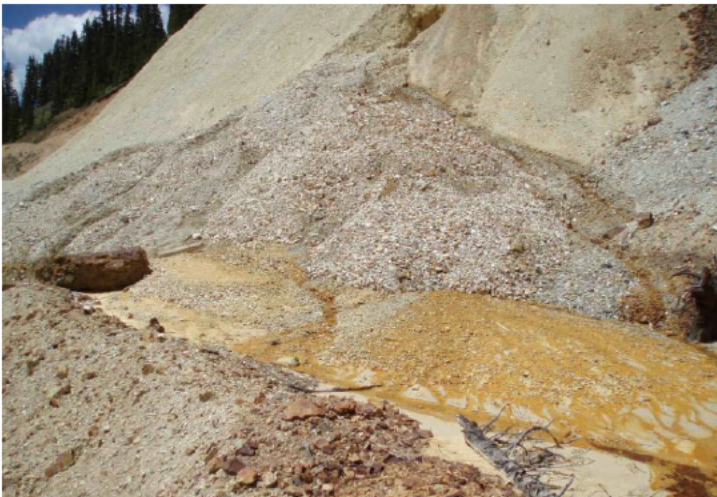
2007 Slope Failure

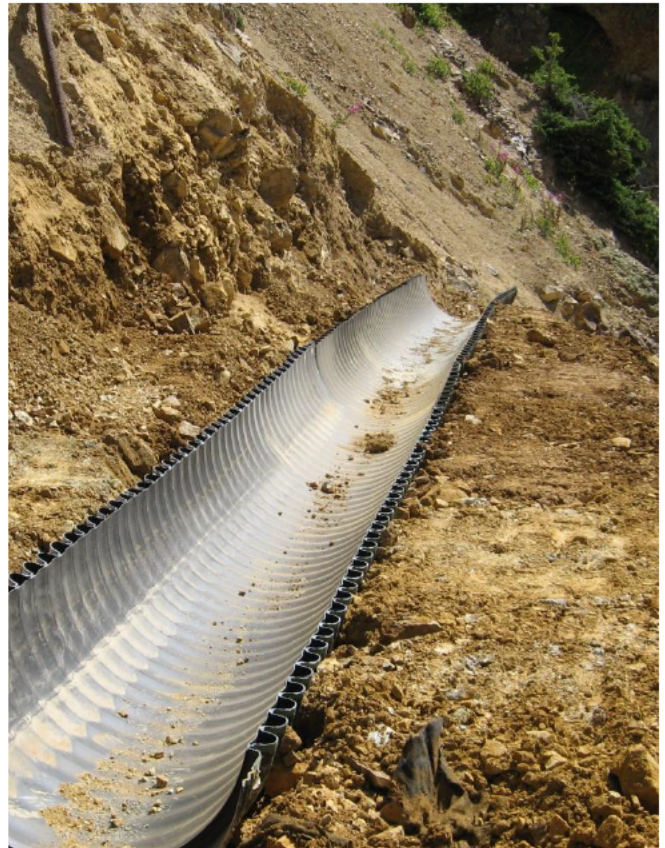
2008 – Installation of permanent portal discharge diversion structure

The project was constructed during the week of August 25, 2008. The new permanent portal discharge diversion structure was excavated into the top of the mine waste and 165 foot of half round 36" diameter corrugated pipe was set at a 2-3% grade.
