Gold King Bond Forfeiture M-1986-013

Phase II – 2009 Reclamation at the Sampson, Number One, and Level Seven Portals

2009 Reclamation at the Sampson, Number One, and Level Seven Portals

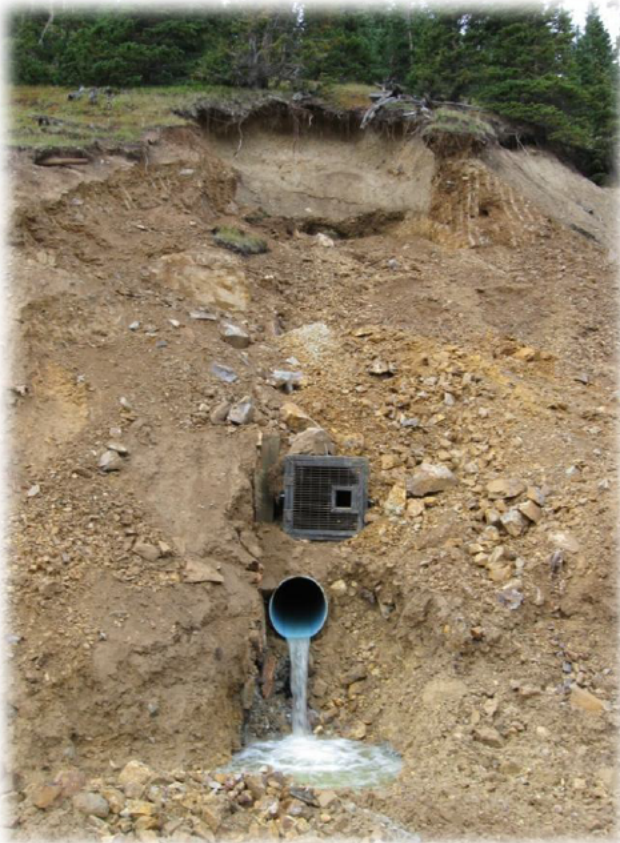
Gold King Level 7 Old Portal Closure

Both Level Seven portals were partially collapsed prior to backfilling in 2009. The Level Seven New Portal required additional fill to remove the unstable fifteen feet of continually collapsing timbered area that remained in front of the complete portal collapse from fifteen feet on. The Level Seven Old Portal also required additional closure in front of the complete portal collapse from thirty feet on. An observation pipe and drainage pipe were placed in the Level Seven Old Portal, but during filling around the pipes, the timbers in the portal collapsed and loose colluvial material completely covered the observation and drainage pipes. The drainage pipe continues to drain at roughly 200 gallons per minute, at the same flow rate as before the collapse. The observation pipe was meant to provide stable access to view the collapse at thirty feet, allowing the landowner and the DRMS to monitor this unstable draining adit, which is arguably one of the worst high quantity, poor water quality draining mines in the State of Colorado. Because of the collapse, DRMS decided to install a well point, driven into the collapse, through the drainage pipe, in an attempt to alleviate concerns about an unstable increase in mine pool head within the Gold King workings. The installed 6 inch perforated steel pipe penetrated approximately 12 feet of collapsed material thought to exist between the original collapse and the end of the drain pipe. The well point was unable to penetrate through any of the original existing collapse in the tunnel.

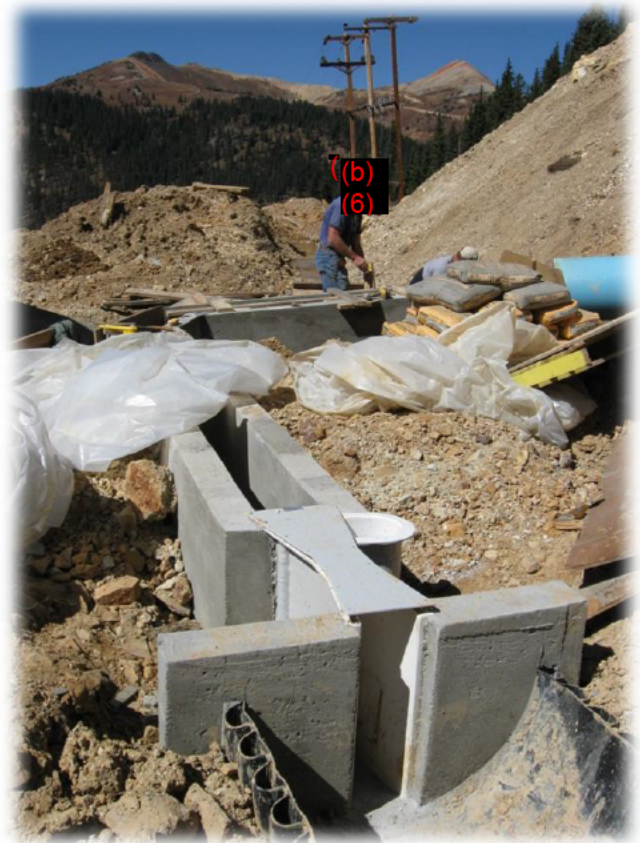
Gold King Level 7 Old Portal with 2" Parshall Flume Installed in Concrete Lined Ditch

A flume was installed at the Level Seven Old Portal as part of the bond revocation reclamation. The two inch Parshall Flume was installed in a concrete lined ditch immediately in front of the HDPE lined ditch. The flume will be used to monitor flow by the landowner and the Animas River Stakeholders Group (ARSG).

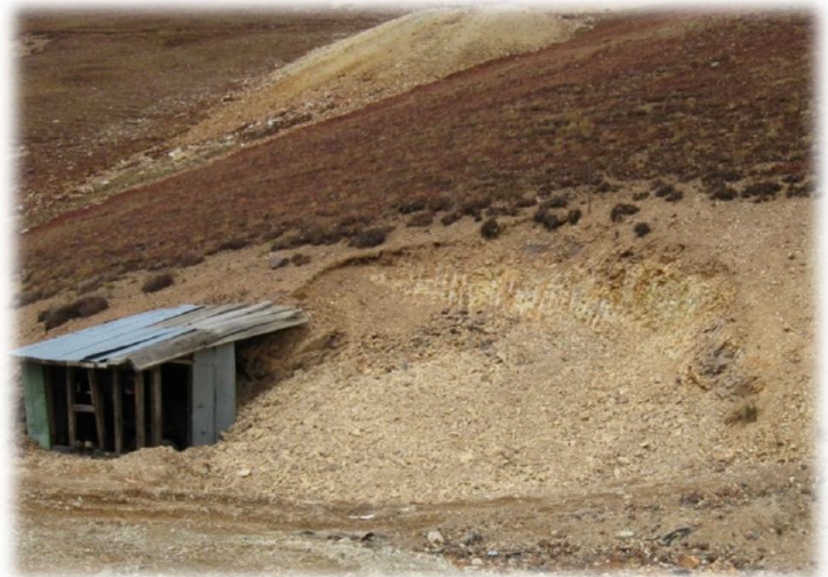
Number 1 Portal backfilled

In 2009 all four permitted adits were backfilled, a flume was installed in the previously lined ditch, and 1600 feet of drill road was reclaimed. The Sampson Portal was backfilled with on-site materials and the wooden and metal debris was buried on-site. The Number One Portal was also backfilled with on-site materials and the debris from the site was buried to the east of the portal in the waste pile. In addition, a 1600 foot long drill road from the Number One Portal to immediately below the Sampson waste pile was re-contoured, ripped, mulched, and seeded.

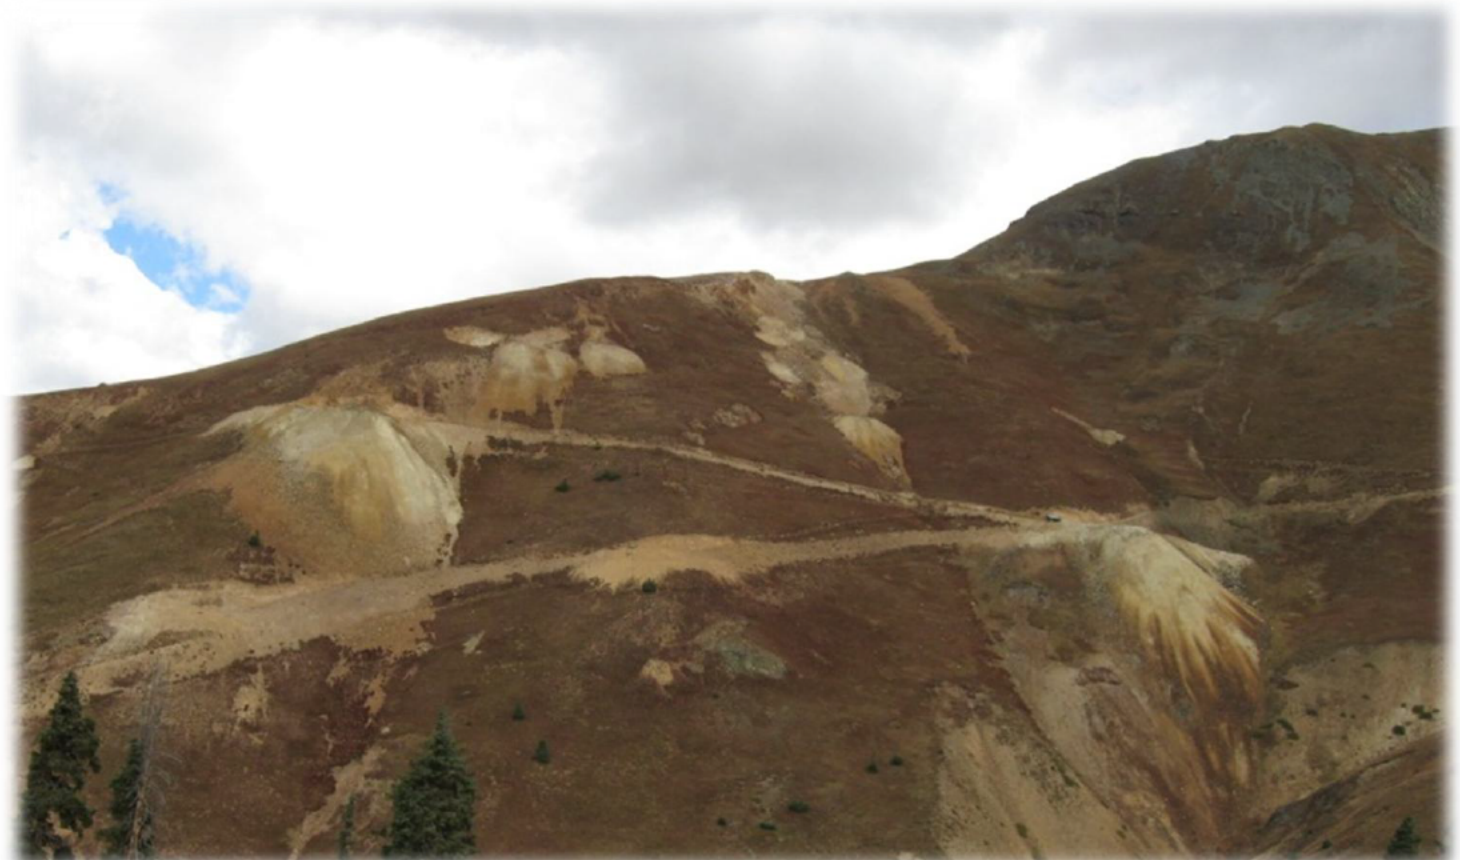
Sampson Portal, Drill Road, and Number 1 Portal as viewed from access road after reclamation. Drill Road has been re-contoured and revegetated in this photo.

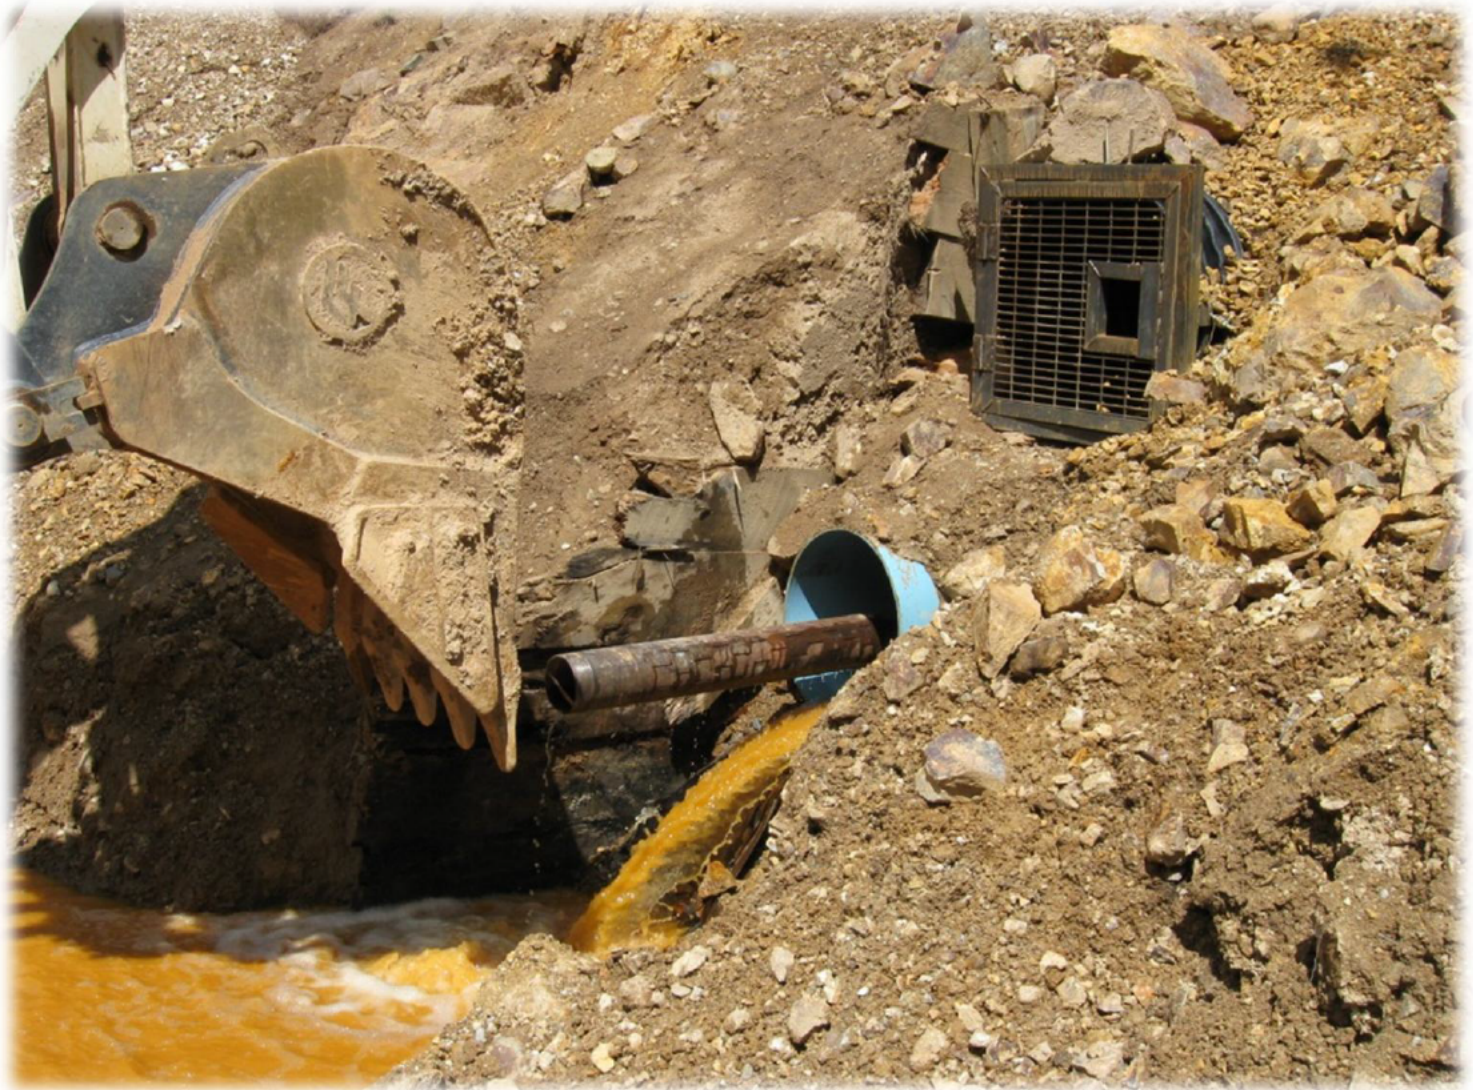
The mine drainage at the Gold King Level 7 Mine contains extremely high levels of metals and continues to flow between 150 and 300 gallons per minute. The mine drainage began after bulkheads were installed in the American Tunnel in 1995, which previously deep-drained the mining district. The mine drainage and the collapse at the Level 7 Old Portal continues to be of concern to the landowner, DRMS, and ARSG. A future project at the site may attempt to cooperatively open the Level 7 Old Portal in an effort to alleviate the potential for an unstable increase in mine pool head within the Gold King workings.

*Gold King Level 7 Old Portal with well-point installed through the drain pipe. This portal may be re-opened in a future project to help stabilize the mine drainage and prevent future **increases in mine pool head**.*
