Bunker Hill Mining and Metallurgical Complex, Idaho, Superfund Case Study

Revitalization of the Bunker Hill Hillsides and Wetlands

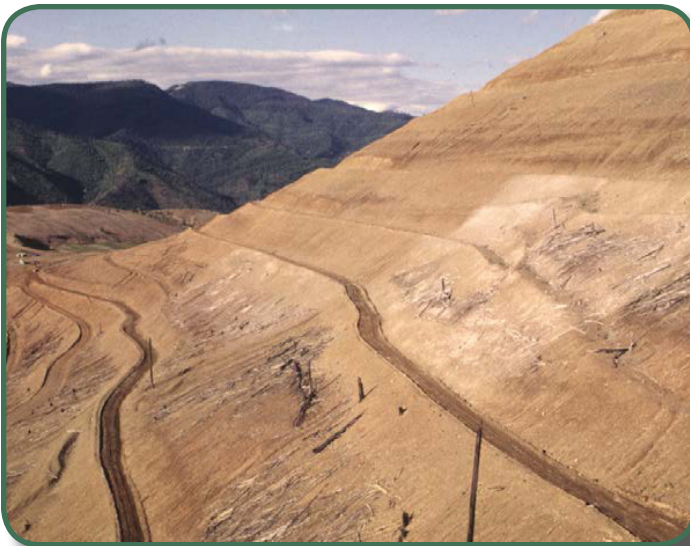
Hillsides 1993

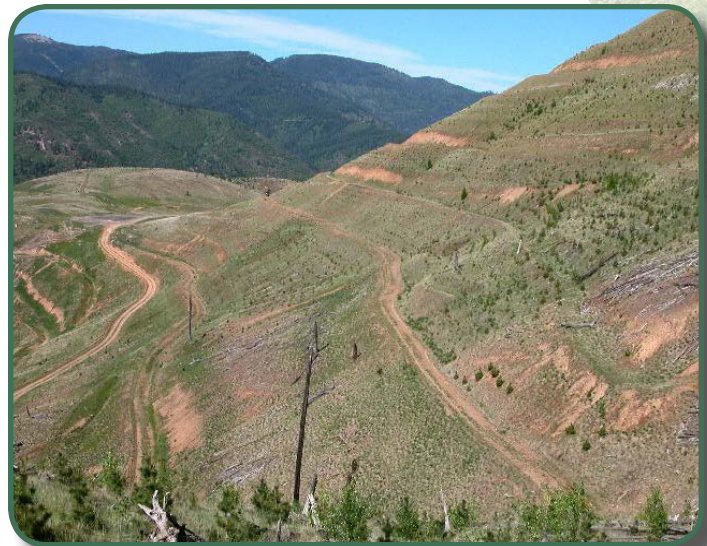
Hillsides 2003

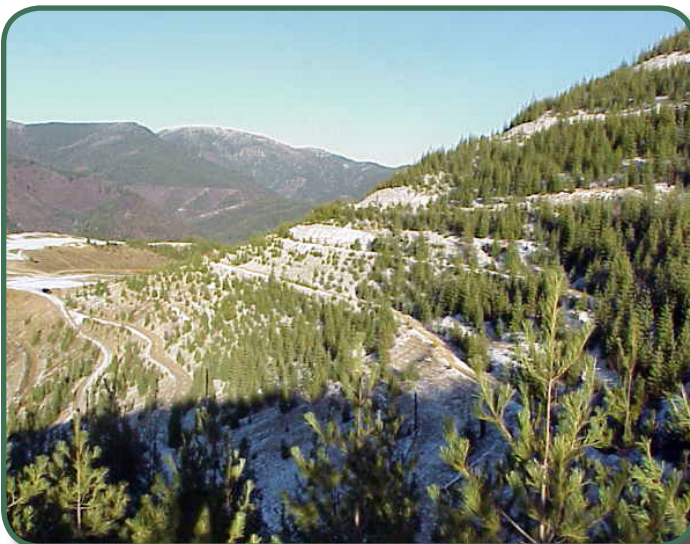
Hillsides 2014

- As of 2014, vegetation had been fully established at all but a few isolated rocky sites.
- Using native herbaceous plants, such as penstemon, and trees, such as woods rose, at this site helped create an attractive habitat for wildlife and pollinators.

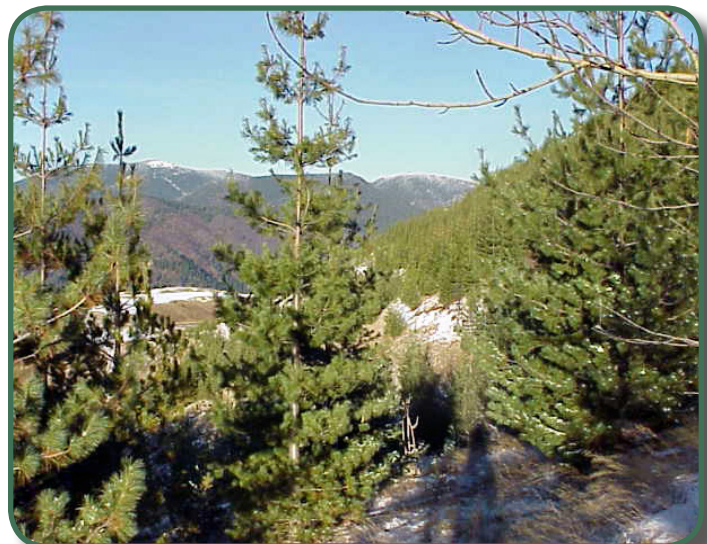
2014 Hillside vegetation growth

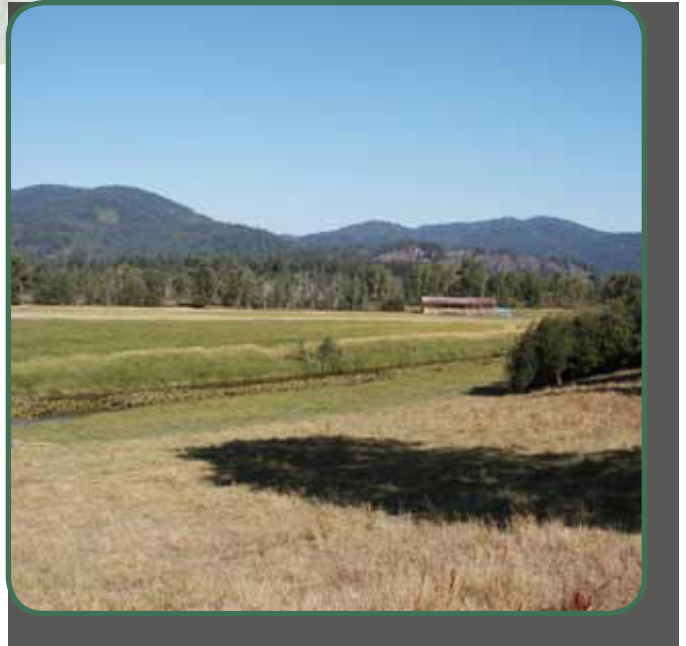
Farmland before wetland restoration
(Source: <http://restorationpartnership.org/wetland-restoration-project.html>)
