Removal Recommendation

Beneficial Use Impairment 11: Degradation of
Aesthetics

**Buffalo River Area of Concern
July 16, 2018**

New York State Department of Environmental Conservation, Buffalo-Niagara
Waterkeeper, Erie County Department of Environment & Planning

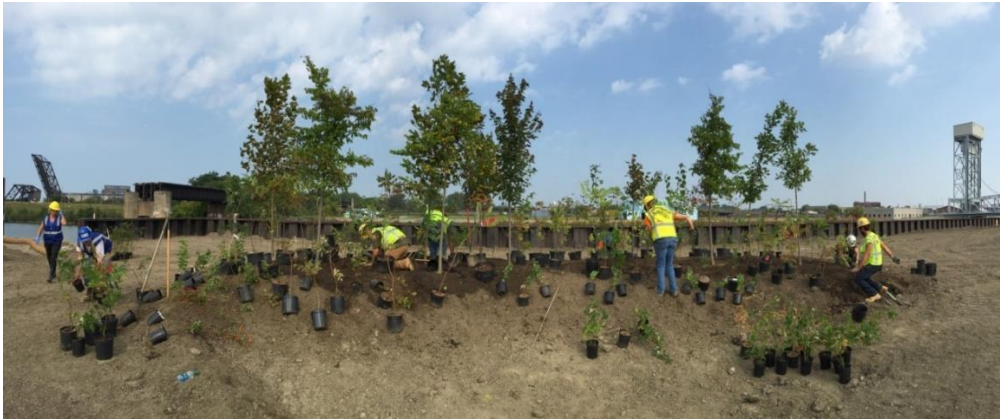
Figure 6. Habitat planting at “RiverBend 2”, a site along the Buffalo River. Taken by BNW, 2015.

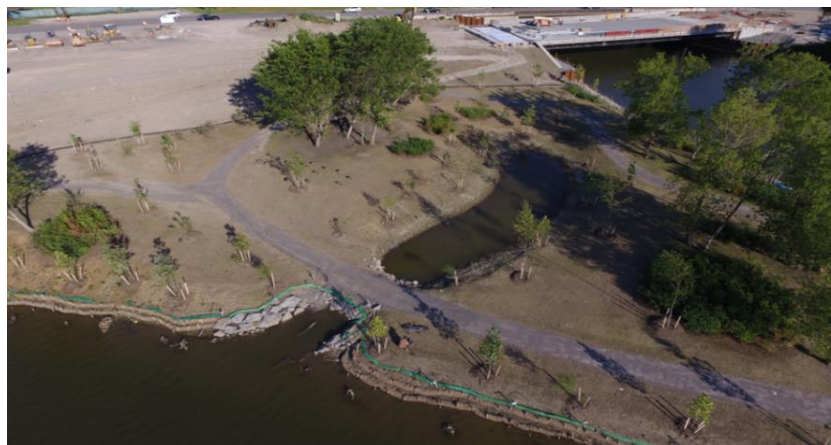
Figure 8. The Bailey Avenue habitat restoration site identified in the Habitat Action Plan. This site restores approximately 765 linear feet of shoreline and the inlet opens up additional fish habitat. Taken from ECDEP, 2017.

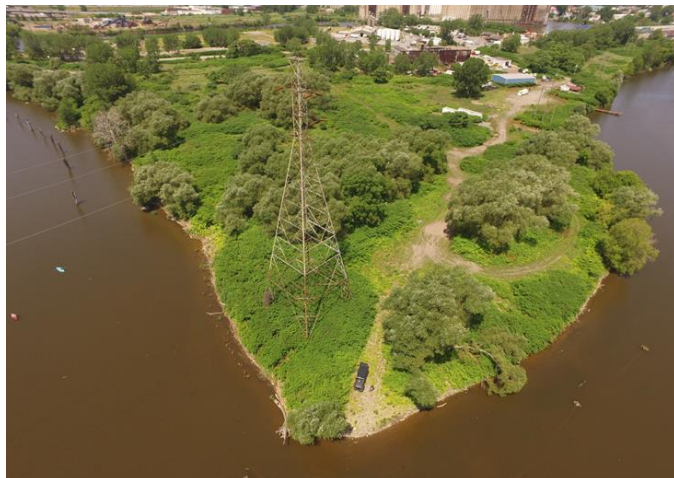
Figure 13. Photograph before invasive species treatment at the toe of Katherine Street Peninsula. Most of the visible vegetation is knotweed or tree-of-heaven, except for the large willow trees.

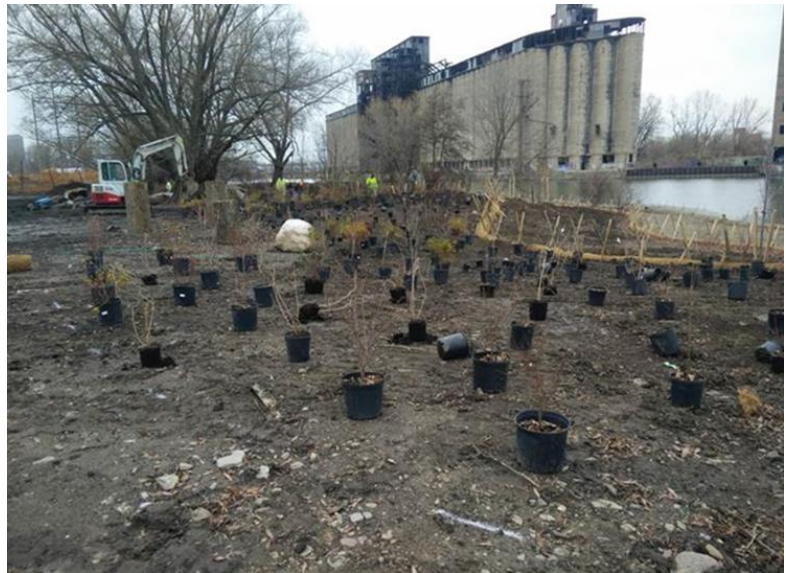
Figure 14. Trees ready for installation following invasive species treatment at the Toe of Katherine Street. Turtle nesting habitat was also created at this site.

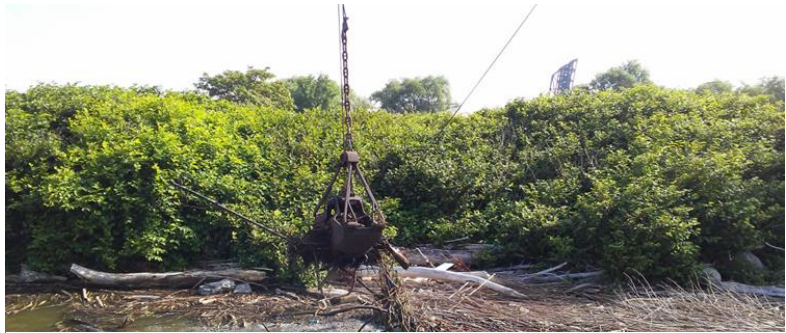
Figure 15. Three barges of large woody debris were removed from the “Blue Tower Turning Basin” site. The debris was removed from this site before in-water habitat was planted. A rootwad chain and floating boom system was then installed to deflect additional accumulation of debris.

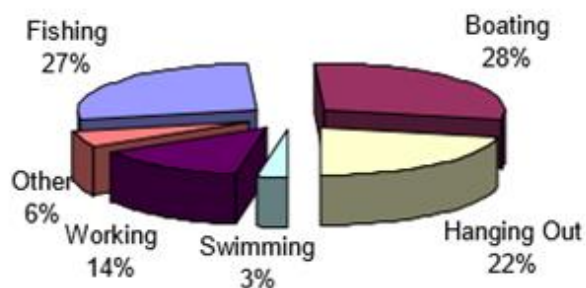
Buffalo River Activities, 2003-04

Figure 17. Summary of popular use activities of the Buffalo River in 2003-2004. “Hanging Out” is defined as any recreational use that is not described by other categories, such as walking, sitting with a friend, eating lunch. Taken from Irvine et al. 2005.

In 2003-2004, a study was conducted to observe how frequently the public visited the Buffalo River.²⁹ For three hours at a time, observers on a boat noted how many people they saw in or alongside the River on randomized days between July and September. On numerous occasions, they did not encounter a single person. In total, they observed 887 people over a 73 day period. After correcting for days that were not sampled, this equated to approximately 6,862 unique visits in 2003 and 5,922 in 2004. It was not in the capacity of the Buffalo River RAC to replicate this study; however, it is conceivable that one could observe 887 people utilizing the Buffalo River AOC in a single summer weekend in 2018.
