**DOCUMENTATION OF ENVIRONMENTAL INDICATOR DETERMINATION**  
Interim Final 2/5/99  
**RCRA Corrective Action**  
**Environmental Indicator (EI) RCRIS code (CA750)**  
**Migration of Contaminated Groundwater Under Control**

**Facility Name:** AMETEK-Haveg  
**Facility Address:** 900 Greenbank Road, Wilmington, Delaware  
**Facility EPA ID #:** DED061805487

**Migration of Contaminated Groundwater Under Control  
Environmental Indicator (EI) RCRIS code (CA750)**

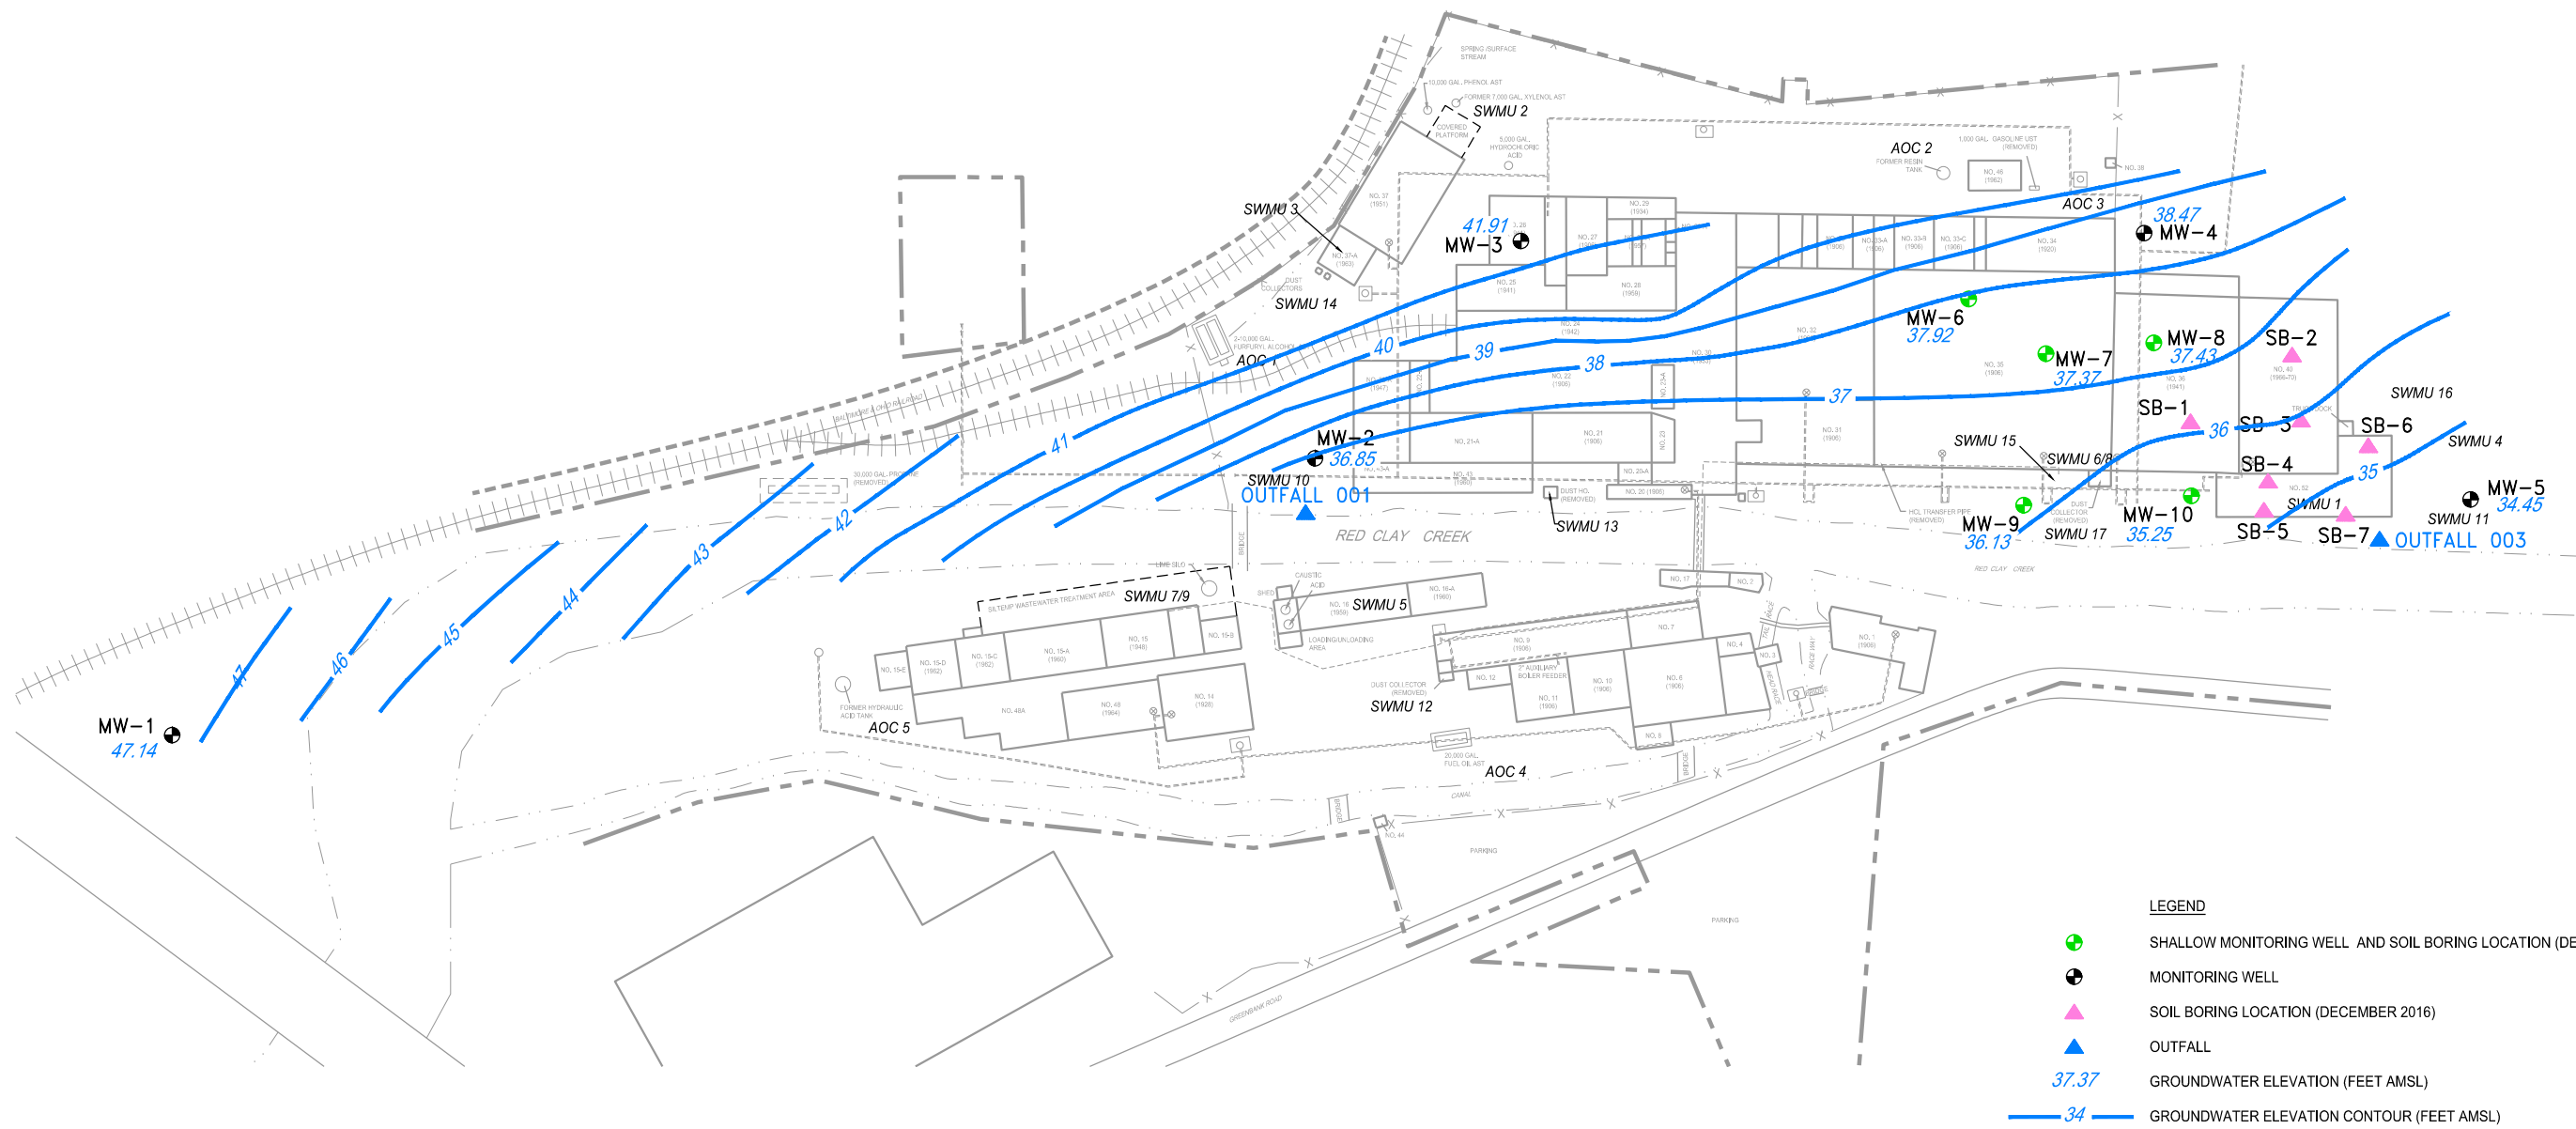
**FIGURE 11**  
**GROUNDWATER ELEVATION CONTOUR MAP - PHASE II**  
**AMETEK, INC.**  
**HAVEG DIVISION - 900 GREENBANK ROAD**  
**MARSHALLTON, DELAWARE**  
**JULY 2017**

Refer to the included map of interpreted contours of the water-table surface, constructed from measurements of water depth in each of the ten (10) monitoring wells on-site. Groundwater flow is interpreted as generally east to west, toward Red Clay Creek. The included map represents groundwater depth data from 2017 and was excerpted from the “Summary of Site Sampling Activities, Supplemental Remedial Facility Investigation,” prepared by AMETEK and dated November 4, 2019.

- SHALLOW MONITORING WELL AND SOIL BORING LOCATION (DECEMBER 2016)
- MONITORING WELL
- ▲ SOIL BORING LOCATION (DECEMBER 2016)
- ▲ OUTFALL
- 37.37 GROUNDWATER ELEVATION (FEET AMSL)
- 34 — GROUNDWATER ELEVATION CONTOUR (FEET AMSL)

Laterally, groundwater contamination appears to be bound by two (2) natural features and three (3) relatively non-impacted monitoring wells. Red Clay Creek to the west and the escarpment to the east act as topographic and/or hydraulic barriers that limit the migration of contaminated groundwater in these respective directions.
