IDENTIFYING AND RECRUITING PARTNERS FOR GREAT LAKES LEGACY ACT PROJECT

Detroit River AOC, Michigan

River Rouge - Ecorse Shoreline Site

December, 2018

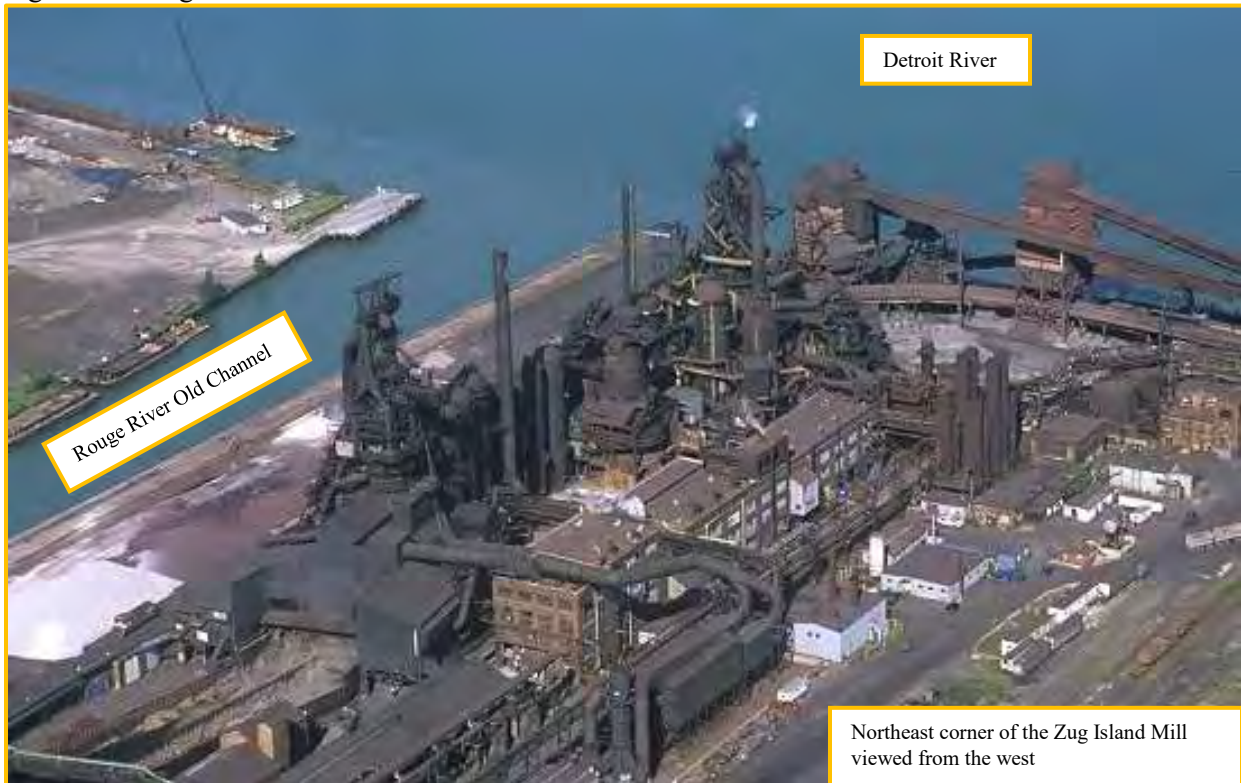
Figure 10 – Zug Island Mill

The first blast furnace for refining iron ore was operational on Zug Island in 1902 (Detroit Iron Works) eventually a second and third blast furnaces were added. The mill produced pig iron to supply the many foundry companies in the area (many in the Harbortown and Riverbend Areas). Ship docks on both the Detroit and Rouge River sides of the island delivered ore and coal that were stored in large piles. Coke was manufactured on-site for the blast furnaces. By 1931 the Zug Island operations were acquired by Michigan Steel Corporation which became part of the National Steel Corporation. See Figure 10 for an aerial photo of the Zug Island Mill.

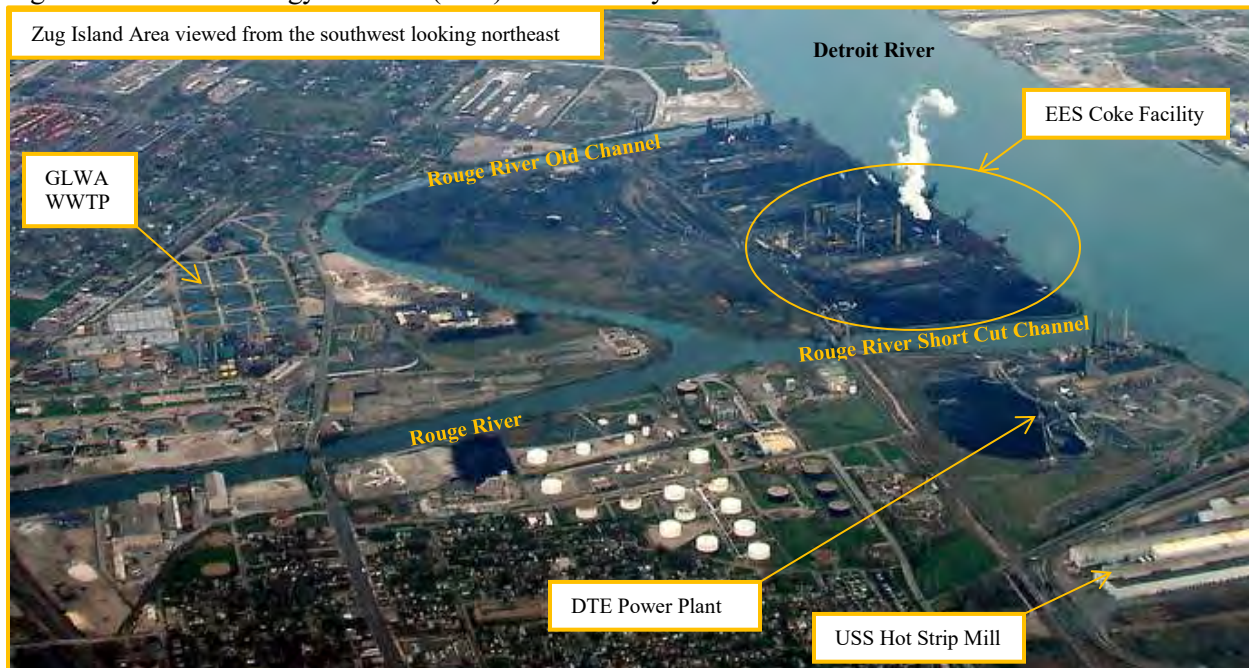
Figure 13 - Edison Energy Services (EES) Coke Battery

When National Steel Corporation went out of business in 2003 most of the steel companies assets were purchased by US Steel. However, number 5 Coke Battery located on Zug Island, once an integral part of the mill, was not acquired by US Steel. Edison Energy Services (EES) Coke Battery, LLC (a wholly owned subsidiary of Detroit Edison) purchased the coke battery from the bankrupt National Steel Company. The street address of the coke battery is 1400 Zug Island Road. See Figure 13 for an aerial photo of the location of the EES Coke Battery.

The relatively clean burning, high BTU and carbon content coke is produced from coal and is required for steel making and other furnace processes. By-products such as tar and light oil are recovered during processing for beneficial use. The EES Coke Battery supplies coke to the Great Lakes Works and ships coke via train to other customers (chiefly ArcelorMittal, in the merchant metallurgical market). The coke battery reportedly produces over a million tons of furnace grade coke, plus nut coke and coke breeze, and recovers about 9 million gallons of tar and almost 2 million gallons of light oil annually.

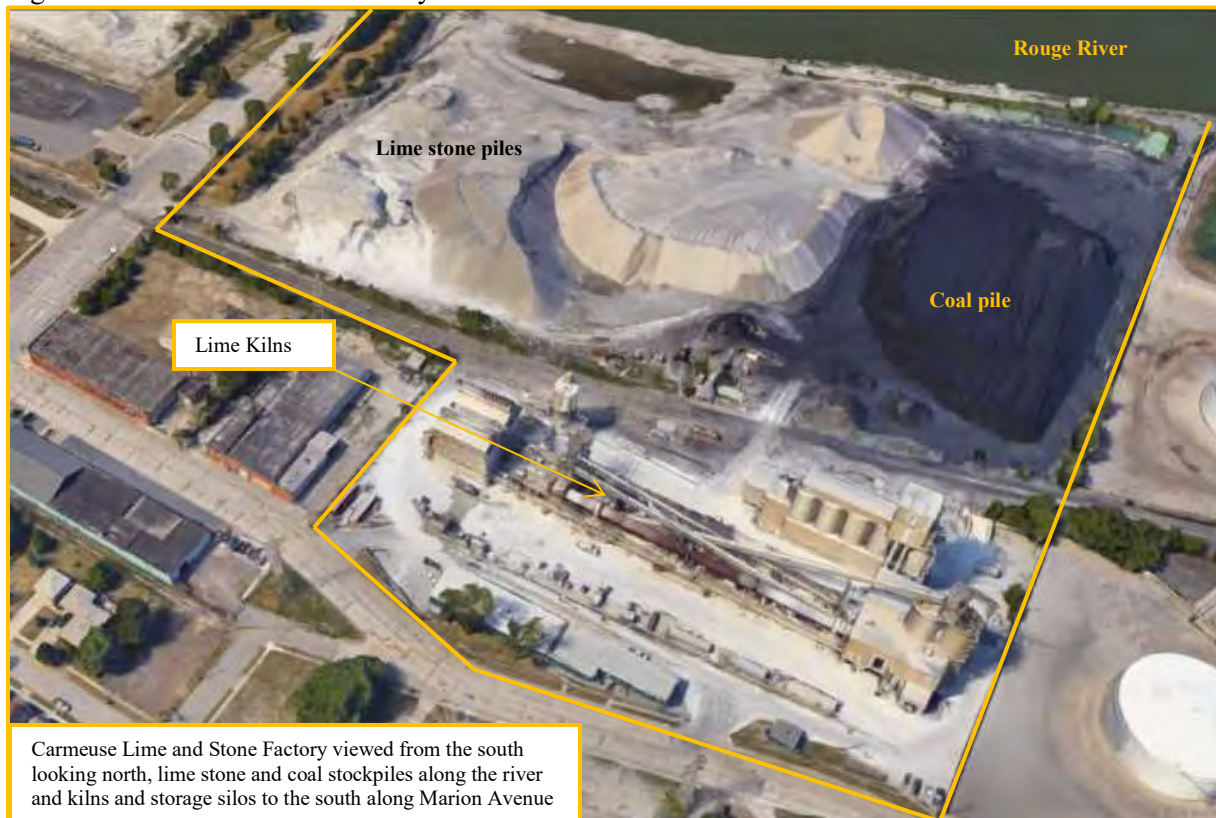
Figure 14 – Carmeuse Lime Factory

Carmeuse Lime & Stone (Carmeuse) operates an existing lime production plant located at 25 Marion Avenue, River Rouge. Limestone is the primary material used to produce the lime. The limestone is brought to the Carmeuse facility by ship, and is stored in the northern half of the property adjacent to the Rouge River. See Figure 14 for an aerial photo of the Carmeuse facility. The limestone comes from quarries in locations such as Manitoulin Island, Ontario; Rogers City, MI; and Gulliver, MI in the southern Upper Peninsula.

Limestone is rock whose makeup includes the mineral calcite. In order to manufacture lime, the calcite must be removed. At Carmeuse, this is accomplished by heating it to temperatures of 1600°F in two rotary kilns. The kilns, which are 300 feet long, are fired by coal with natural gas used at start up. Each kiln has a maximum production capacity of 550 tons of lime product per day.

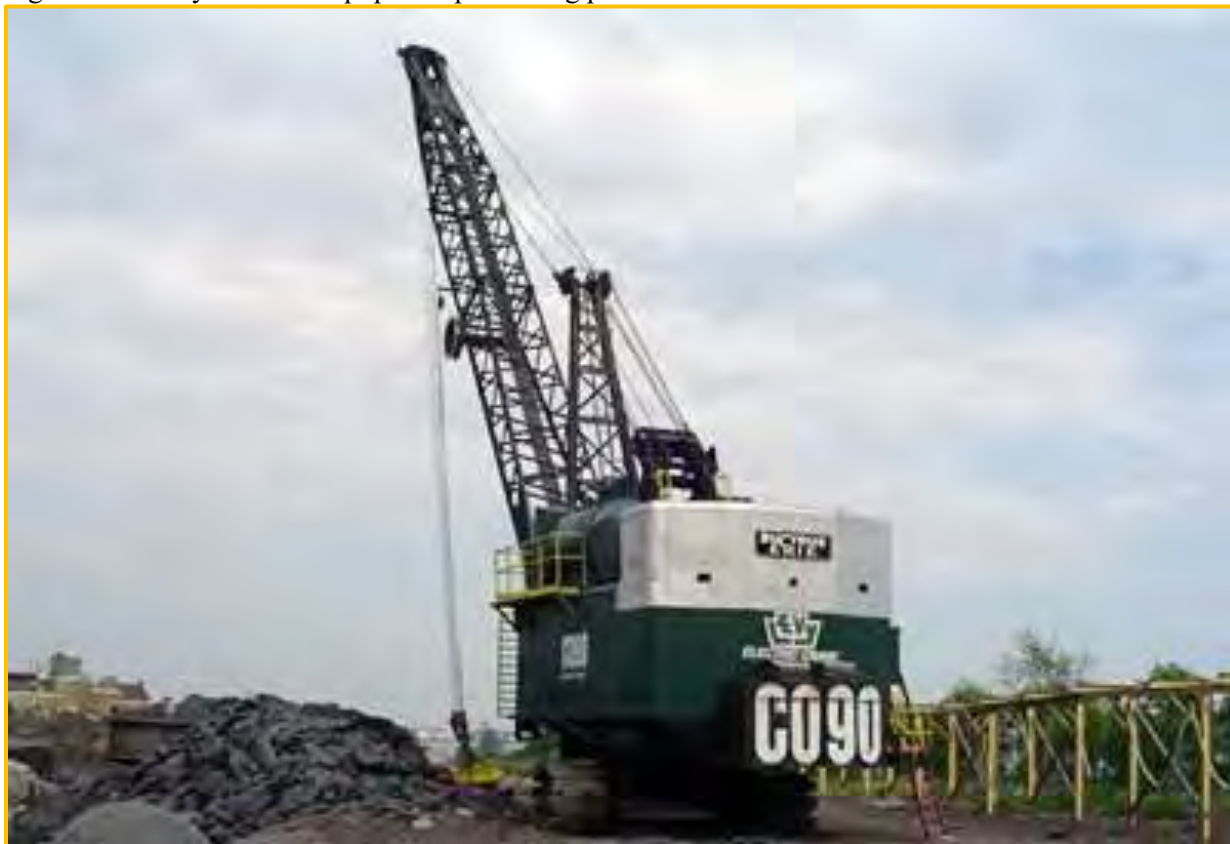
Figure 23 – Levy Plant #3 Equipment processing pile

The Levy Plant #3 consists of over 100-acres of material piles, roadways, sheds, conveyors, and processing buildings. Over the years Levy has expanded services to the steel mill that now includes steel scrap processing, debris handling, desulf iron processing, BOF and desulf pot hauling, BOF / caster slag trucking, revert scrap trailer operation, tundish skull handling / processing, equipment / lowboy rentals, and slag pot repair (as listed on the Levy web page). Although the primary product of the site is steel furnace slag processing – 22x slag (a dense graded base aggregate for paving, produced by crushing and screening steel furnace slag). See Figure 23 for a photo of equipment working a slag pile.

Edward C. Levy established a steel mill support company from a trucking company in 1918. Starting with the Ford Rouge Steel Plant, Levy began by hauling steel slag from the mill. Levy quickly branched out and provided his services to other steel mills and began processing the slag into sub-base for road construction. Levy Plant #3 was established just south of the newly constructed Great Lakes Steel Corporations Ecorse Works at 100 East Westfield along the Detroit River in 1930.
