IDENTIFYING AND RECRUITING PARTNERS FOR GREAT LAKES LEGACY ACT PROJECT

Detroit River AOC, Michigan

Riverbend Site

December, 2018

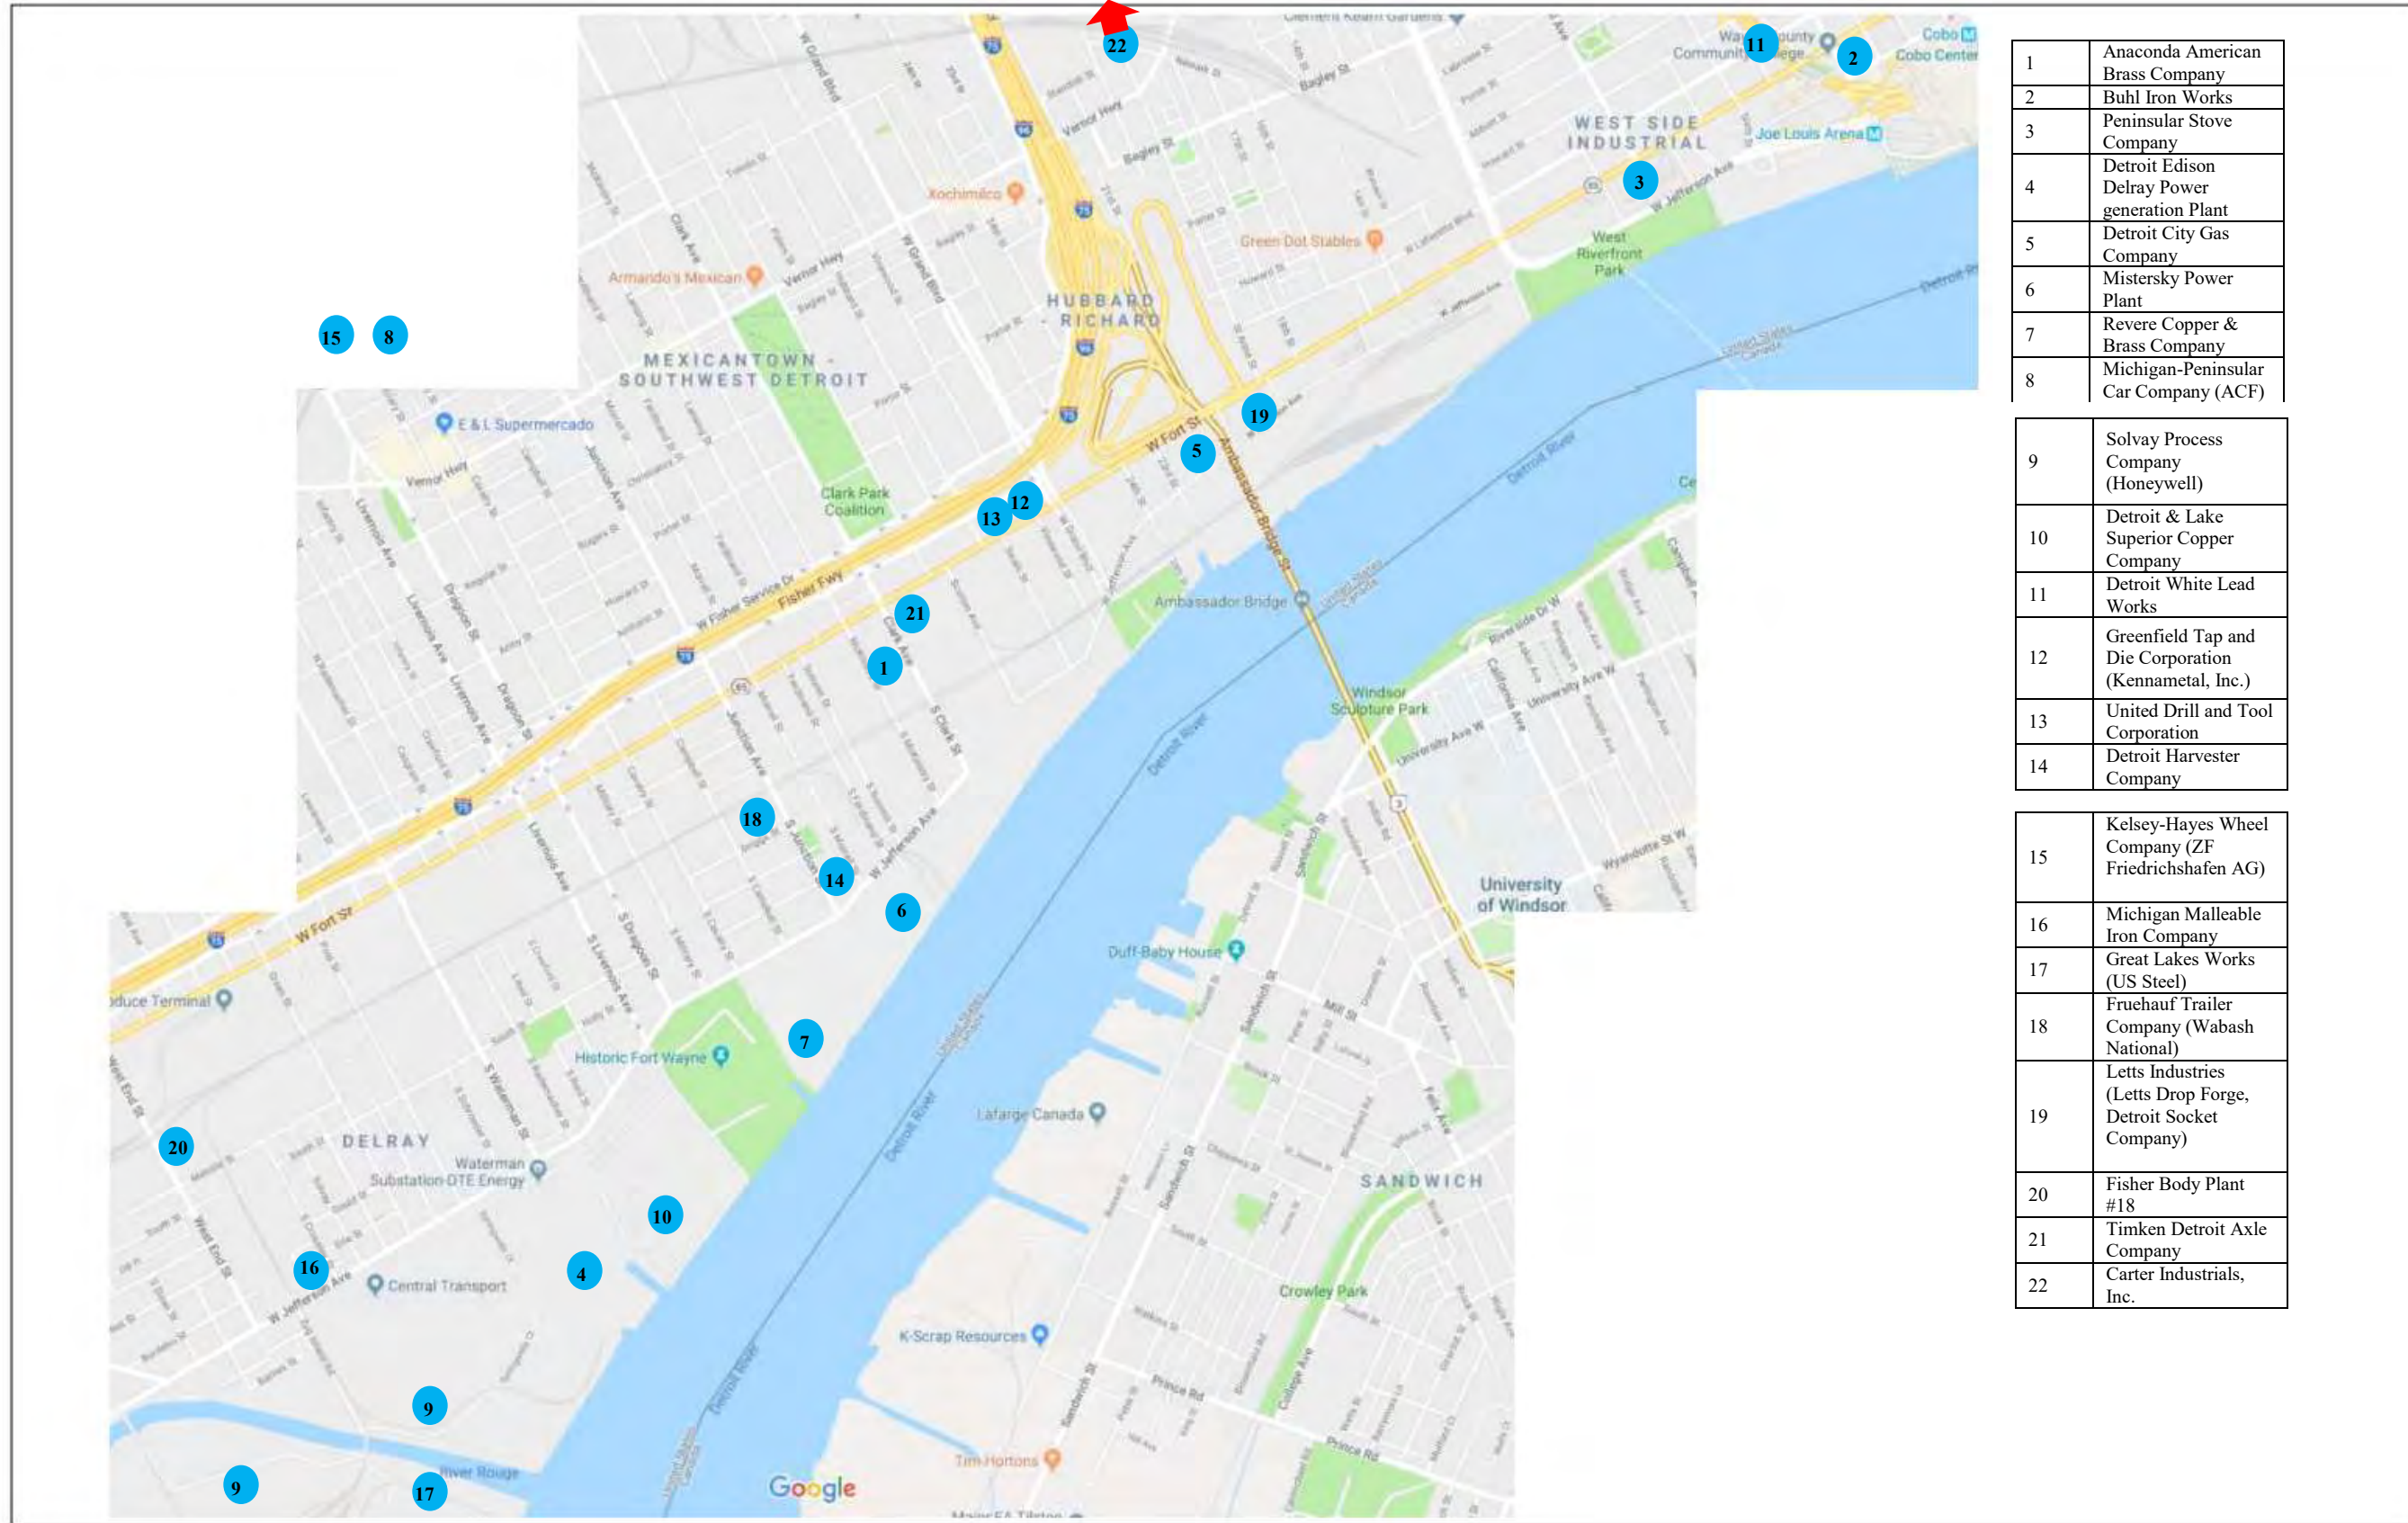
Figure 4 – Locations of Identified Potential Remediation Partners

1	Anaconda American Brass Company
2	Buhl Iron Works
3	Peninsular Stove Company
4	Detroit Edison Delray Power generation Plant
5	Detroit City Gas Company
6	Mistersky Power Plant
7	Revere Copper & Brass Company
8	Michigan-Peninsular Car Company (ACF)

9	Solvay Process Company (Honeywell)
10	Detroit & Lake Superior Copper Company
11	Detroit White Lead Works
12	Greenfield Tap and Die Corporation (Kennametal, Inc.)
13	United Drill and Tool Corporation
14	Detroit Harvester Company

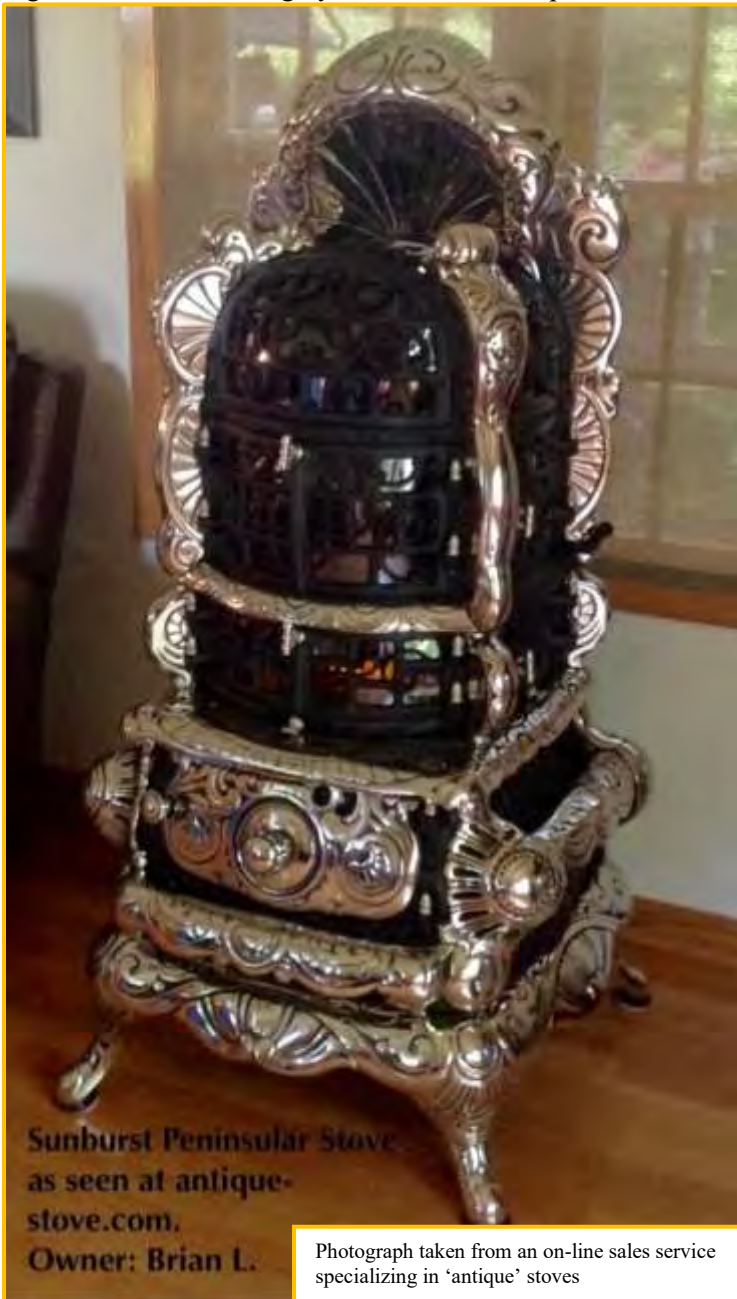
Figure 9 – Photo of a highly ornate and nickel plated Peninsular Stove

Most stoves were highly ornate (style was a major selling feature) with continually changing styles. Extensive nickel plating (and some aluminum) was used to increase ornamentation. See Figure 9 with an example of one of the highly ornate stove. Electroless plating uses tanks of pre-cleaning acid solutions, hypophosphorous acid, and rinses. Spent solutions would have been discharged to the river.

Sunburst Peninsular Stove
as seen at antique-
stove.com.
Owner: Brian L.

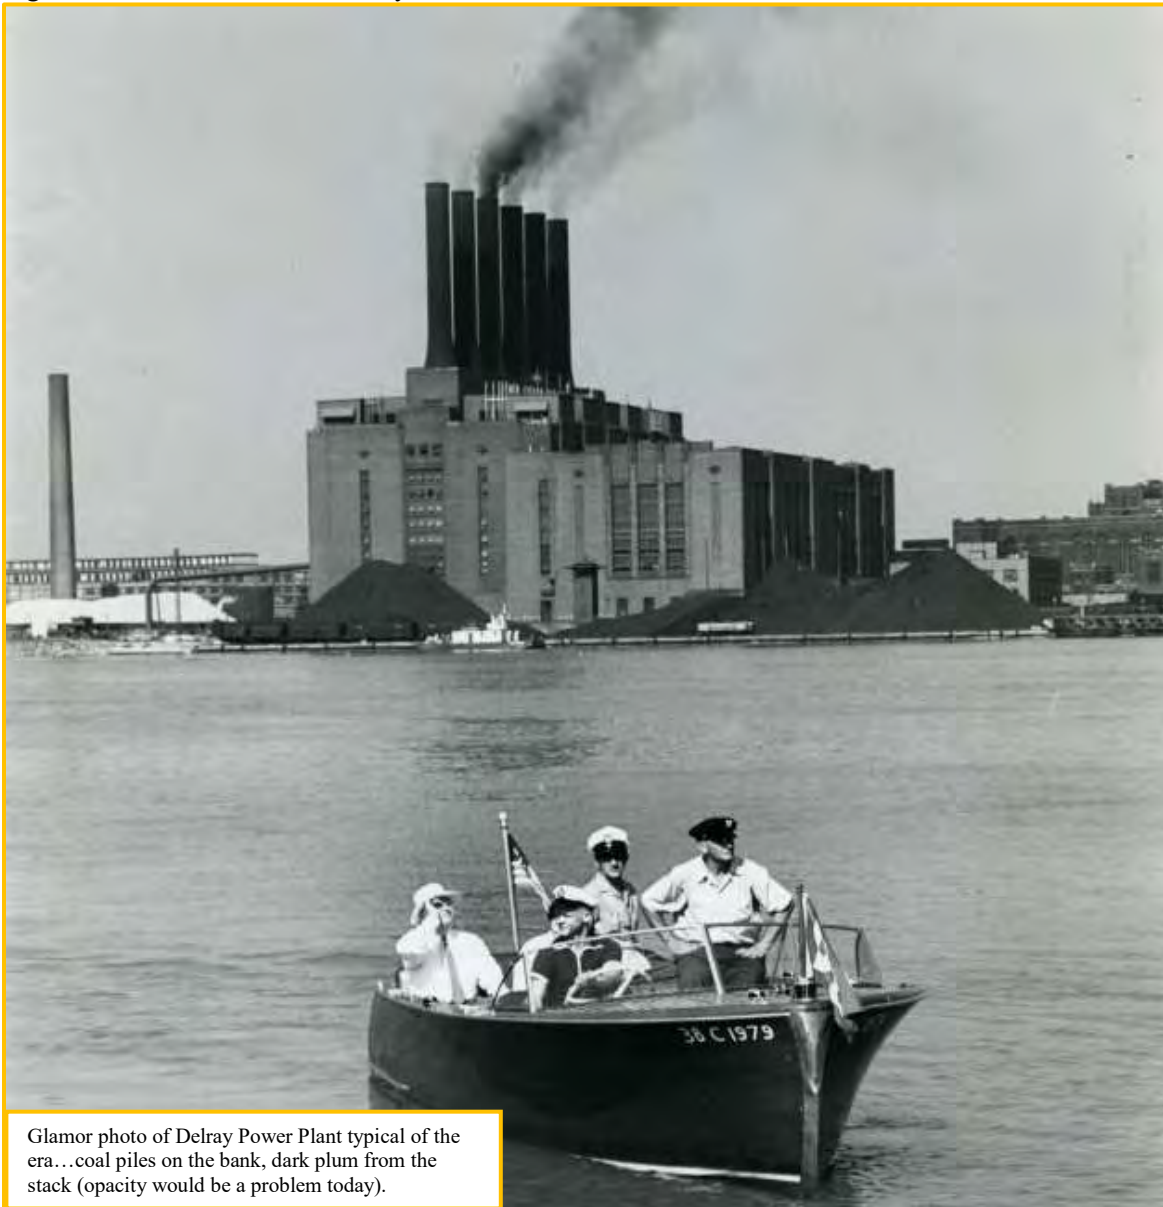
Figure 12 – Glamor shot of Delray Power Plant, circa 1953

Glamor photo of Delray Power Plant typical of the era...coal piles on the bank, dark plum from the stack (opacity would be a problem today).

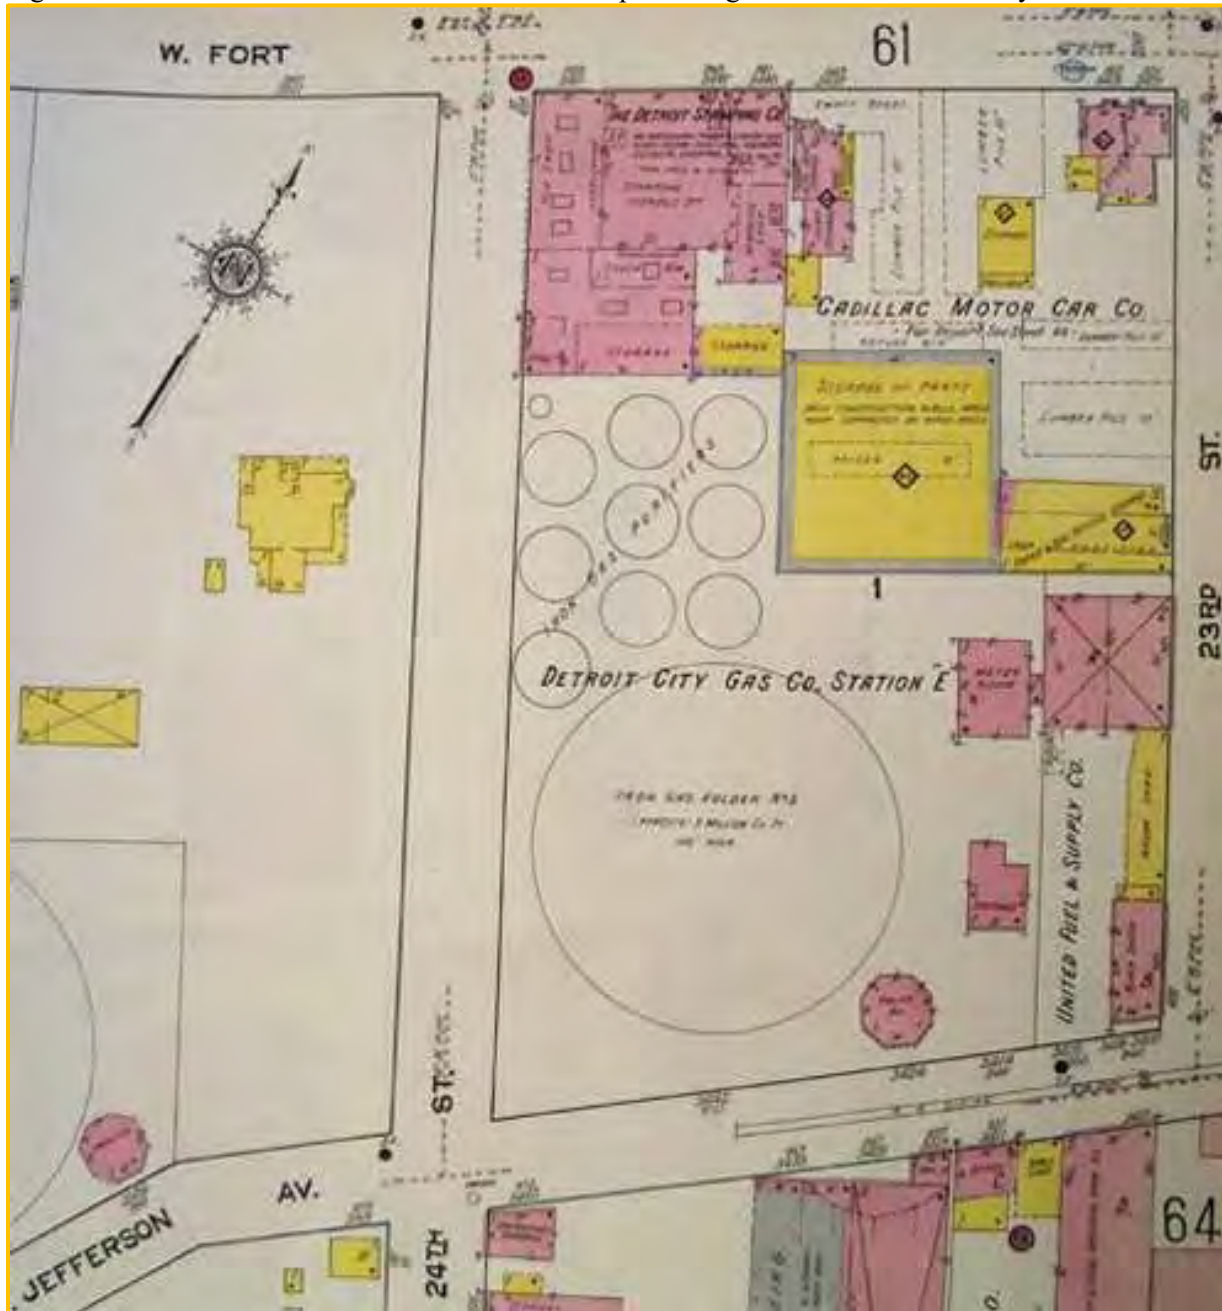
Figure 13 – A section of Sanborn Fire Insurance Map showing some of the Detroit City Gas Co. tanks

Between 1849 and 1889, coal gas usage flourished. The Detroit Gas Light Co. built a second manufacturing plant on West Jefferson Ave. at 21st Street down to 24th Street near the future site of the Ambassador Bridge and extended its gas main to side streets as demand for gas lighting increased. See Figure 13 for a segment of Sanborn Fire Insurance Map showing some of the Detroit Gas Light Co. storage tanks.

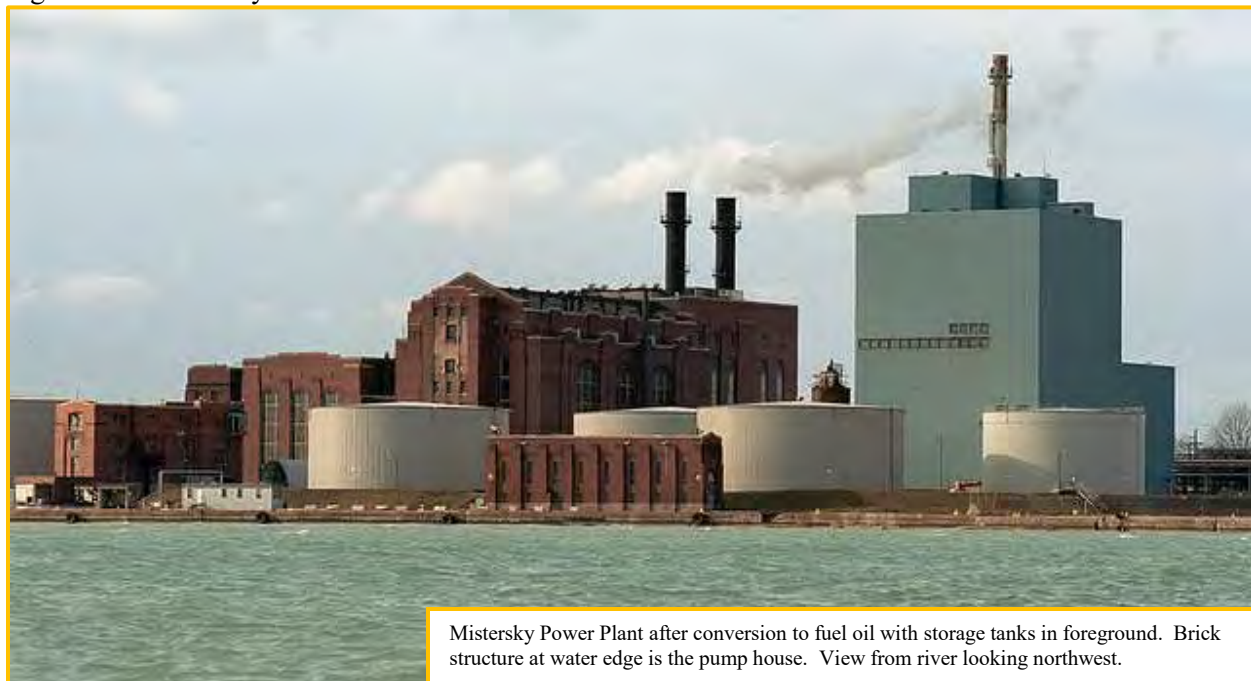
Figure 14 – Mistersky Power Plant

The Mistersky electrical power generating plant was completed and operational in 1927 at 5425 West Jefferson Avenue (at Junction Street) to the foot of the river for the Detroit Public Lighting Department. The power plant provided electricity for Detroit City public lighting, City buildings and a few other users and replaced a smaller power plant at Randolph Street and the foot of the river. The plant was expanded several times to add new boilers to keep up with the demand as Detroit grew. The power plant operated on coal until sometime after World War II when it was converted to no. 6 fuel oil (seven large tanks added to store fuel). A natural Gas fired turbine was the final addition. See Figure 14 for a view of the Mistersky Power Plant after conversion to fuel oil. The Mistersky Power Plant reached a peak generating capacity of 184,000 kilowatts in 1979. A long, slow decline of demand, lack of funding, maintenance, and repair ended in 2010 with shut-down of the powerhouse. DTE assumed electrical supply and lighting infrastructure restoration and maintenance.

Detroit and DTE still occupy the Mistersky Power Plant site. DTE has established a ‘tie-line’ (or interchange) that connects the DTE electrical distribution system to the former Detroit Public Lighting Department supply grind at the powerhouse. In addition, the site is used for equipment storage to support DTE maintenance work and new construction activities (site activities are managed by sub-contractors to DTE). Some (not all) of the former oil storage tanks are now owned and operated by Waterfront Petroleum Terminal Company (office at 5431 West Jefferson Ave.), and the remaining tanks are no longer used.

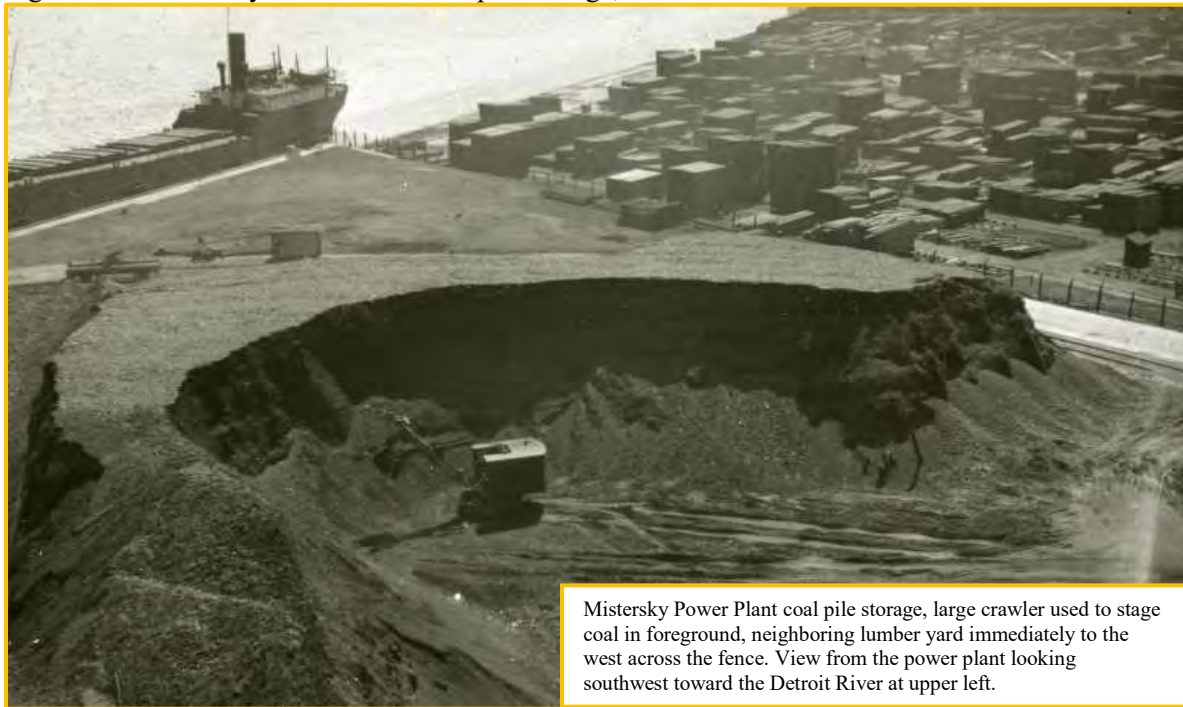
Figure 16 – Mistersky Power Plant coal pile storage, circa 1928

Mistersky Power Plant coal pile storage, large crawler used to stage coal in foreground, neighboring lumber yard immediately to the west across the fence. View from the power plant looking southwest toward the Detroit River at upper left.

open shoveling and scooping of coal would have created large plums of heavy particulate laden dust that would have quickly dropped out on land and water. See Figures 15, 16 and 17 for early photos of coal handling at Mistersky Power Plant. Further, it is unclear what provisions were made for handling, storage, and disposal of the large volumes of fly ash that the powerhouse would have generated. Trace amounts of mercury, zinc, copper, boron, lead, arsenic, cadmium, chromium, and selenium are found in virtually all coal and fly ash.

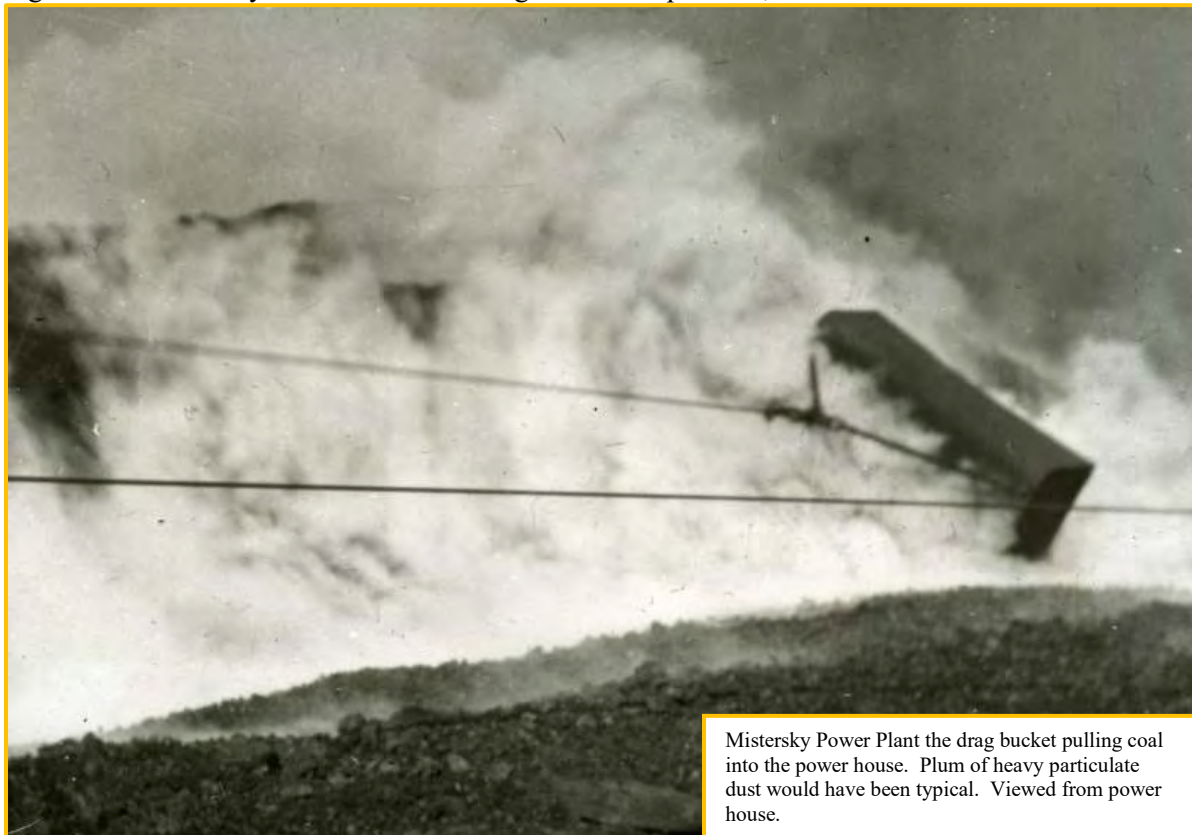
Figure 17 – Mistersky Power Plant coal drag bucket in operation, circa 1928

Mistersky Power Plant the drag bucket pulling coal into the power house. Plum of heavy particulate dust would have been typical. Viewed from power house.

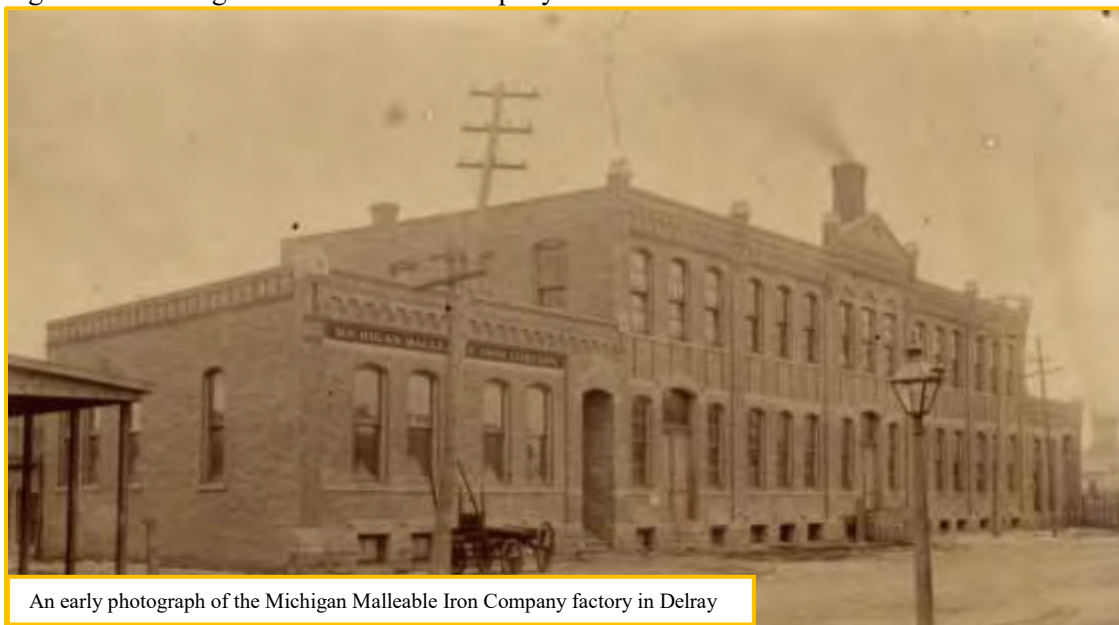
Figure 25 - Michigan Malleable Iron Company

An early photograph of the Michigan Malleable Iron Company factory in Delray

Michigan Malleable Iron Company established a grey iron foundry in the then City of Delray between Crossley and Anderson Streets in the late 1800s. The foundry was a job shop providing iron castings to a variety of customers. The foundry was large and successful employing hundreds of men (primarily Hungarian immigrants) for many years. It appears the company operated several foundries around Michigan. See Figure 25 for an early photo of the Michigan Malleable Iron Company street-side façade (the factory extended out the back).

The foundry and machining operations would have resulted in significant quantities of waste water (primarily cooling water) containing heavy metals discharged directly into the Detroit River. The enterprise closed around 1960. No successor entities have been identified.

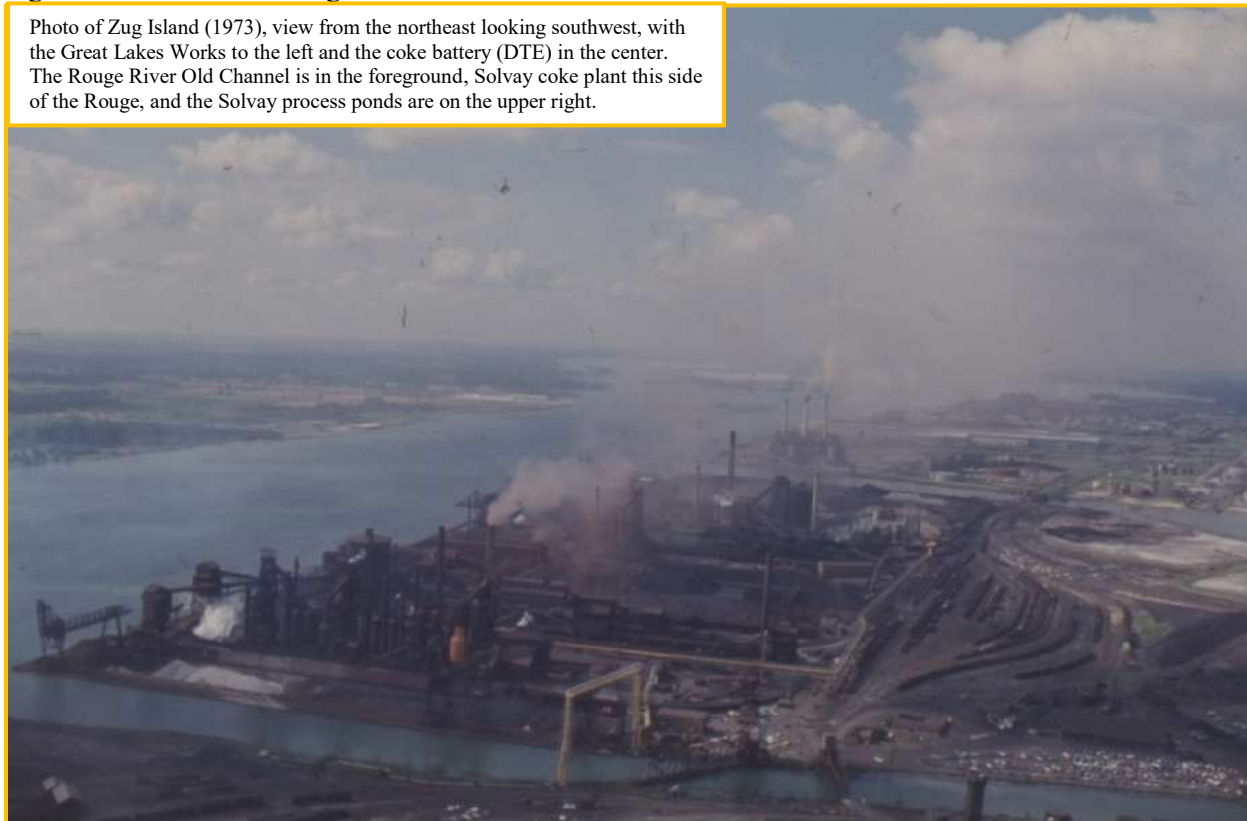
Figure 26 – US Steel on Zug Island

Photo of Zug Island (1973), view from the northeast looking southwest, with the Great Lakes Works to the left and the coke battery (DTE) in the center. The Rouge River Old Channel is in the foreground, Solvay coke plant this side of the Rouge, and the Solvay process ponds are on the upper right.

Detroit Iron & Steel Company began Great Lakes Works operation on Zug Island in 1902. Since start-up, operations have changed hands several times and are now owned and operated by US Steel. Steel manufacturing consumes large quantities iron ore, scrap steel, limestone, coal, and coke that are delivered to the facility by freighters at wharfs on the Old Channel and Detroit River. See Figure 26 for an aerial photo of Zug Island from 1973.
