**PRL 96-21  
Emergency Repairs for Red Hill Tanks**

EMERGENCY REPAIRS FOR RED HILL TANKS

**Dames & Moore**  
Emergency Repairs For Red Hill Tanks at the Fleet Industrial & Supply Center  
Contract No. N62742-96-C-1356

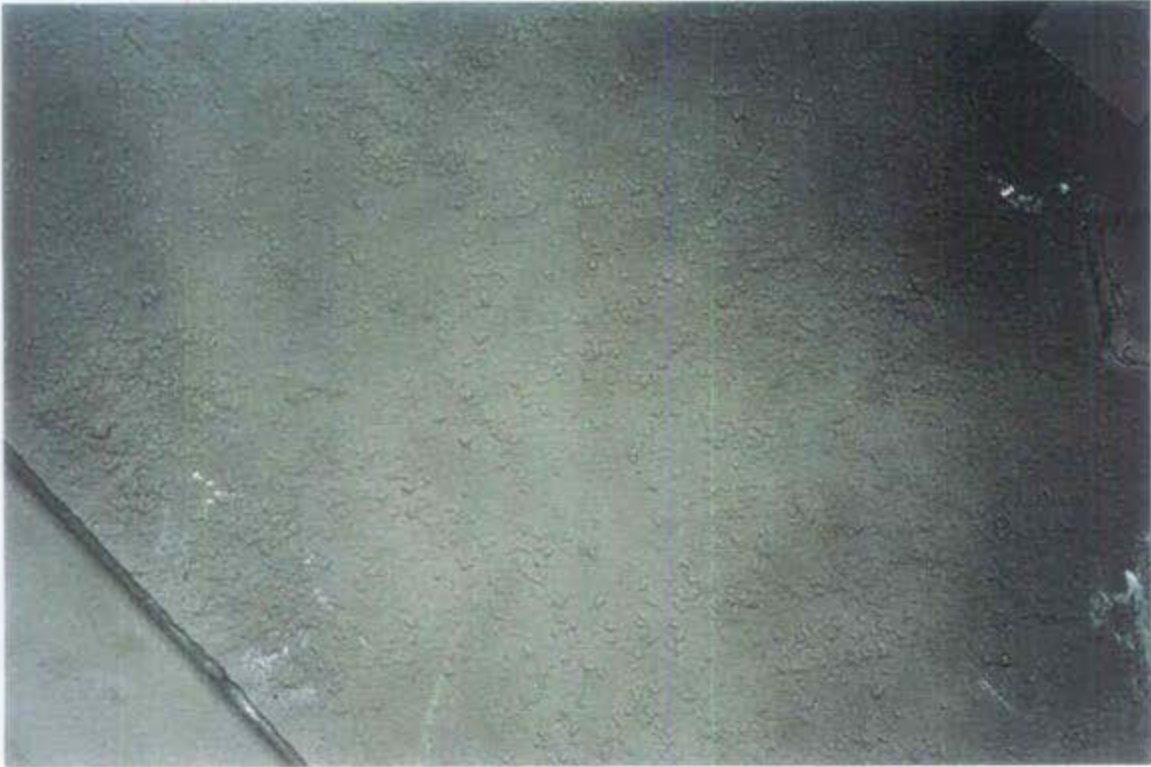
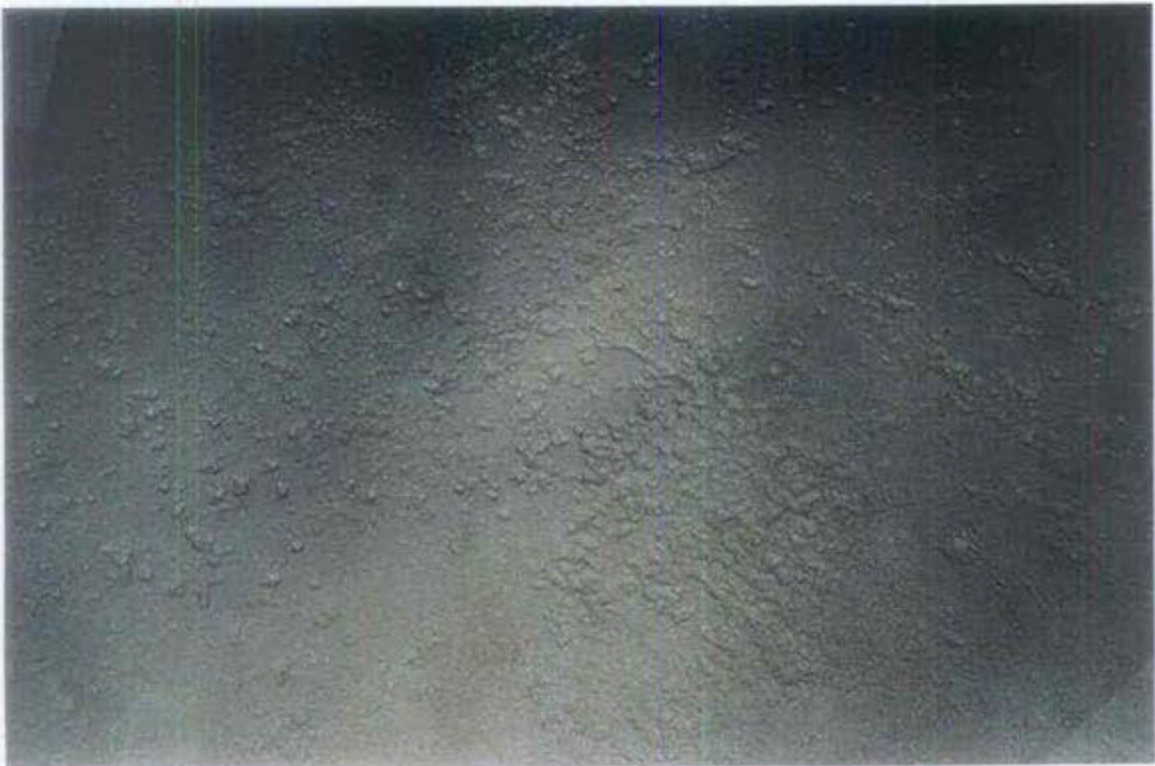
**PICTURES OF PITTING AT BOTTOM OF TANK**
