Project Title: CLEAN, INSPECT, AND REPAIR STORAGE TANKS 5 & 17
Location: PEARL NAVAL BASE – REDHILL COMPLEX, Pearl Harbor, HI
Task Order No.: N62583-09-D-0132/0003
WGS Project Number: 54118
Date: 18 Nov, 2010

**TANK 5 & 17 CLEANING, INSPECTION
AND REPAIRS PROJECT**

TANK 5 INSPECTION REPORT

**FINAL DRAFT TANK INSPECTION
& INTEGRITY REPORT**

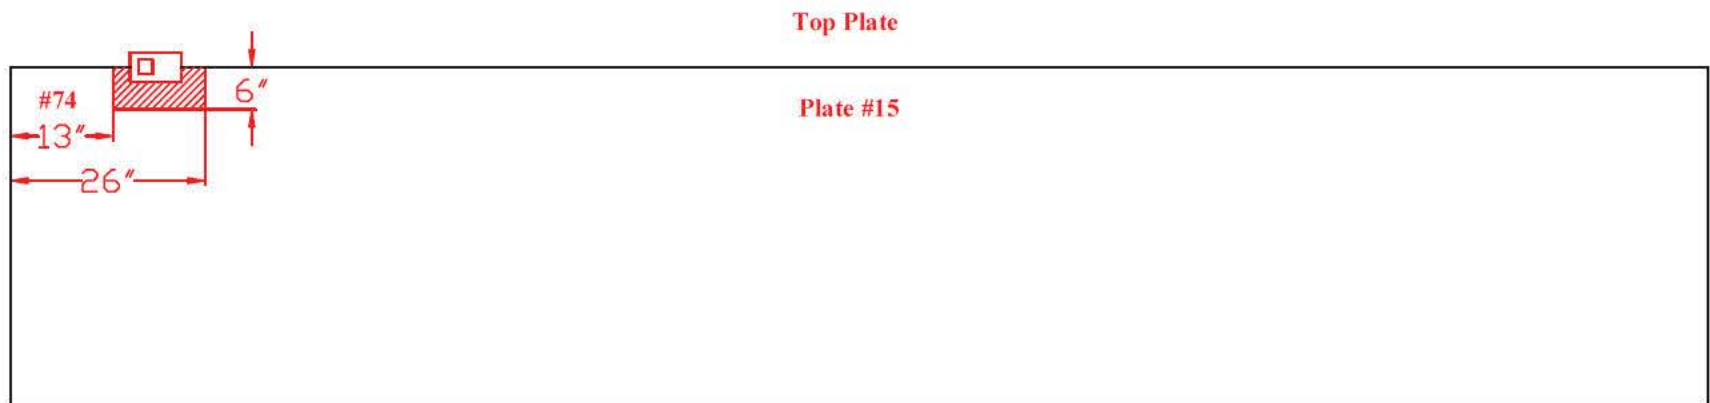
Row: 27
 Plate #: 15

- #74 - WL(APP) - 0.186"

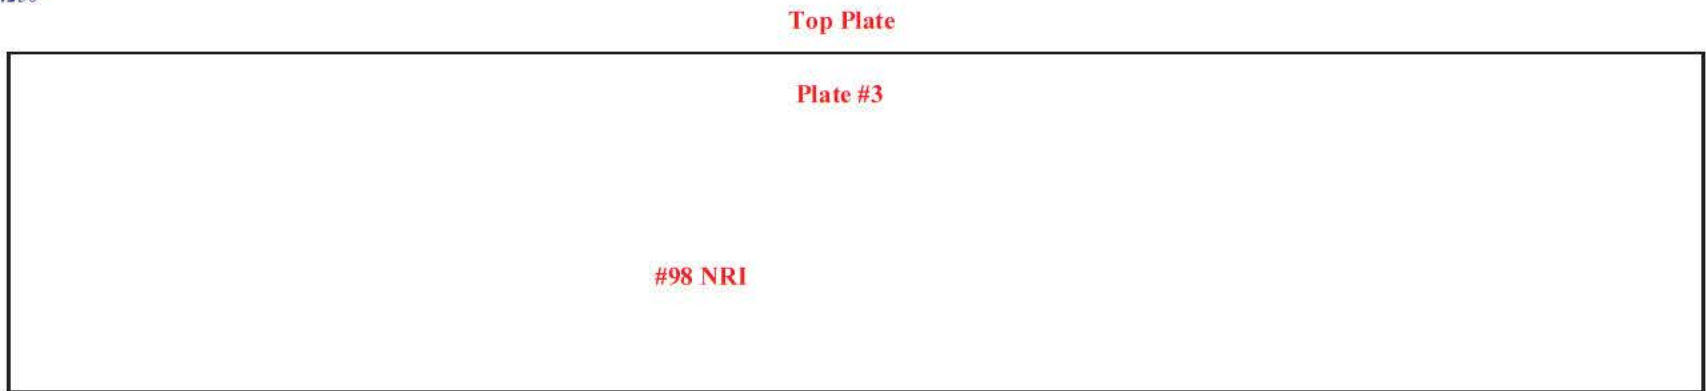
Row: 12
Plate #: 3

Flaw # - Type - Remaining:
#98 - NRI

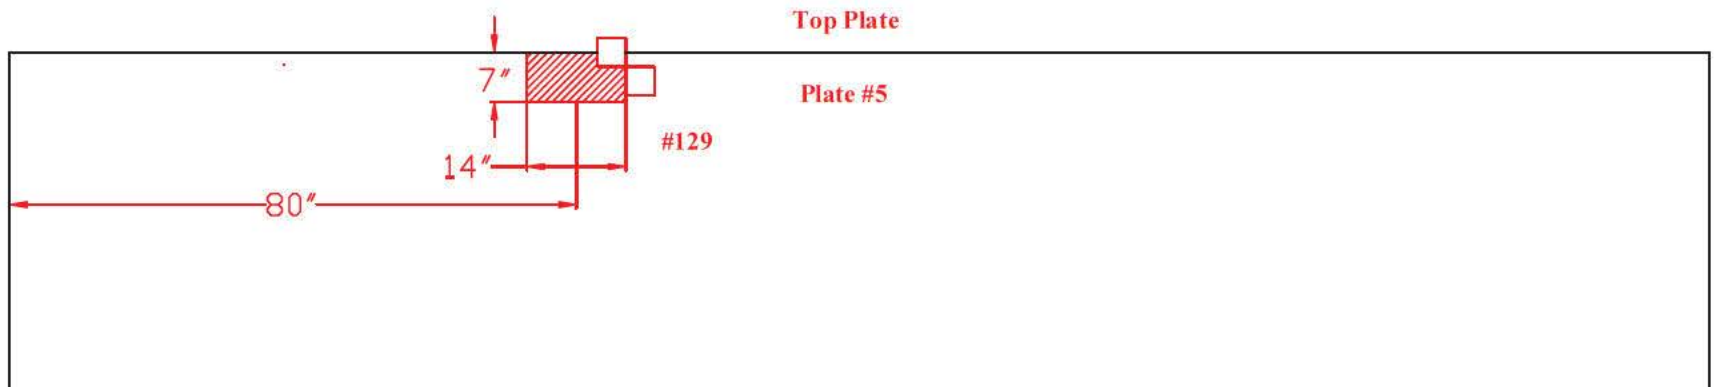
Row: 4
 Plate #: 5

Flaw # - Type - Remaining:
 #129 - WL(APP) - 0.230"

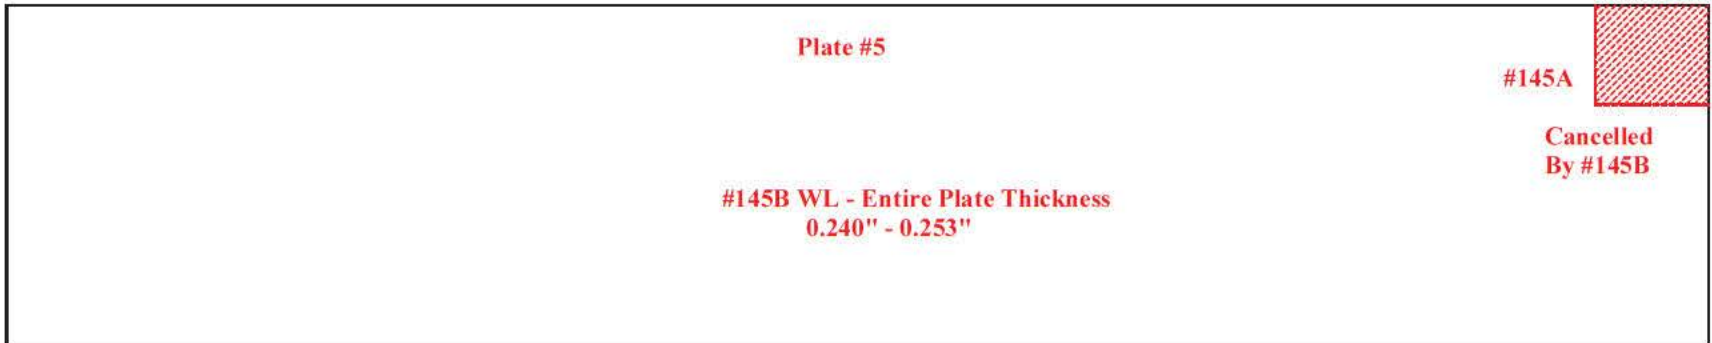
#145A - Not Valid
Due To #145B
#145B - WL - Entire Plate
(0.240"-0.253")

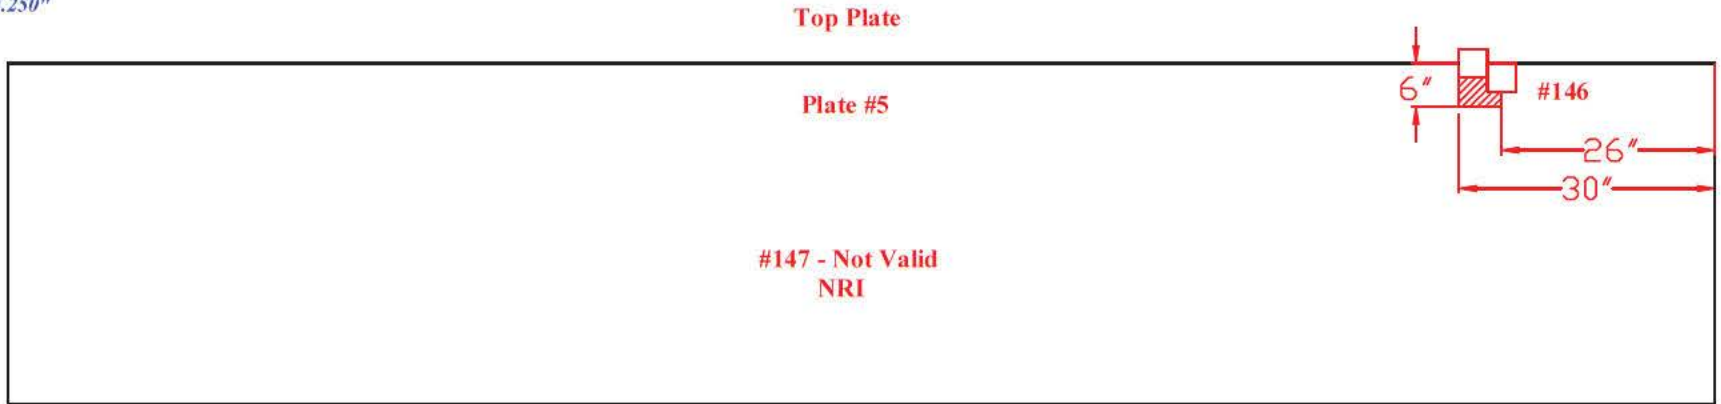
#146 - WL(APP) - 0.240"

#147 - Not Valid NRI

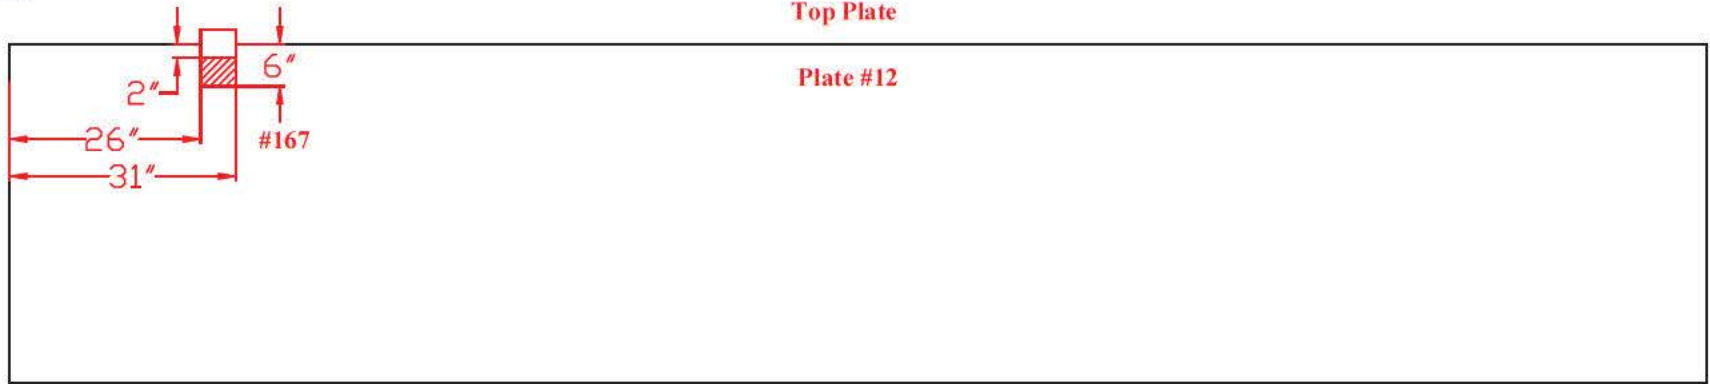
Row: 8
Plate #: 12

#167 -WL(APP) - 0.153"

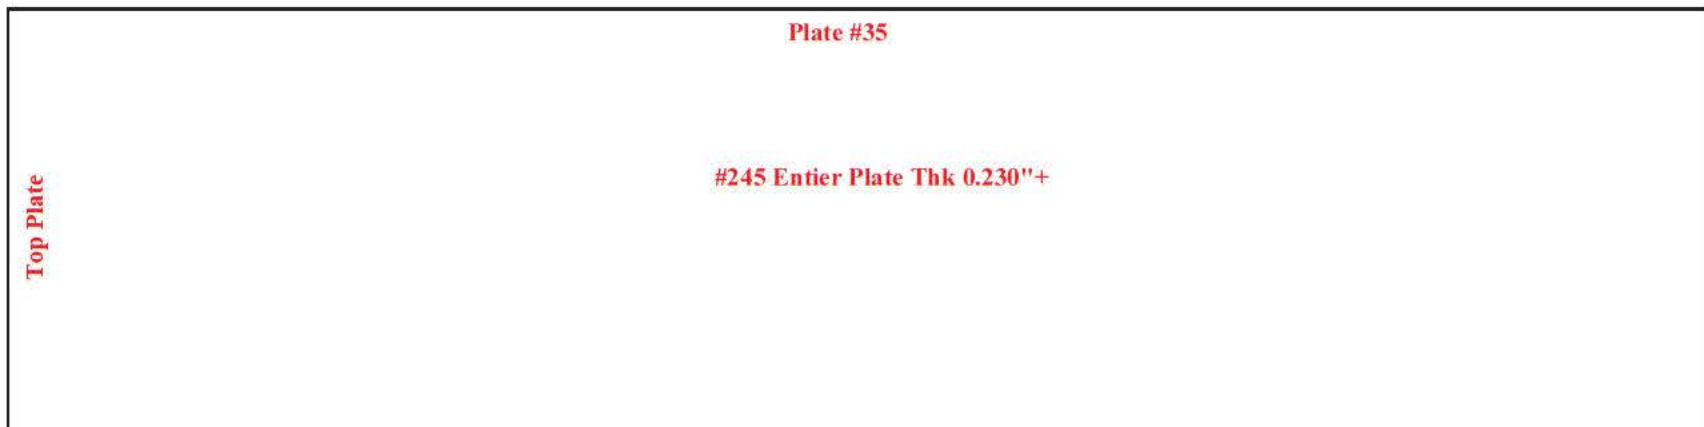
Course: 3
Plate #: 35

#245 - WL - 0.230"+
(Entire Plate)

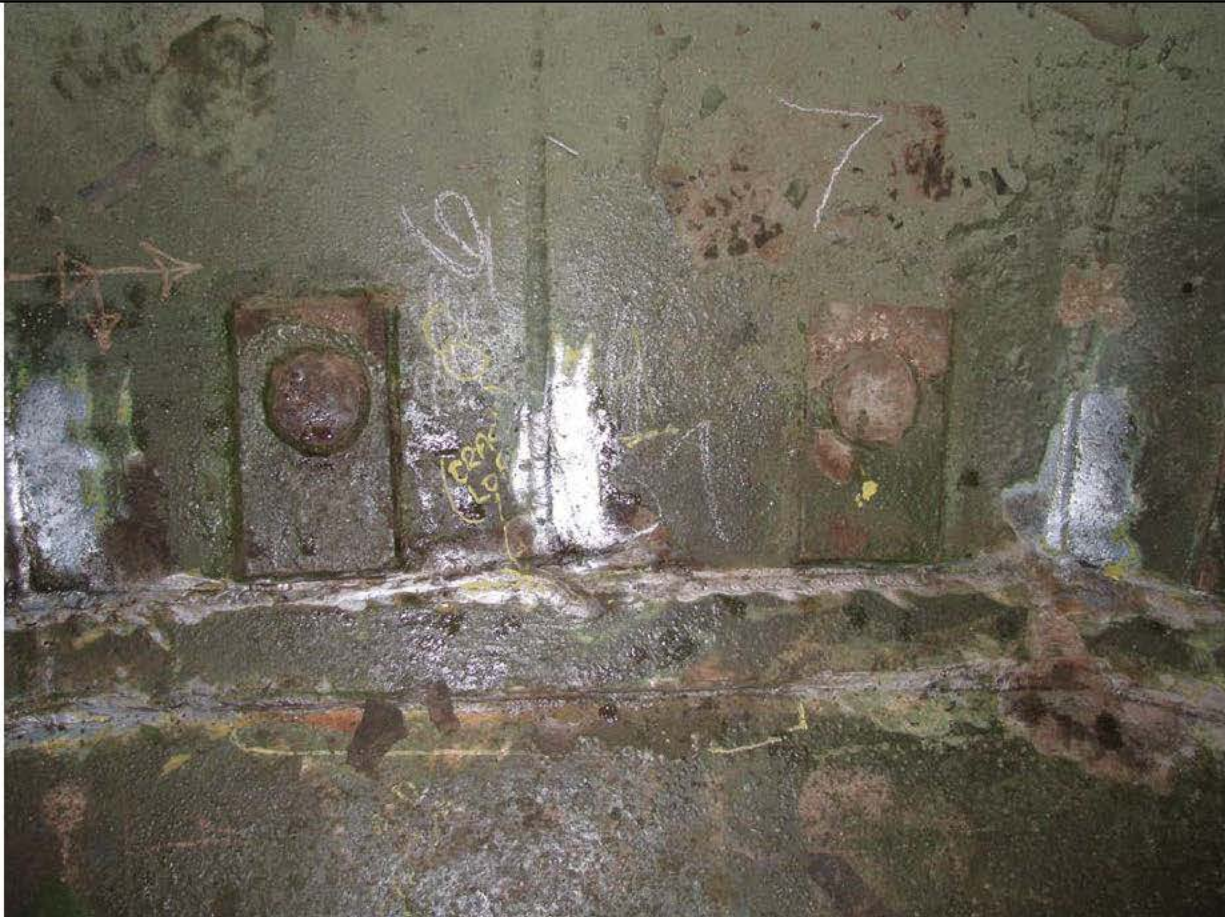
Comments: Indication Noted in 6-7 area was at the edge of a grinding mark and was a straight linear indication that was a welding defect that was opened to the surface after the grinding was performed.

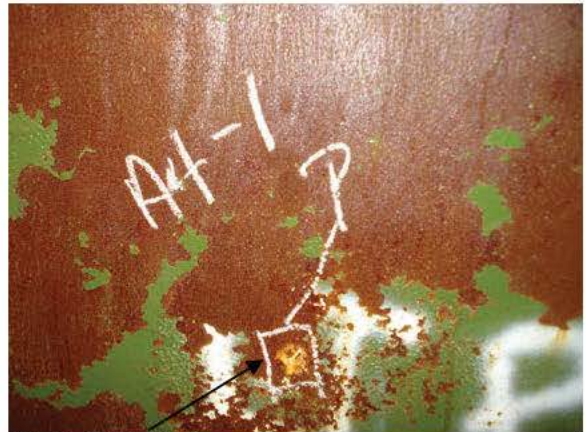
A-P4-1 PITS

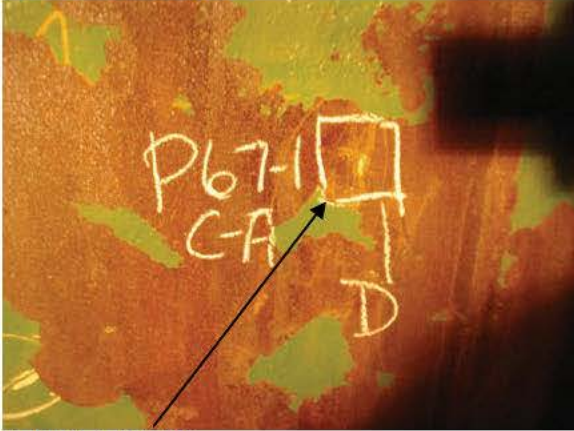
UPPER DOME

A-P64-2 GOUGE REPAIR

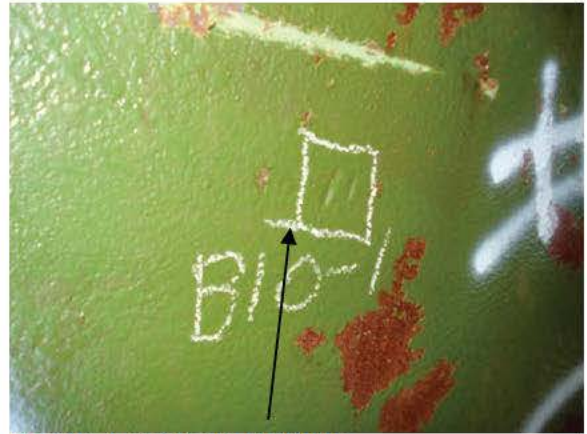
A-P72-1 GOUGE REPAIR

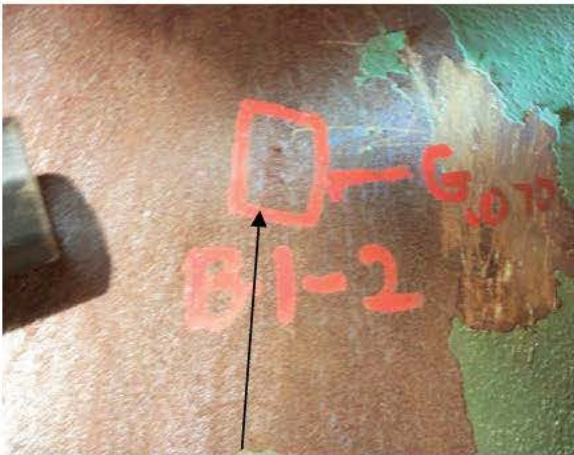
B-P10-1 GOUGE REPAIR

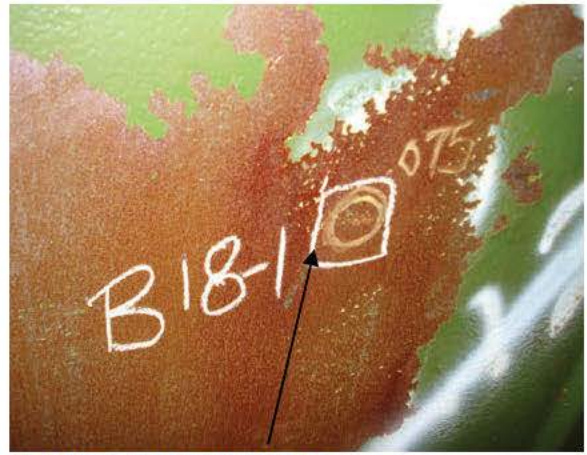
B-P1-1 GOUGE REPAIR

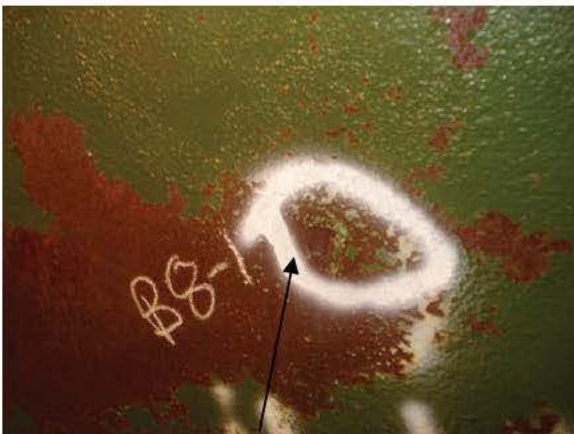
B-P18-1 DENT REPAIR

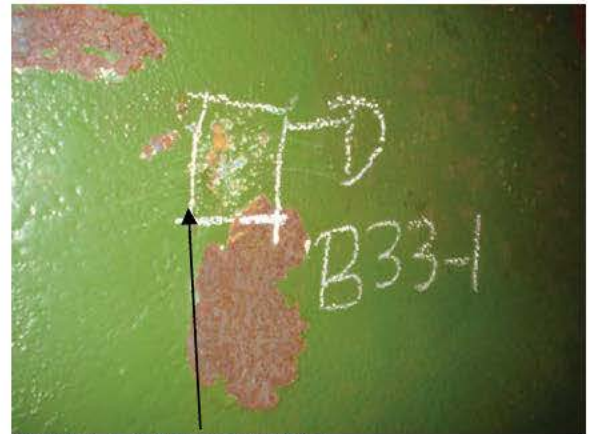
B-P27-1 PIT REPAIR

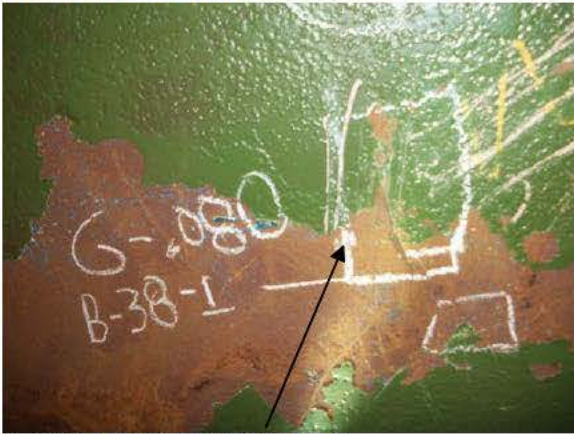
UPPER DOME

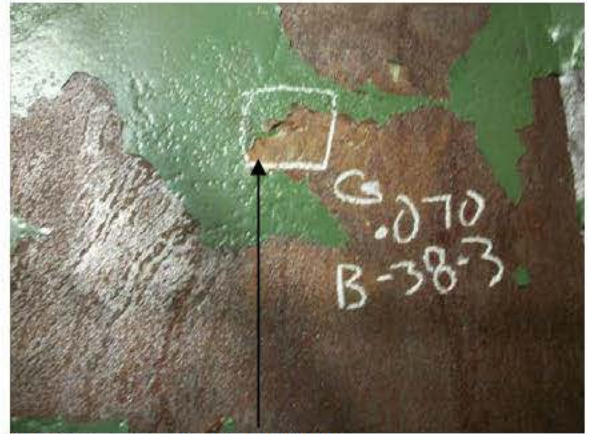
B-P38-1 GOUGE REPAIR

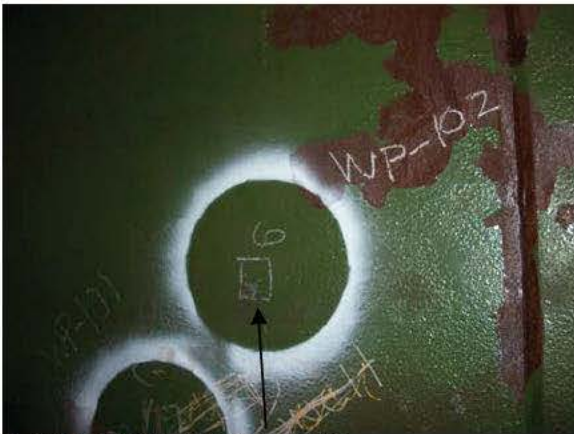
B-P38-4 GOUGE REPAIR

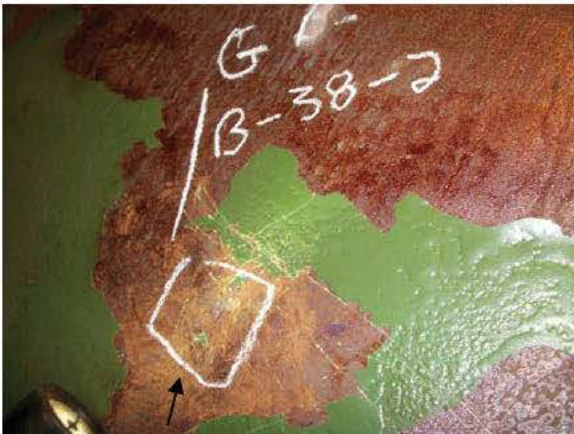
B-P40-1 WELD BUILD UP

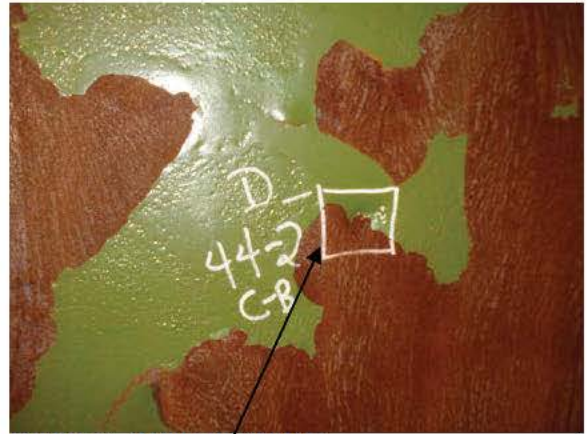
B-P43-1 WELD REPAIR- LACK OF FUSION
SLAG INCLUSION

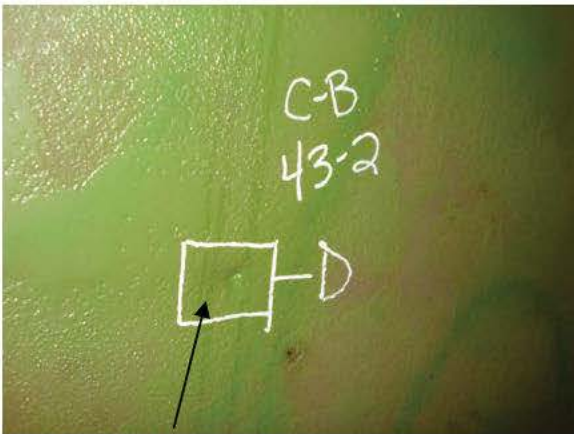
B-P44-2 DENT REPAIR

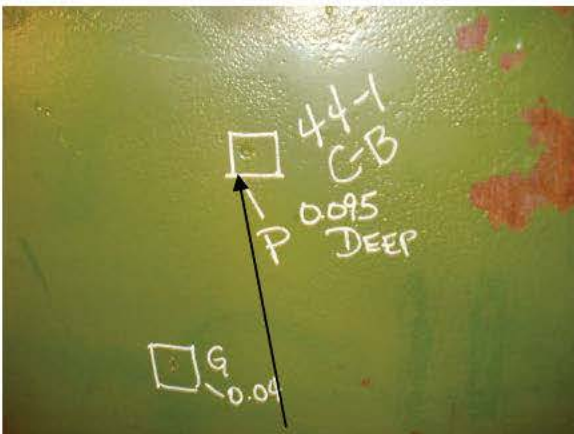
B-P45-1 WELD REPAIR- SLAG INCLUSION

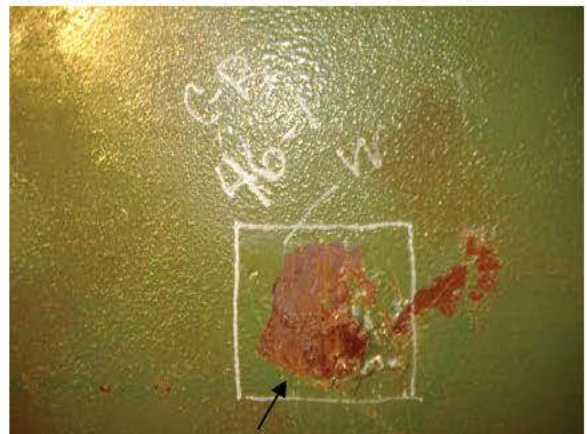
B-P44-1 GOUGE REPAIR

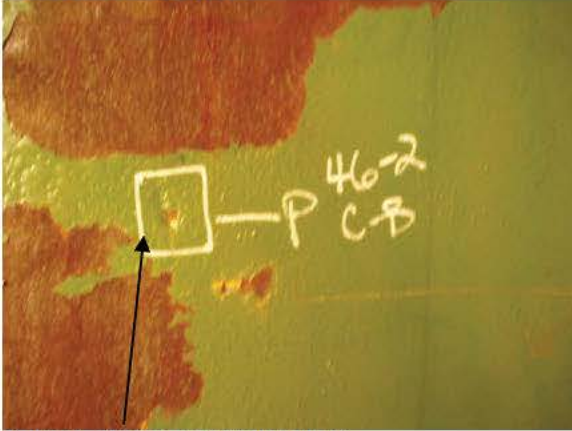
B-P46-1 GOUGE

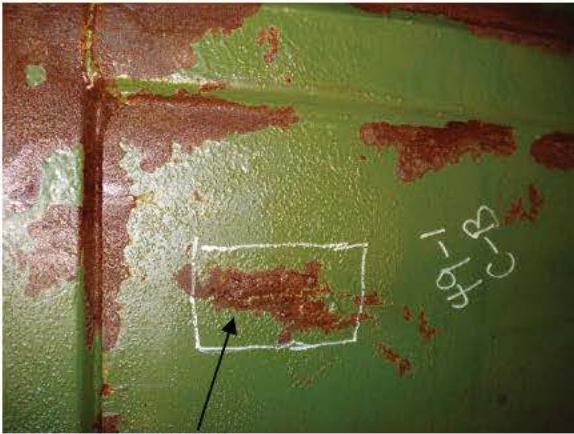
B-P48-1 WELD REPAIR- LACK OF FUSION

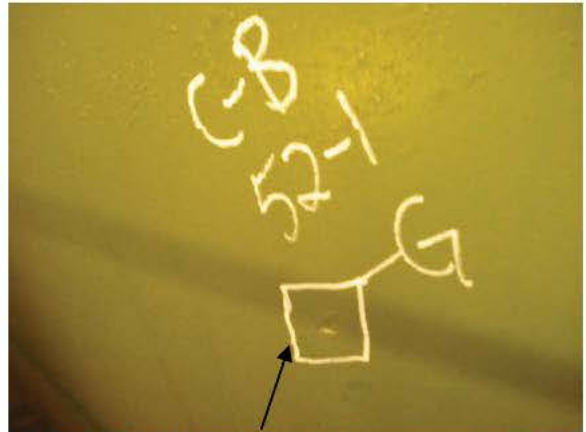
B-P49-2 WELD BUILD UP

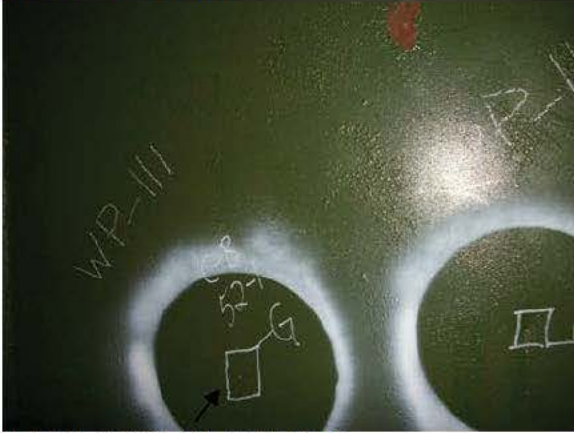
B-52-2 GOUGE REPAIR

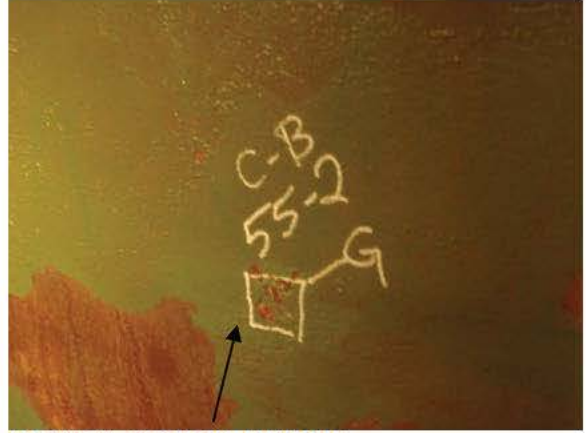
B-P52-3 GOUGE REPAIR

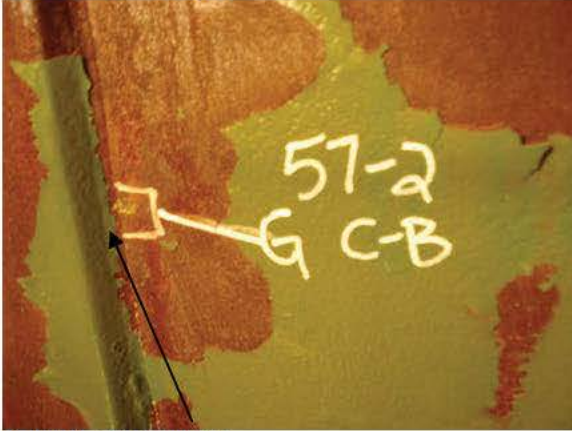
B-P57-1 WELD REPAIR- UNDERCUT

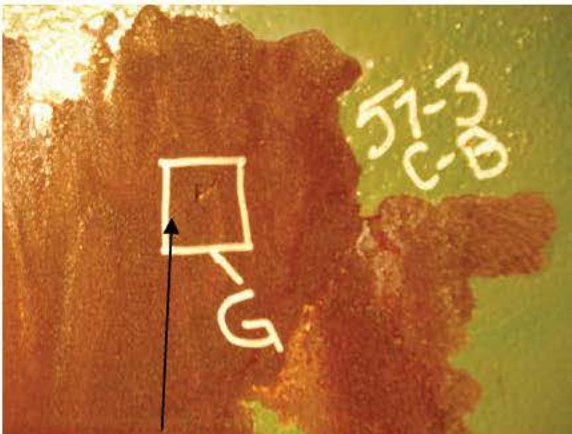
B-P58-2 WELD BUILD UP

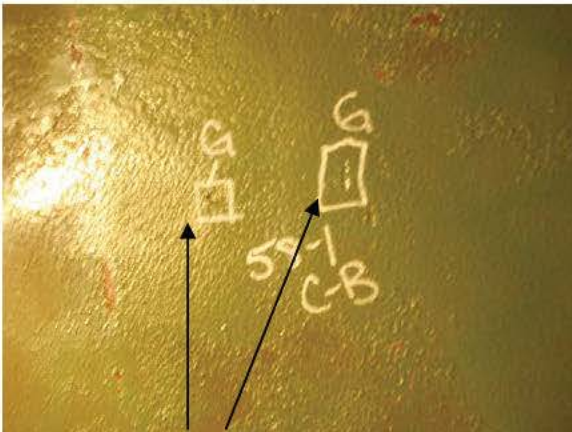
B-P59-1 GOUGE REPAIR

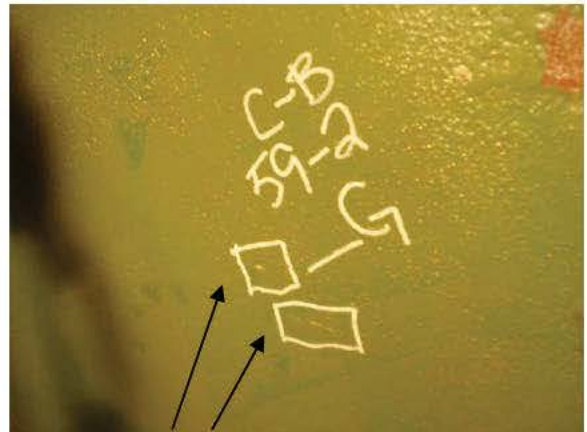
B-P58-1 GOUGES

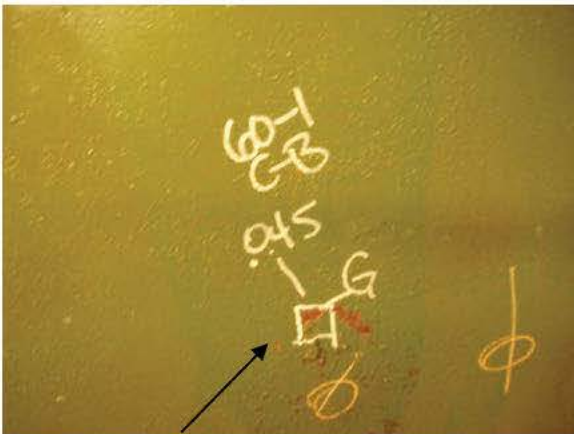
B-P62-1 GOUGE REPAIRS

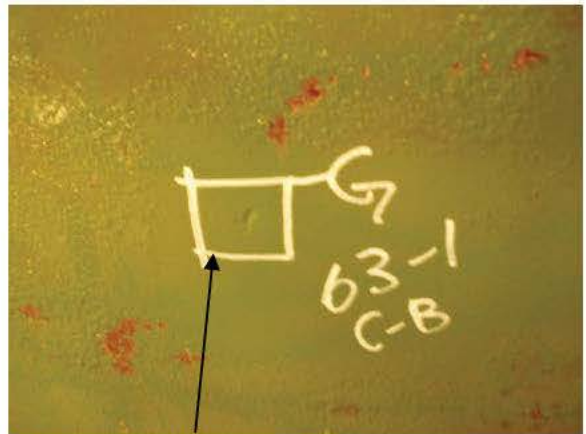
B-P60-1 GOUGE

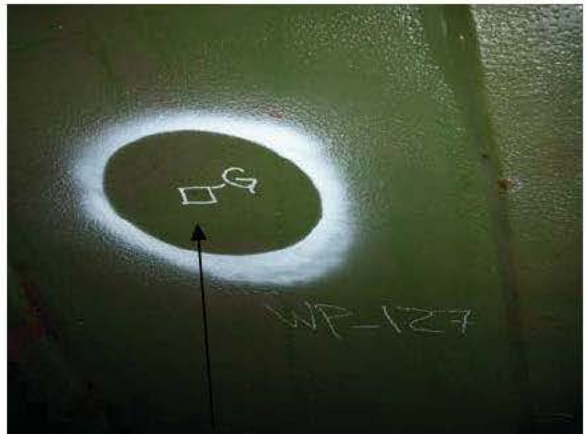
B-P61-1 GOUGE REPAIRS

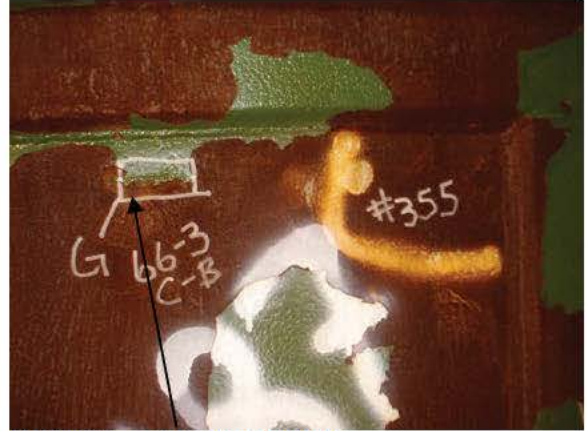
B-P65-1 GOUGE REPAIRS

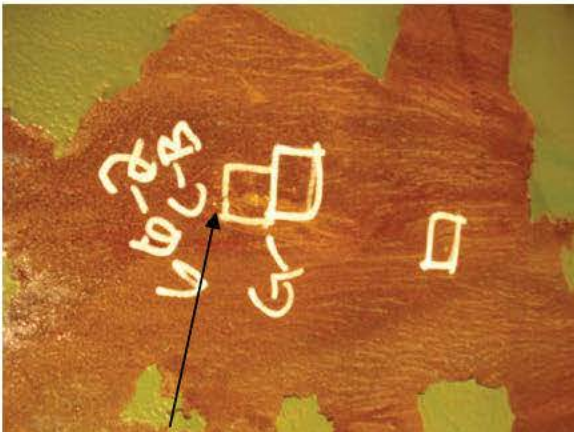
B-P67-1 GOUGE REPAIRS

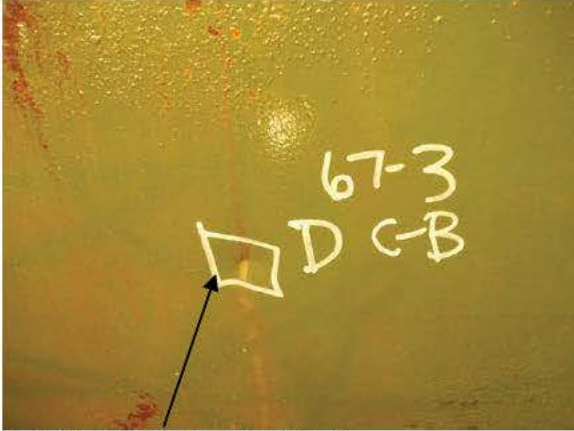
UPPER DOME

B-P67-2 GOUGE REPAIR

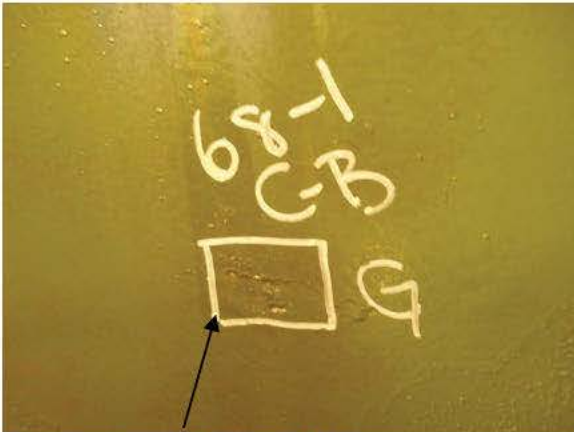
B-P70-2 GOUGE REPAIRS

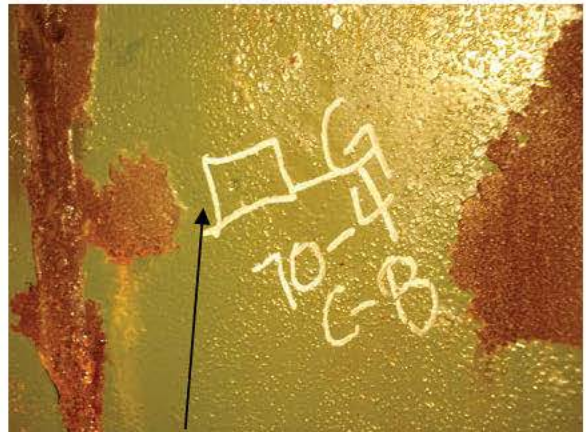
B-P70-1 WELD BUILD UP

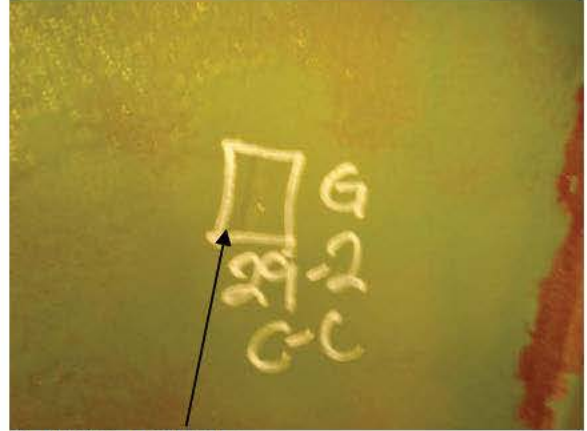
C-P27-1 DENT REPAIR, GOUGE

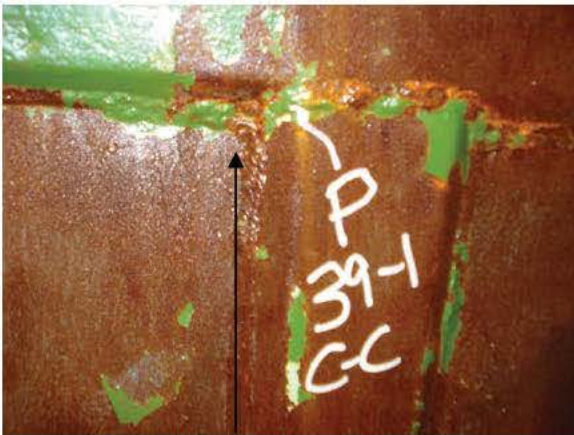
C-P39-1 WELD- POROSITY

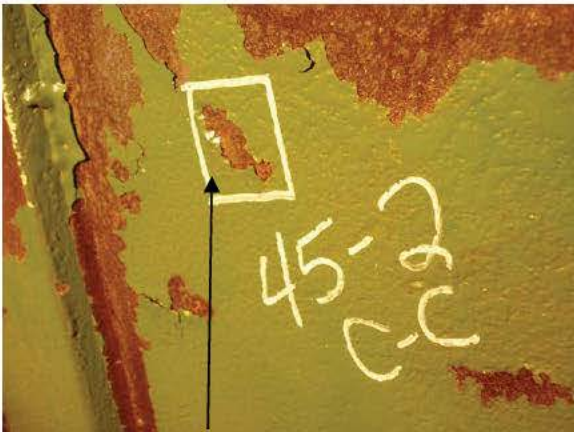
C-P45-2 GOUGE

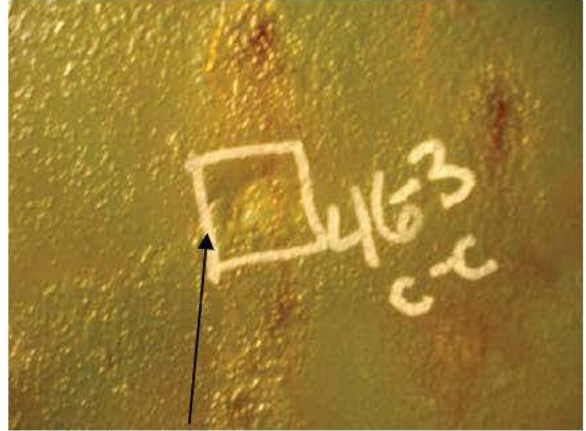
C-P46-3 GOUGE

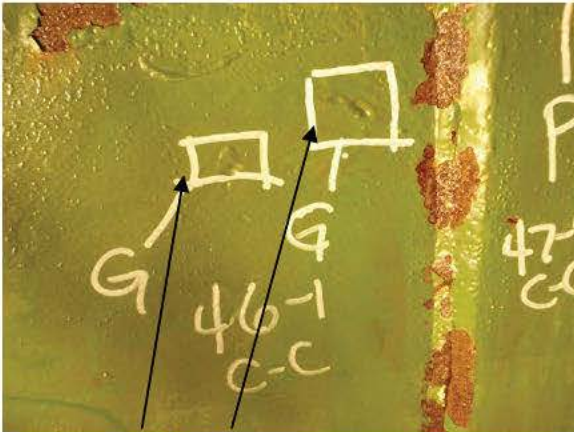
C-P46-1 GOUGES

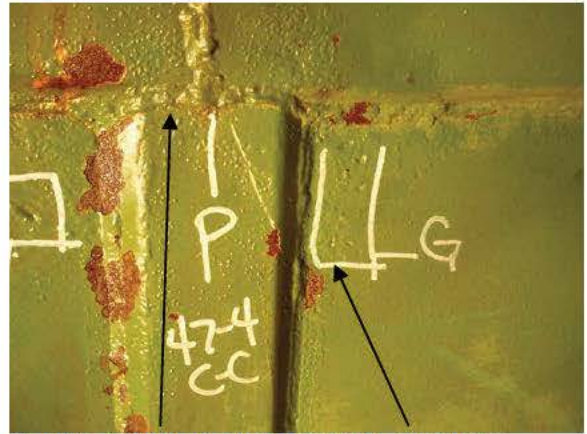
C-P47-4 WELD- POROSITY, GOUGE

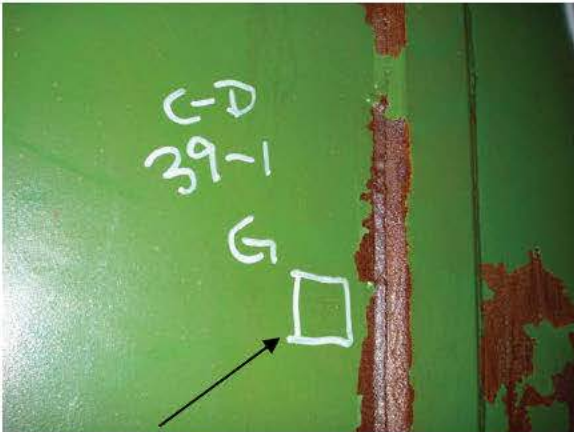
D-P39-1 GOUGE

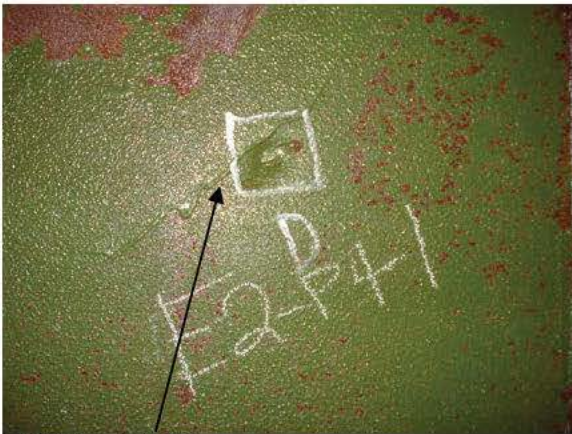
E2-P4-1 DENT

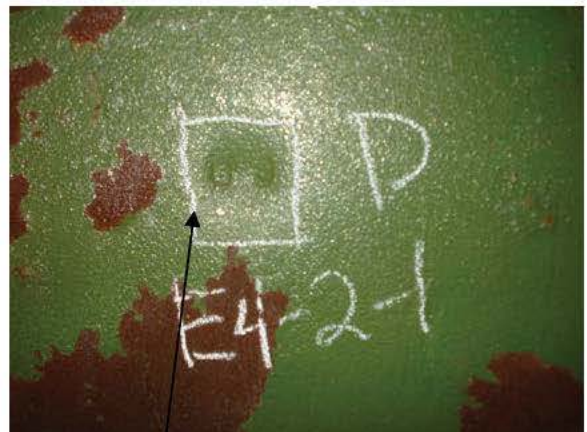
E4-P2-1 DENT

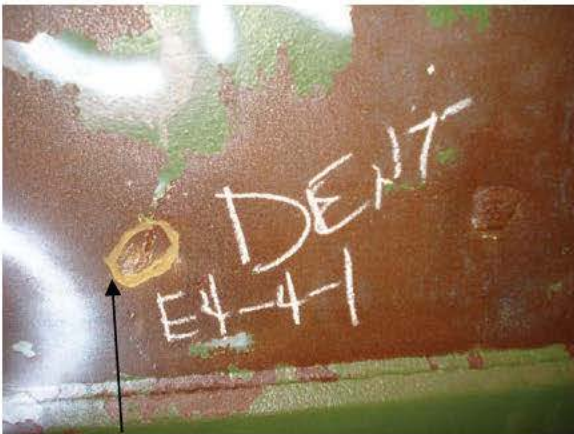
E4-P4-1 DENT

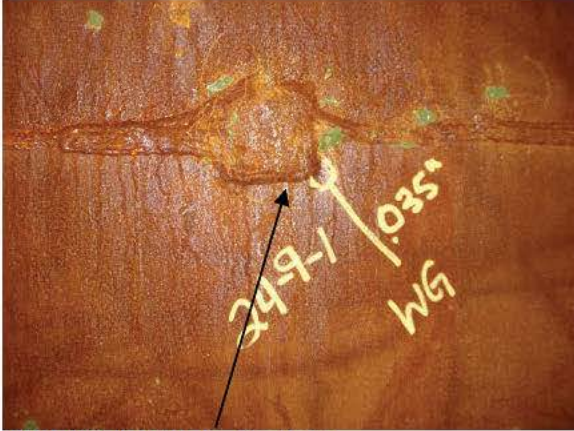
R24-P9-1 WELD GOUGE

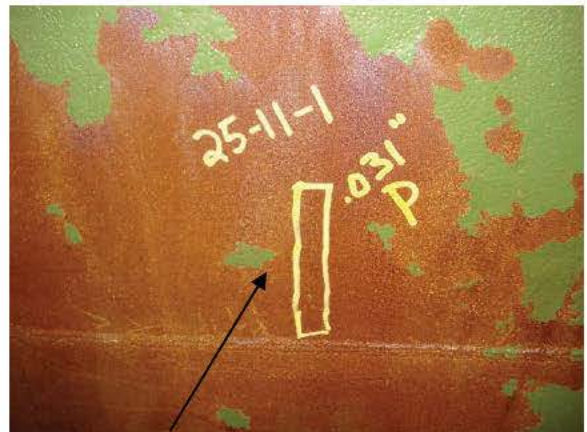
R24-14-3 PIT

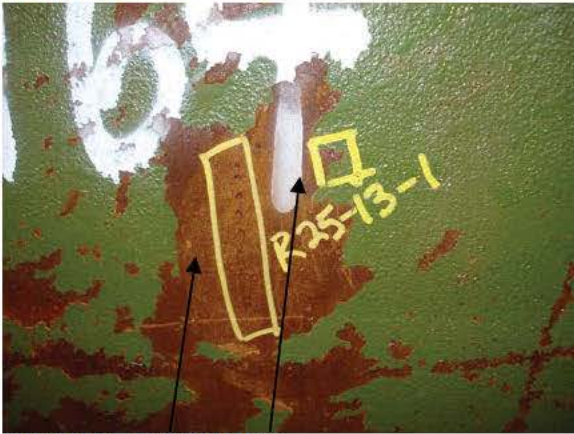
R25-P11-1 PIT

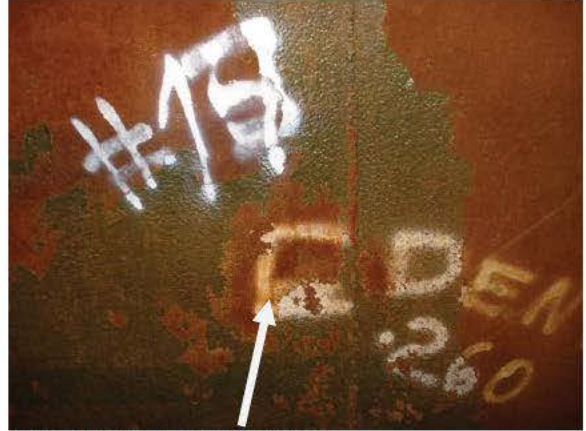
C2-P15-3 DENT REPAIR

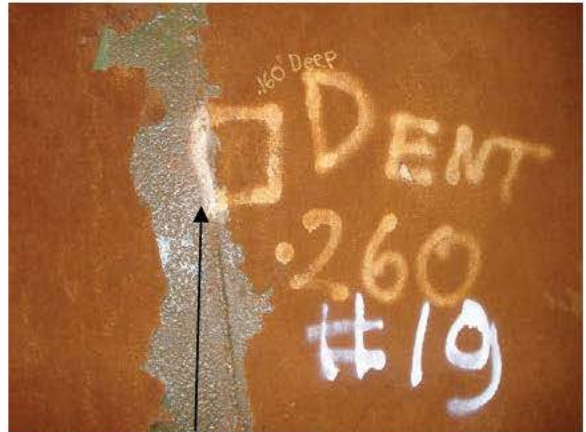
C2-P16-3 DENT REPAIR
