NOVEMBER 30, 2023

MUNICIPALITY OF TOA ALTA OCTOBER 2023 MONTHLY REPORT  
Civ. No. 3:21-01087-DRD

NIVIA I. AYALA, PE  
TERRATEK ENGINEERING GROUP, PSC  
P.O. Box 367445 San Juan, PR 00936

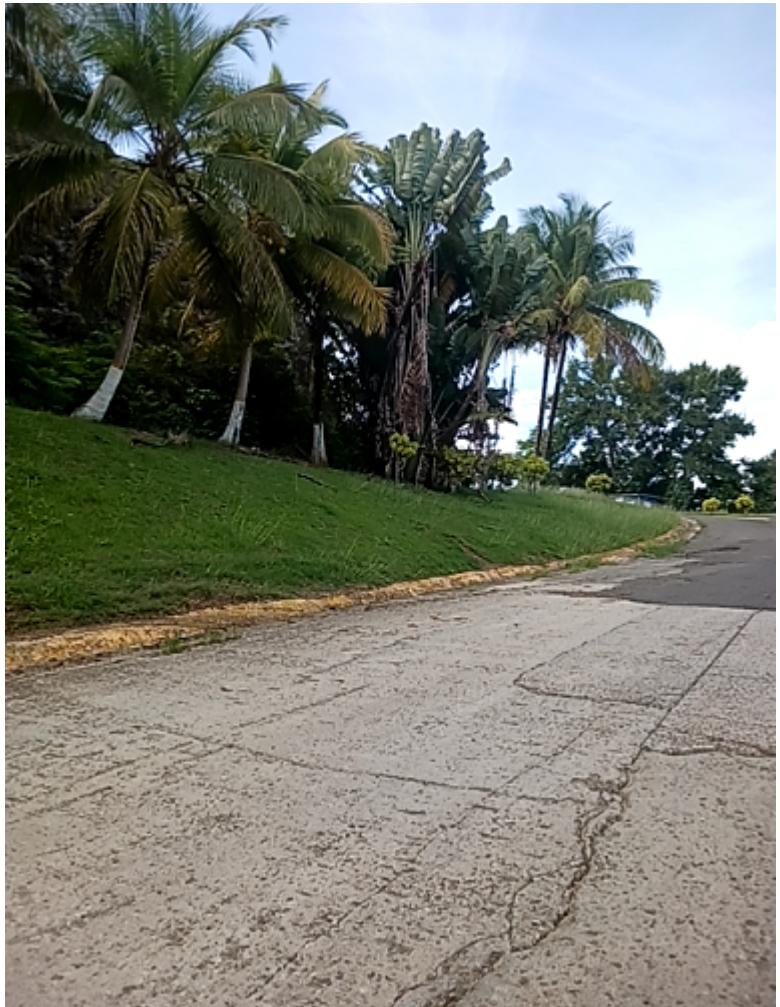
**Incluir Foto**

**Estan los diques limpios y sus  
valvulas cerradas con candado?**

SI

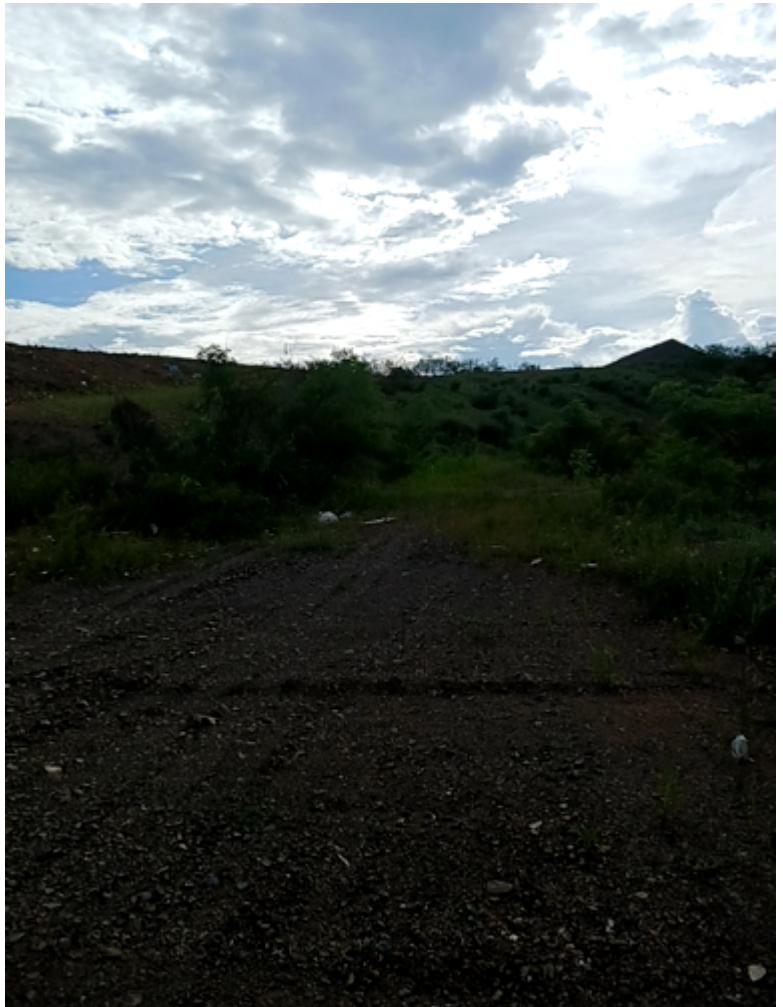
**Incluir foto**

**Condicion Operacion Recibo de Escombros**

Necesita Limpieza

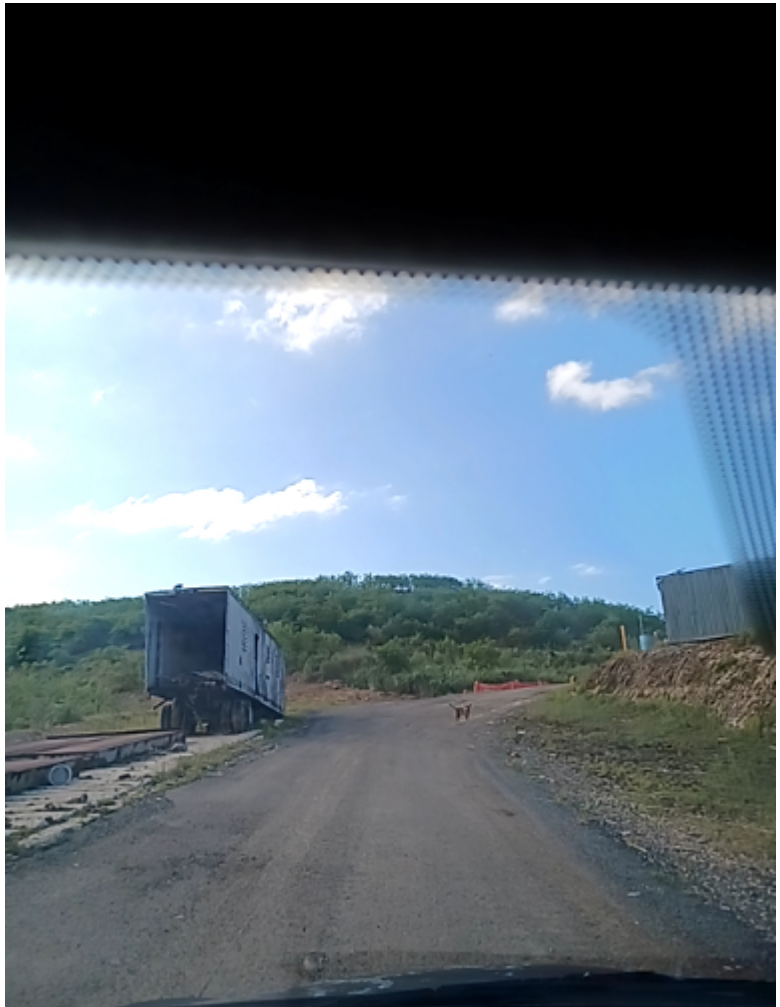
**Incluir Foto**

**Estan los diques limpios y sus  
valvulas cerradas con candado?**

SI

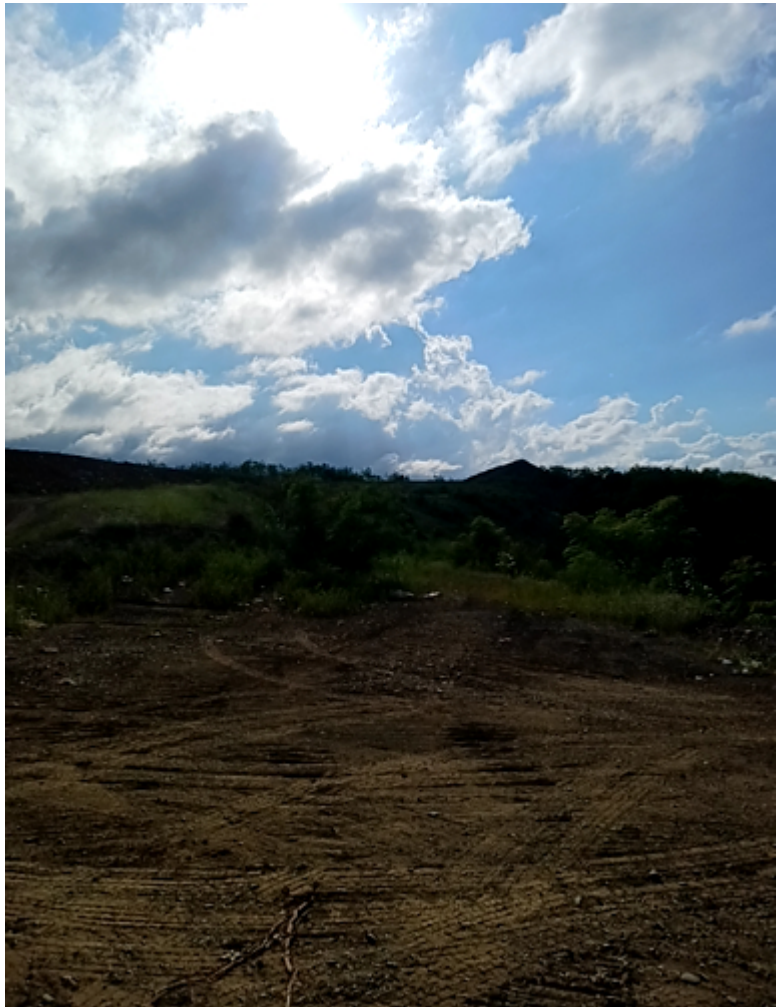
**Incluir foto**

**Condicion Operacion Recibo de Escombros**

Necesita Limpieza

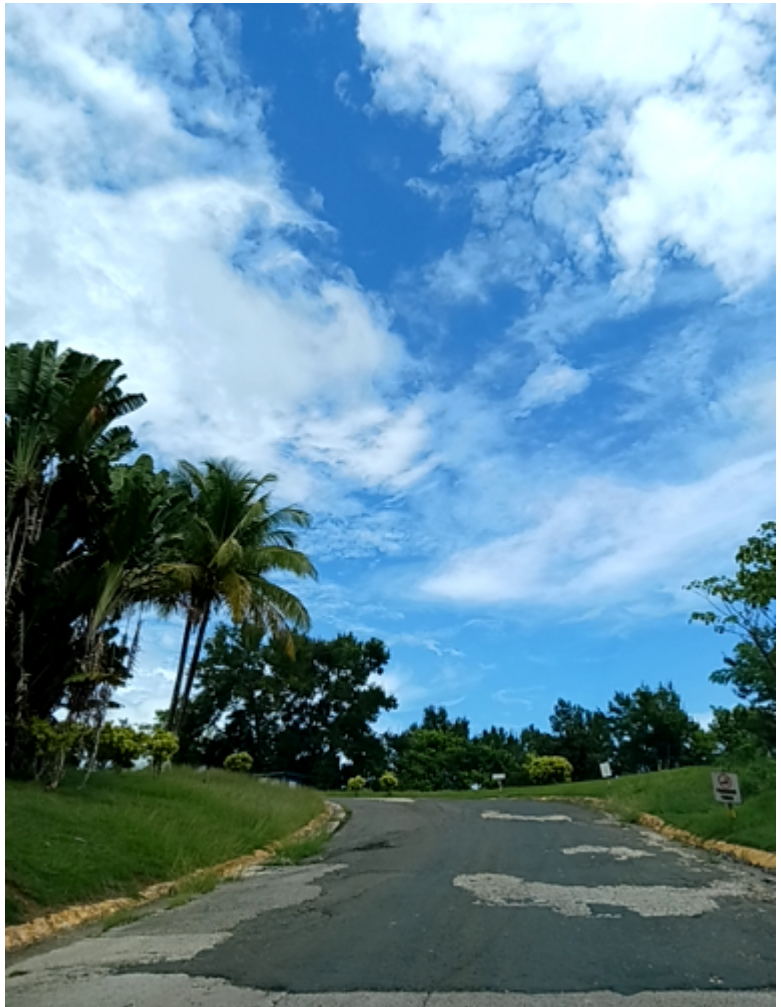
**Incluir Foto**

**Estan los diques limpios y sus  
valvulas cerradas con candado?**

SI

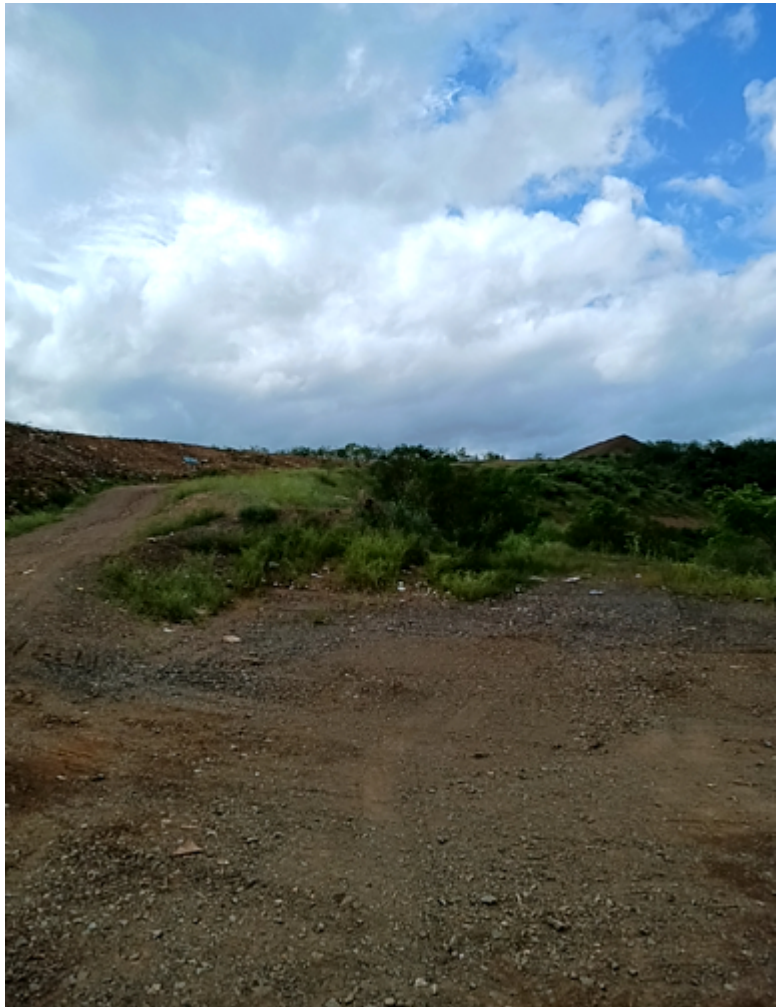
**Incluir foto**

**Condicion Operacion Recibo de Escombros**

Necesita Limpieza

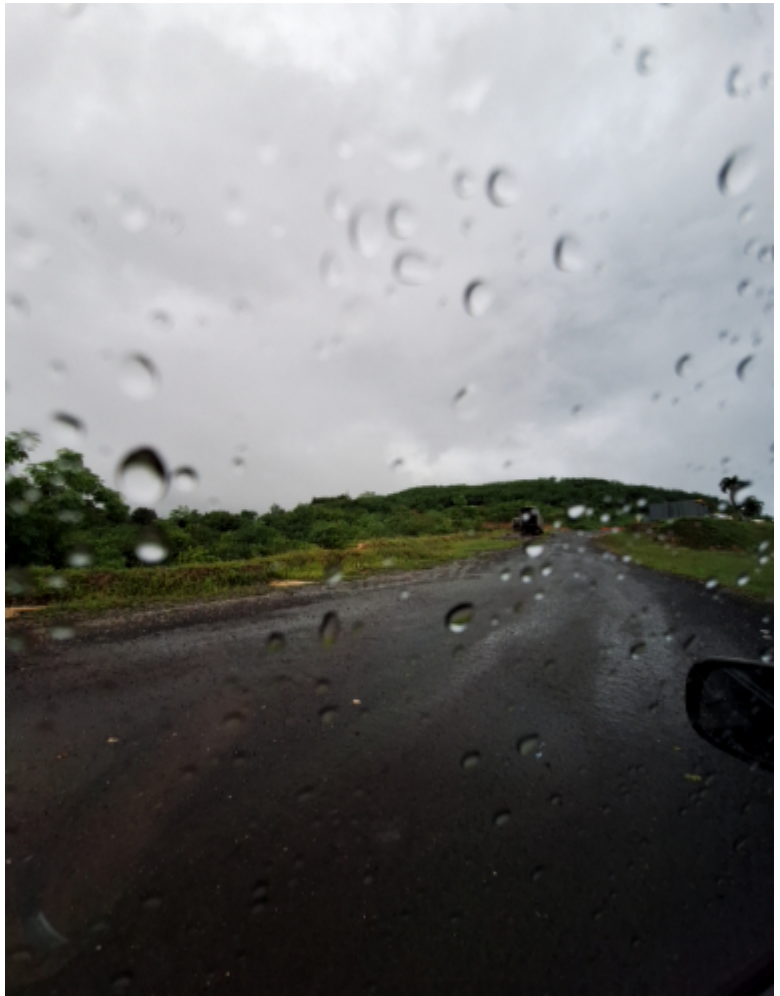
**Incluir Foto**

**Estan los diques limpios y sus  
valvulas cerradas con candado?**

SI

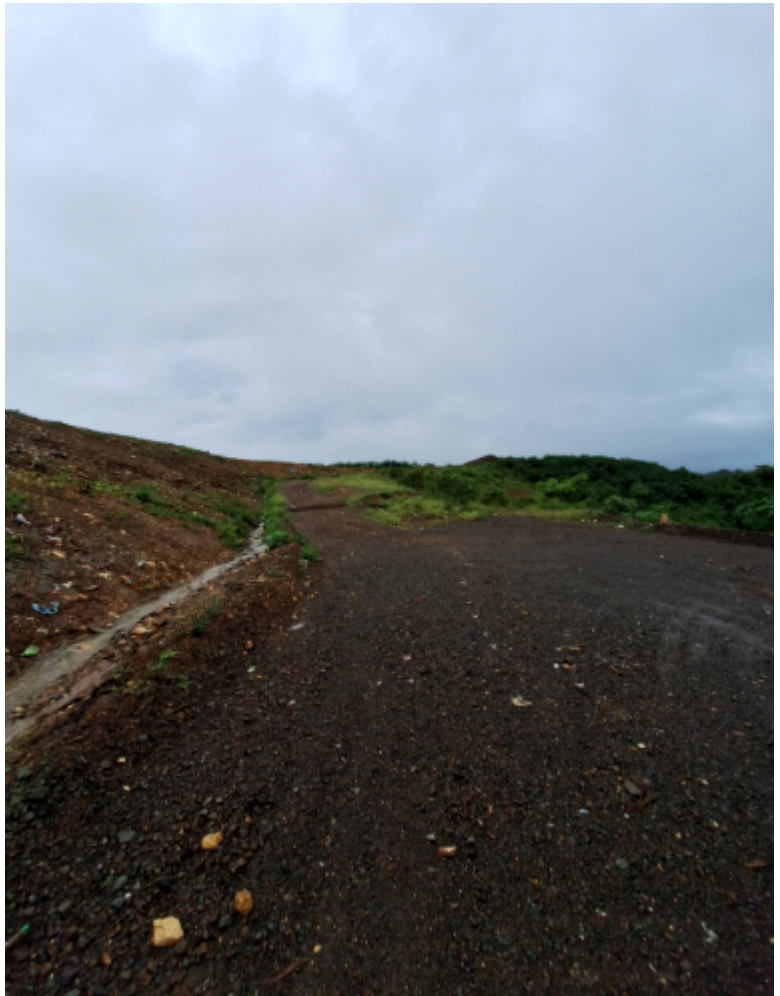
**Incluir foto**

**Condicion Operacion Recibo de Escombros**

Necesita Limpieza
