MUNICIPALITY OF TOA ALTA JANUARY 2023 MONTHLY REPORT  
Civ. No. 3:21-01087-DRD

N. AYALA  
TERRATEK ENGINEERING GROUP, PSC  
P.O. Box 367445 San Juan, PR 00936

Municipality of Toa Alta Civ. No. 3:21-01087-DRD		
Reporting Period:	February 01 to 28, 2023	
Reporting Number:	07	
Reporting Official:	Nivia Ayala, PE/TerraTek	
Reporting Date:	3/18/2023	
Description of Compliance with each requirement of the Order		
ID	Requirement	Compliance Status
1	Daily Cover	Daily cover was completed prior to April 30, 2022.
2	Cessation of Waste Disposal	In-Compliance
3	Posting of Signs	In Compliance
4	Intermediate Cover	Intermediate cover was scheduled to start by October 1, 2022. In a meeting with DNER, MTA agreed to start intermediate cover task by July 01, 2023, to the top deck and including stormwater runoff chutes. After DNER approves, or approves with modifications or conditions, any MTA revised permanent closure plan, and if the approved plan includes a schedule for completion of Intermediate Cover, that schedule shall control. Please see Additional comment for ID 4 item.

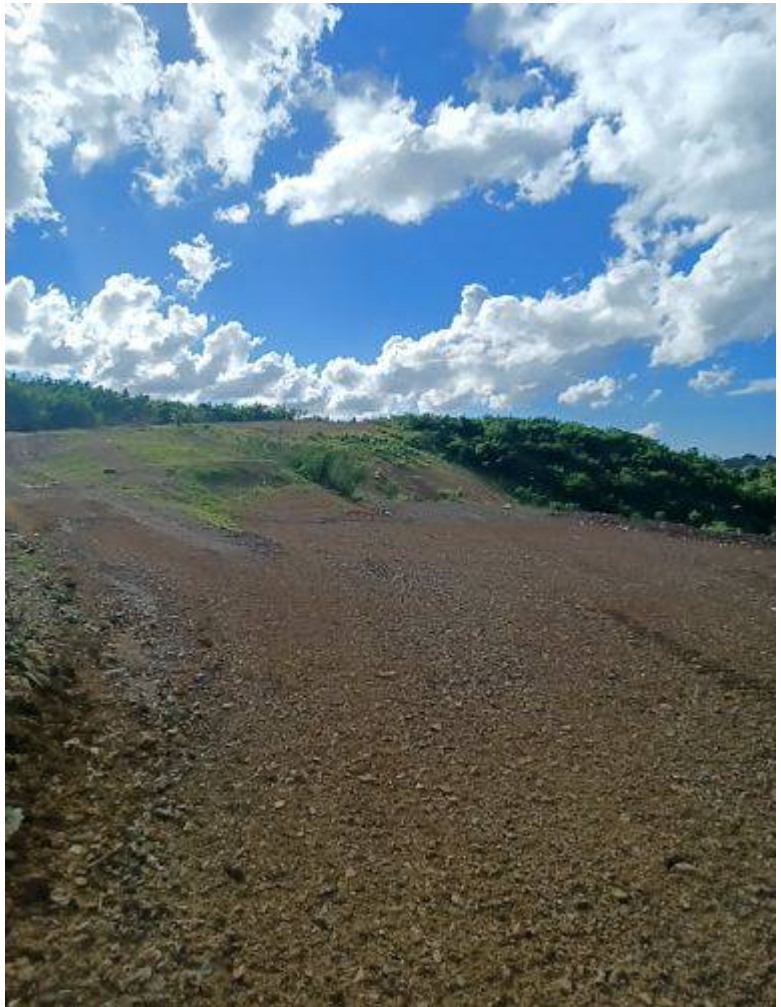
**Condicion Operacion Recibo de Escombros**

Necesita Limpieza

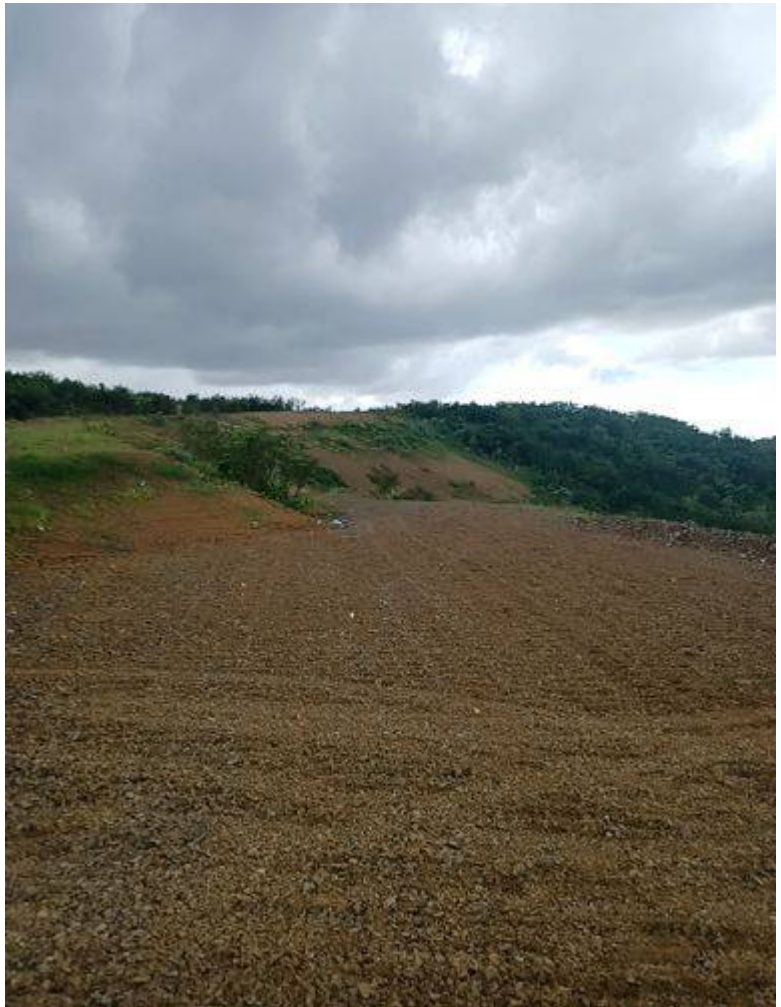
**Condicion Operacion Recibo de Escombros**

Necesita Limpieza

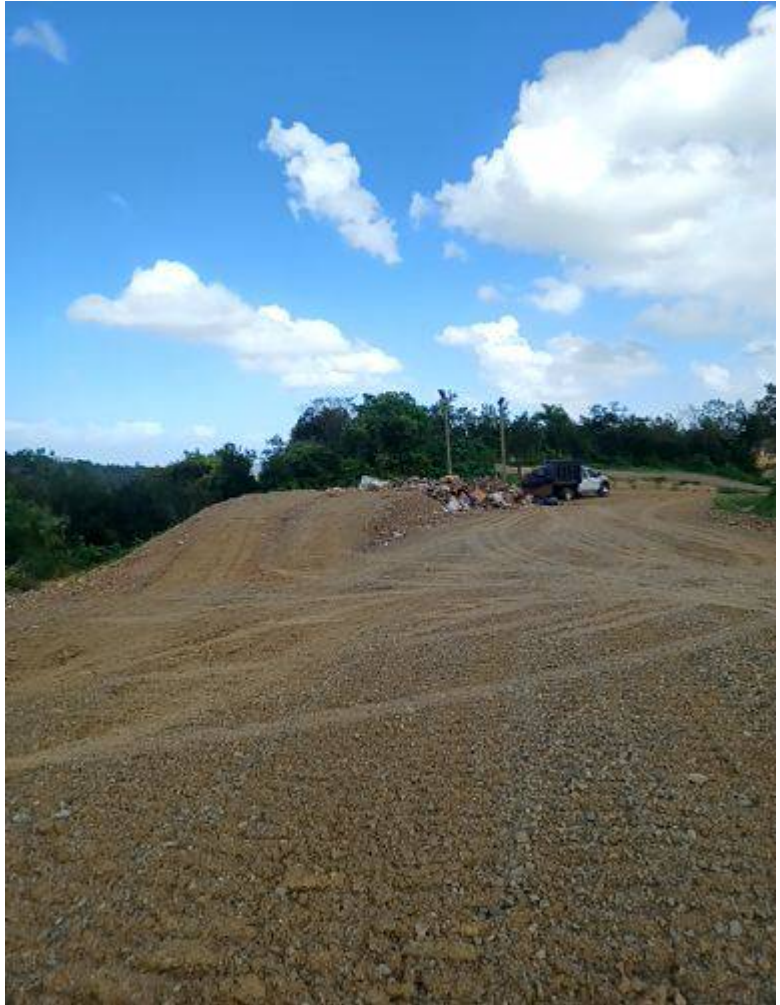
**Tomar foto**

**Condicion Operacion Recibo de Escombros**

Necesita Limpieza
