MUNICIPALITY OF TOA ALTA JULY 2024
MONTHLY REPORT
CIV. No. 3:21-01087-DRD

NIVIA I. AYALA, PE
TERRATEK ENGINEERING GROUP, PSC
P.O. Box 367445 San Juan, PR 00936

Municipality of Toa Alta Civ. No. 3:21-01087-DRD		
Reporting Period:		July 01 to July 31, 2024
Reporting Number:		22
Reporting Official:		Nivia Ayala, PE/TerraTek
Reporting Date:		08/30/2024
Description of Compliance with Each Requirement of the Order		
ID	Requirement	Compliance Status
1	Access	In-Compliance
2	Daily Cover	In Compliance
3	Cessation of Waste Disposal	In-Compliance
4	Posting of Signs	In Compliance
5	Intermediate Cover	A new intermediate cover phase spanning approximately 4.5 acres is currently underway, with robust clearing and grubbing activities commencing this month.
6	Maintenance of Cover	In-Compliance
7	Slope Stability	In compliance with agreed short-term controls, safety barrier fencing, and H&S program.
8	Leachate Management	
8a	Leachate Management Plan	A formal Leachate Management Plan was submitted with the Preliminary Closure Plan on October 31, 2023.
8b	Management of Leachate Collected from Landfill	Permit Approved GDG-24-706-001

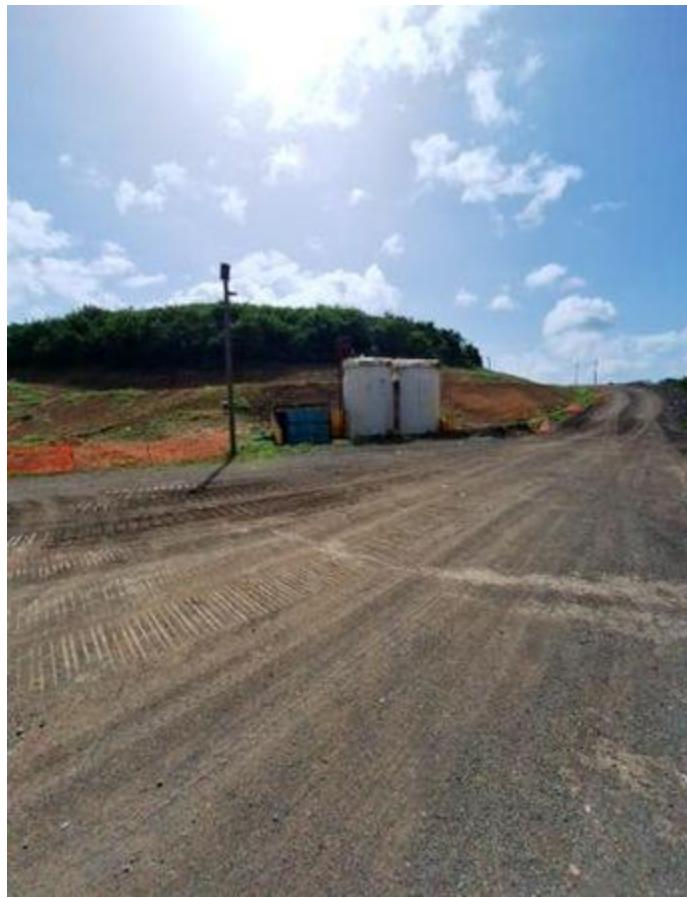
Daily Cover at the facility was completed on April 30, 2022. Daily Cover covered all areas of exposed waste.

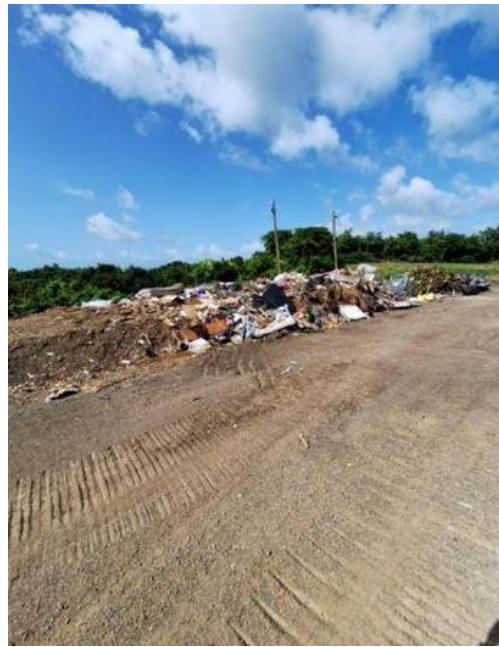
The cessation of waste disposal at the facility was completed by March 30, 2022. However, as agreed in the Stipulation, the temporary storage of construction and demolition (C&D) waste, bulk household waste (durable goods such as mattresses, furniture, and appliances), or yard waste (vegetation waste generated by land maintenance) for final disposal at a different landfill is active and been performed daily.

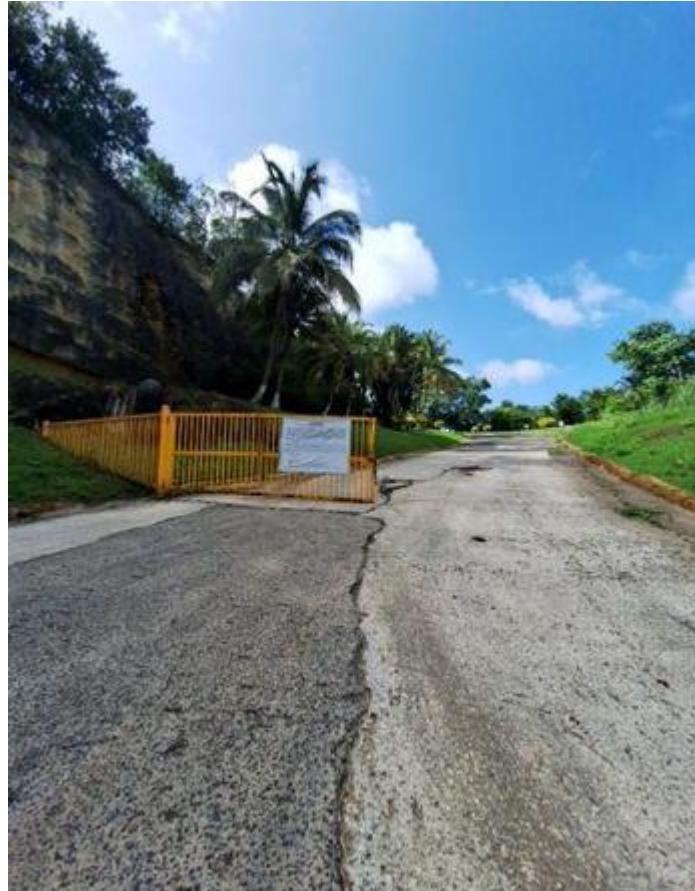
Foto Entrada

Esta la entrada limpia y libre de Si
basura?

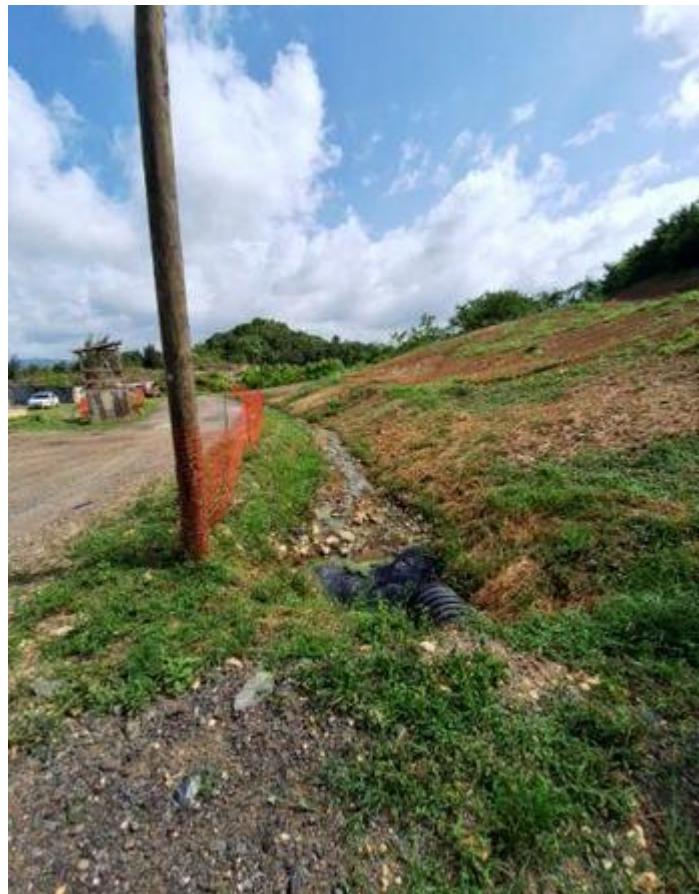
Tomar foto de bermas y canales

Buena

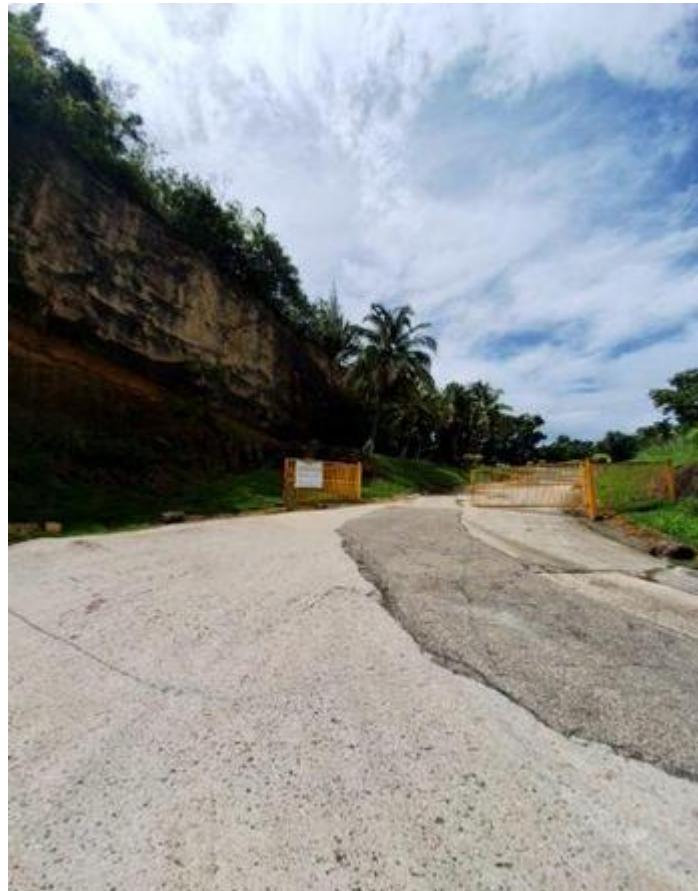
Foto Entrada

Esta la entrada limpia y libre de Si
basura?

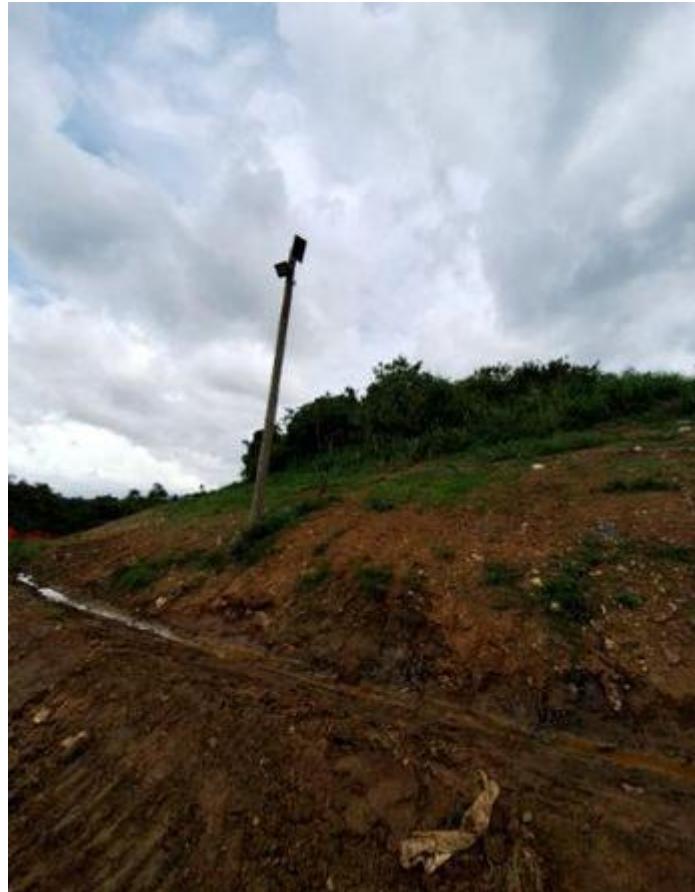
Incluir Foto de los datos del pluviometro

Los datos del pluviometro se reportan a las oficinas centrales. Segun se aprecia en el instrumento no hay lluvia acumulada.

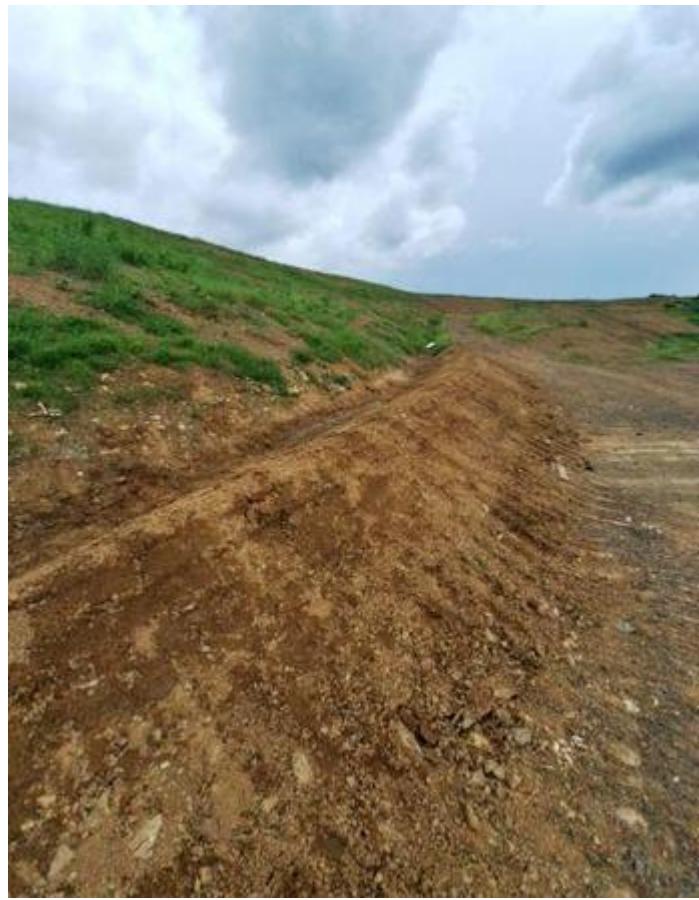
Tomar foto de bermas y canales

Buena

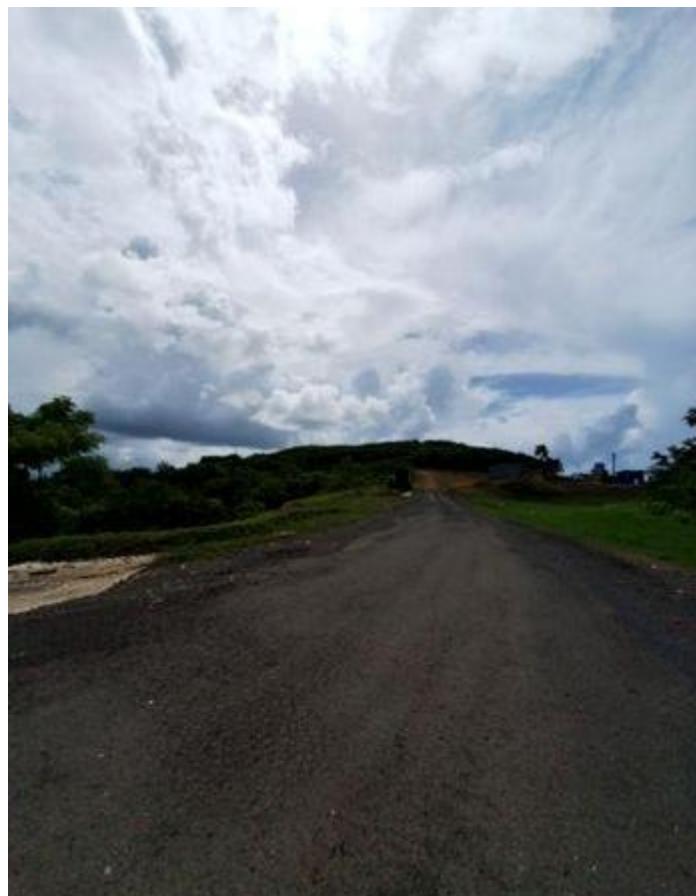
Añadir fotos sobre las condiciones del camino perimetral.

Excelentes condiciones

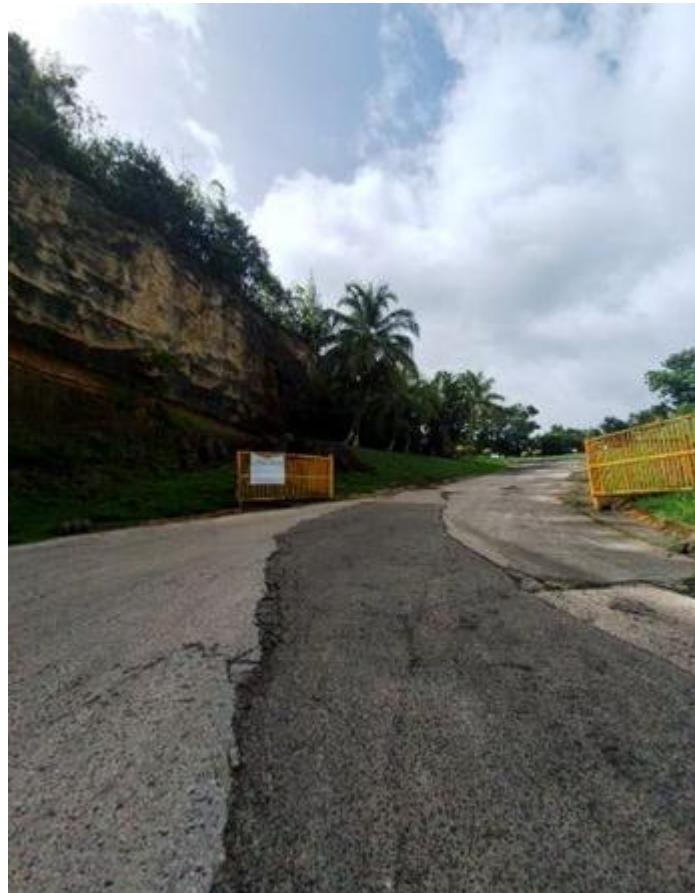
Foto Entrada

Esta la entrada limpia y libre de basura? Si

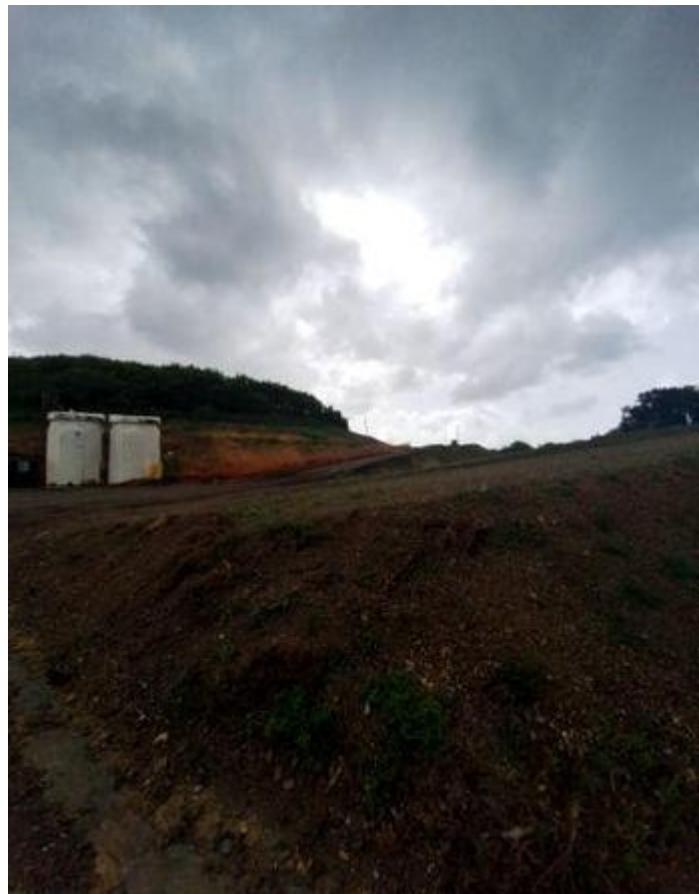
Añadir fotos sobre las condiciones del camino perimetral.

Excelentes condiciones

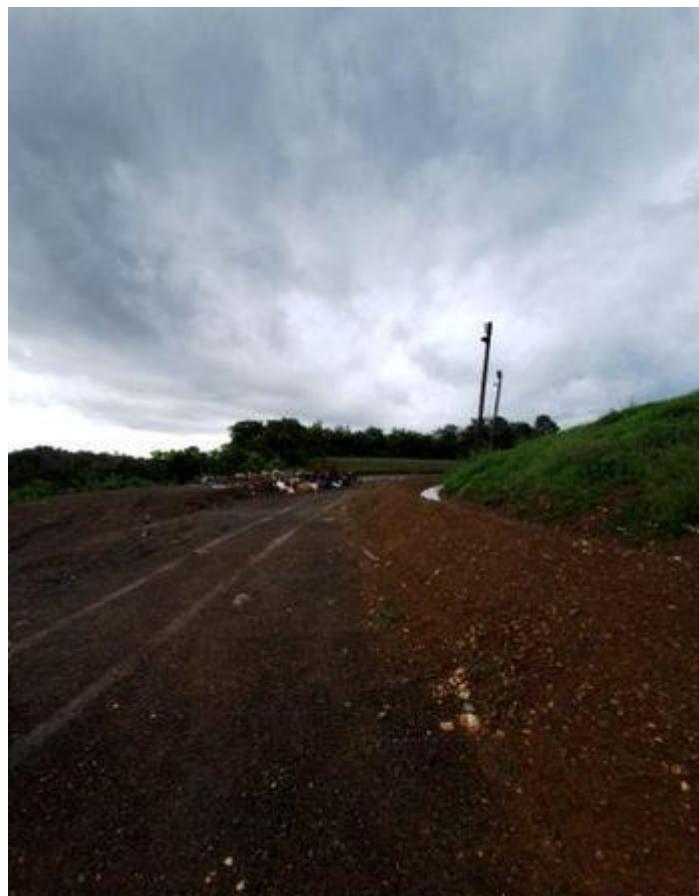
Tomar foto de la estacion de
trasbordo

Condicion Operacion Recibo
de Escombros

Buena

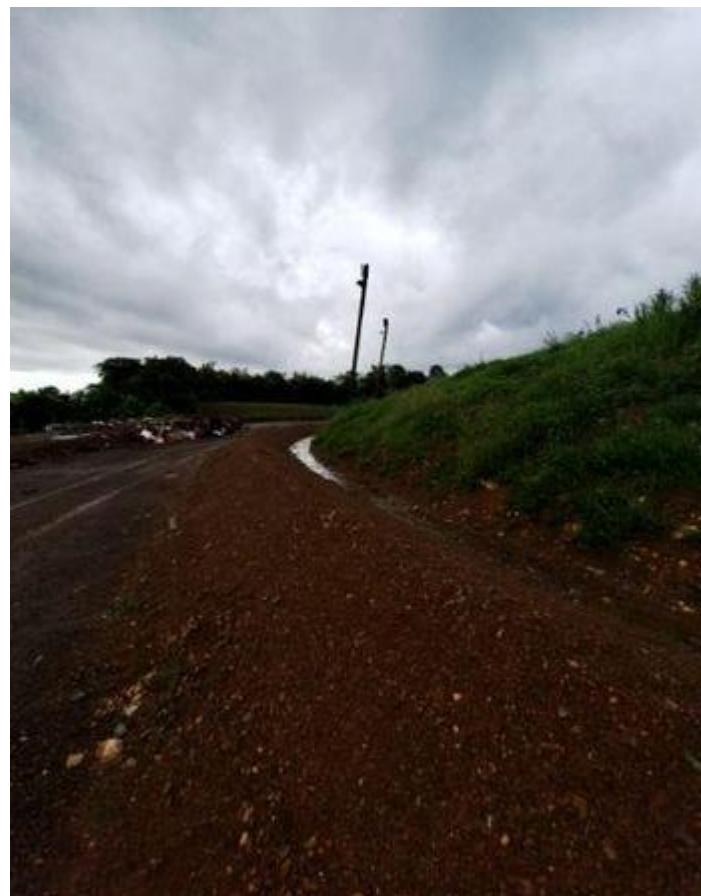
Tomar foto de bermas y canales

Condicion de medidas de control de erosión y sedimentación

Buena

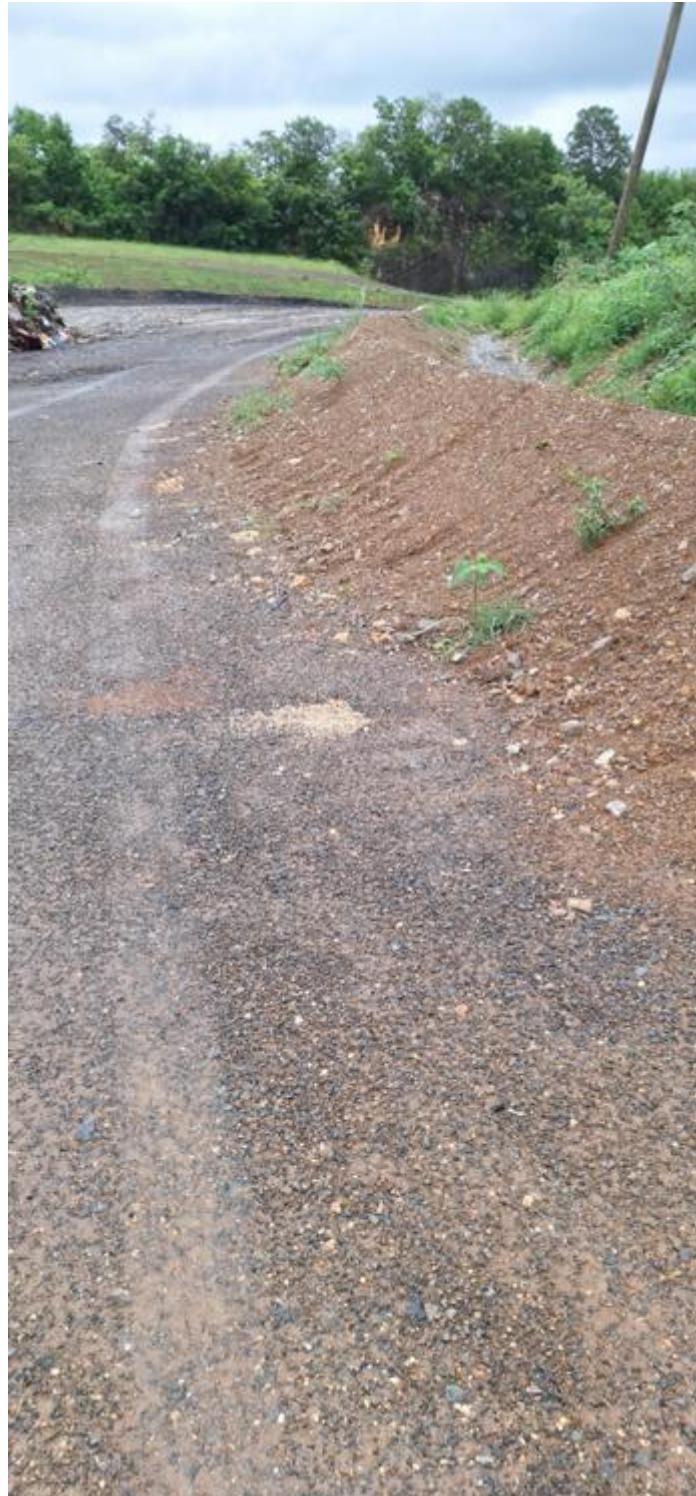
Añadir fotos sobre las condiciones del camino perimetral.

Condicion de los caminos internos

Excelentes condiciones

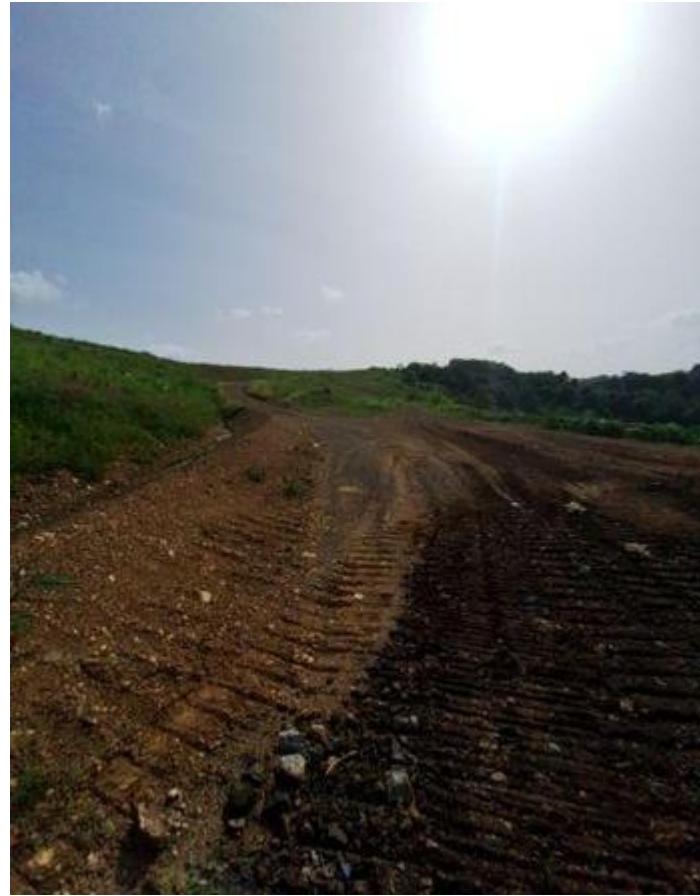
Incluir foto

Condicion de Cubierta Talud
Norte

Excelentes condiciones

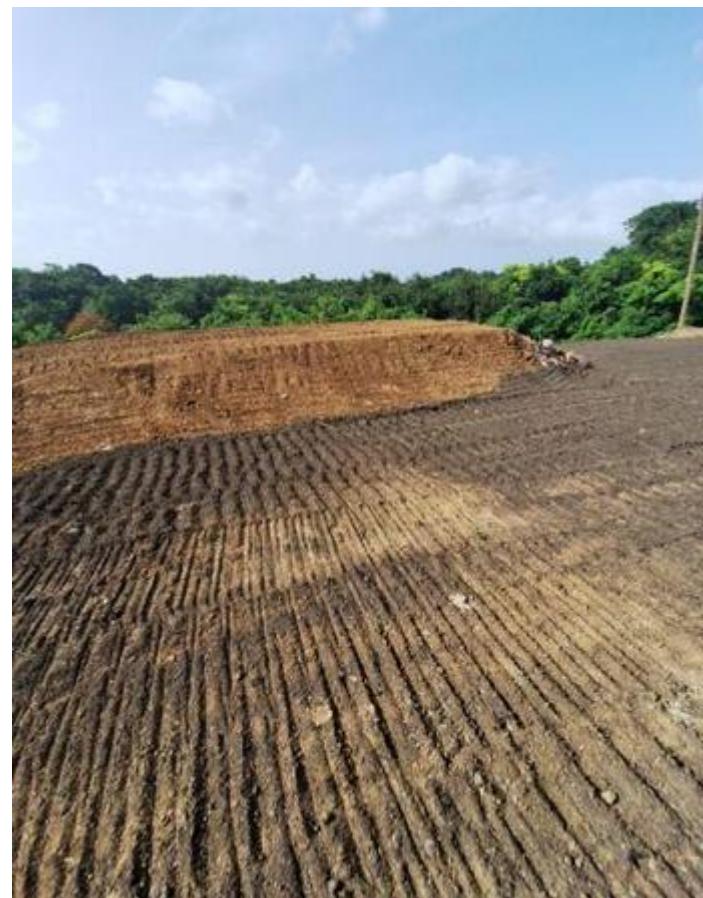
Tomar foto de la estacion de
trasbordo

Condicion Operacion Recibo
de Escombros

Buena

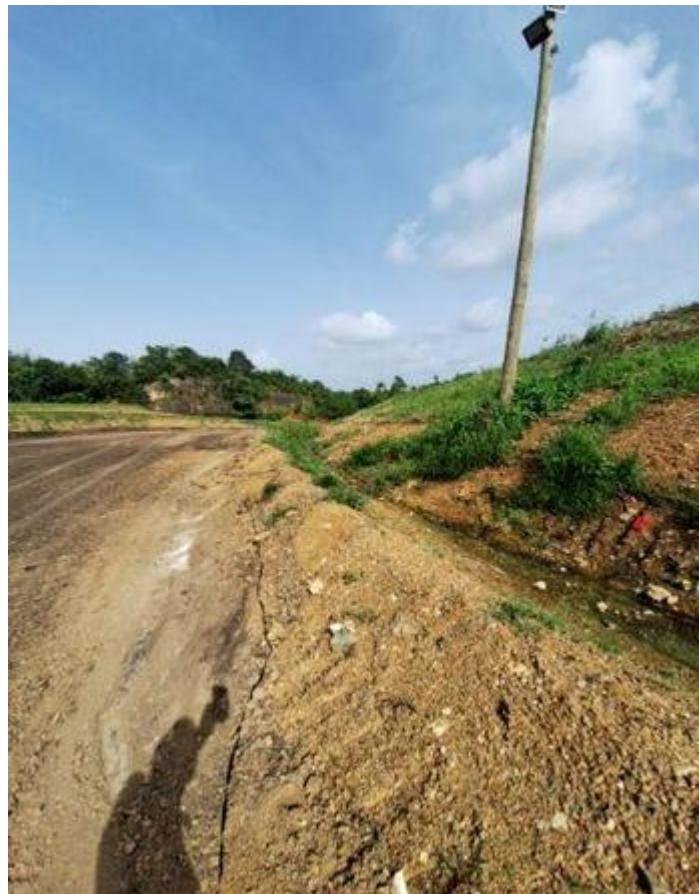
Tomar foto de bermas y canales

Condición de medidas de control de erosión y sedimentación

Buena

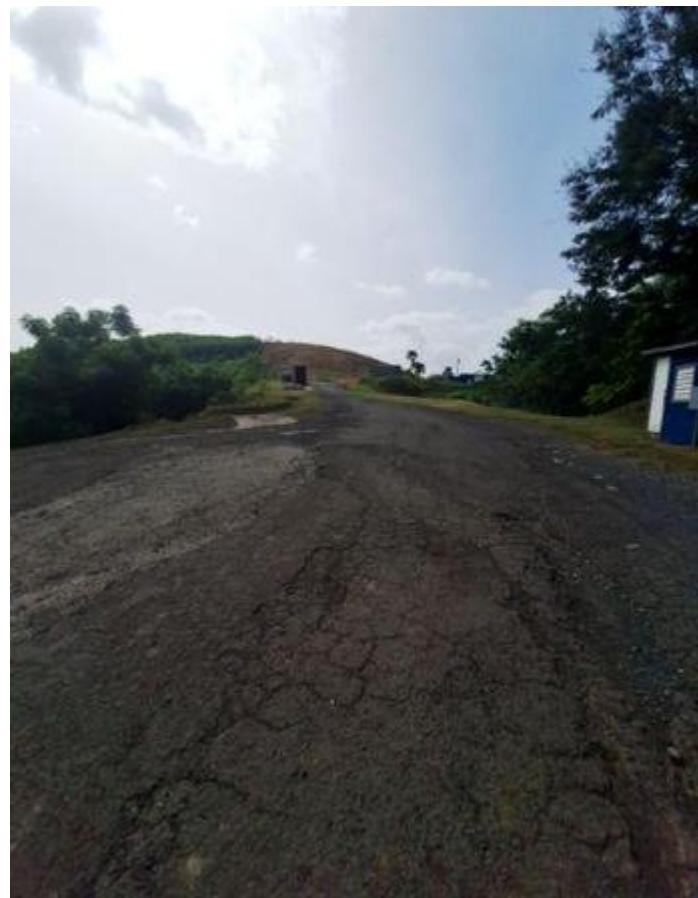
Añadir fotos sobre las condiciones del camino perimetral.

Condicion de los caminos internos

Excelentes condiciones
